# Lake Michigan Watershed Ravine Inventory, Lake and Cook Counties, Illinois

## Summary Report

March 2019

Thirty-three ravines in Lake County and seven ravines in Cook County were assessed in the late fall of 2018 and the early winter of 2019 by Lake County Stormwater Management Commission (SMC). An additional thirteen ravines in Lake County were assessed by the City of Lake Forest in the summer of 2017. Appendix A contains an index map of all the ravines inventoried. It is accompanied by a set of maps with one map for each individual ravine inventoried. This report updates previous summaries produced in 2009 (“Stresses and Opportunities in Illinois Lake Michigan Watersheds: Strategic Sub-Watershed Identification Process Report (SSIP) for the Lake Michigan Watershed Ecosystem Partnership”) and in 2013 (Addendum #1).

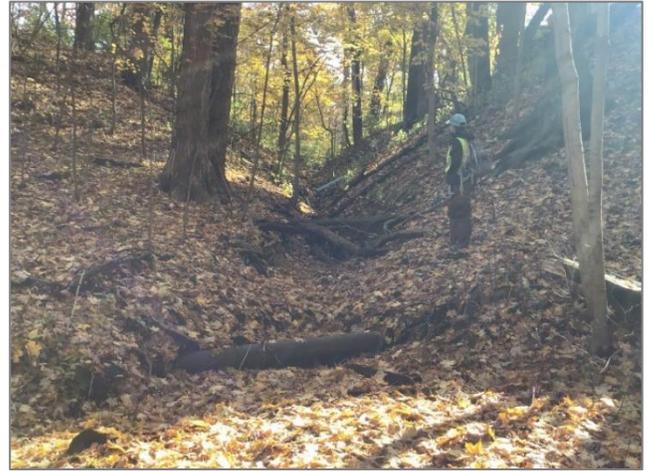
**Figure 1.** Gully rated 'most unstable' in Ravine 7L.

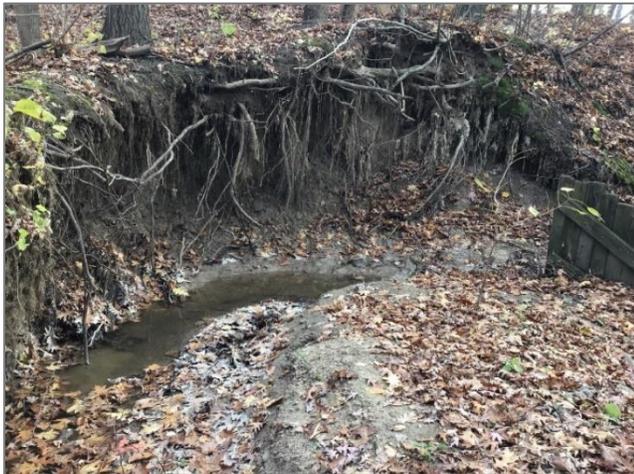
**Figure 2.** Gully rated 'unstable' in Ravine 10L.

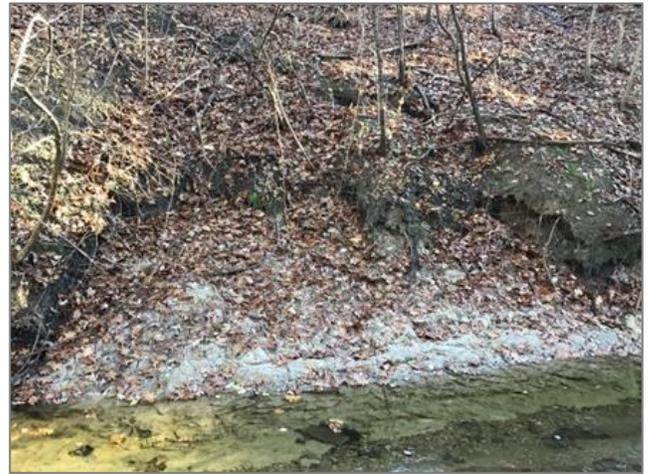
**Figure 3.** Scarp rated 'most unstable' in Ravine 3L.

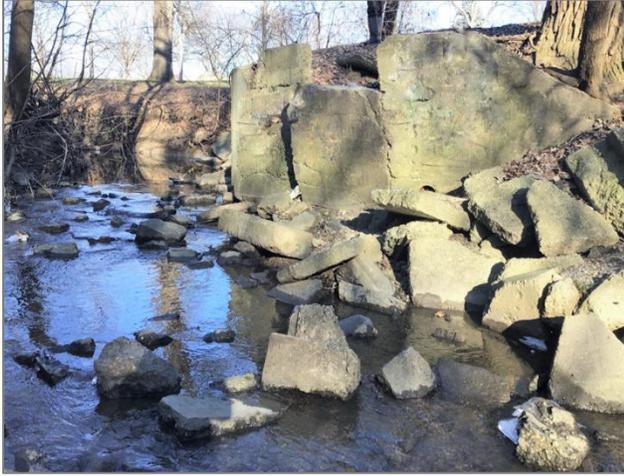
Figure 5. Failed structure, concrete head wall

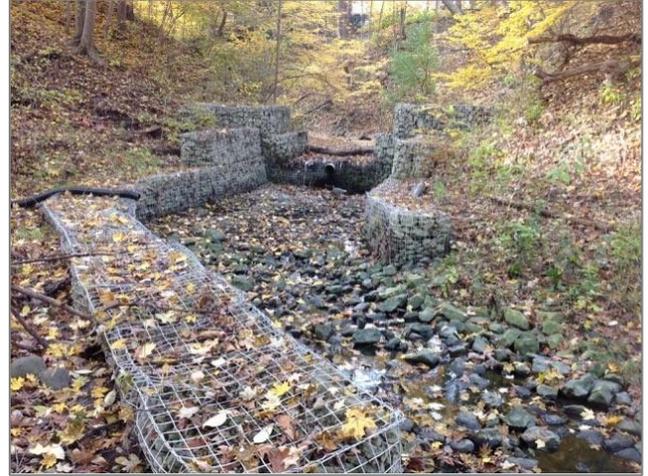
Figure 6. Existing project in Ravine 10L.

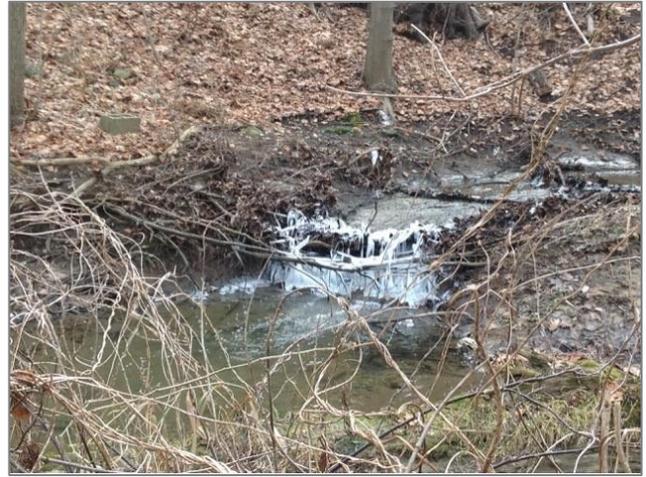
Figure 8. Natural knick point in Bull Creek.

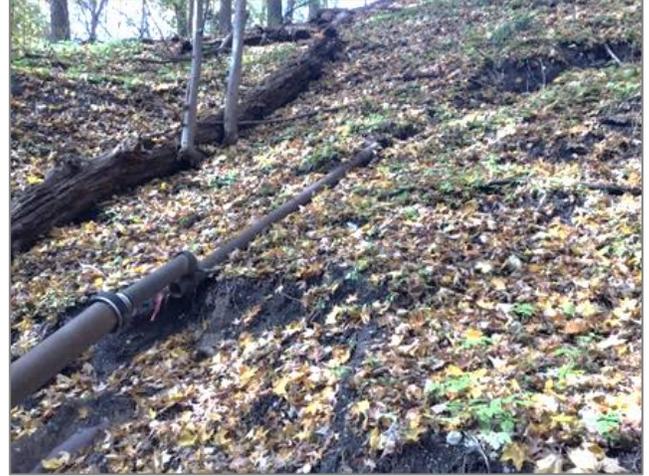
Figure 10. Disconnected metal pipe as a 'discharge point'.
