**2007 SUMMARY REPORT
of
Valley Lake
Lake County, Illinois**

**LAKE COUNTY HEALTH DEPARTMENT
ENVIRONMENTAL HEALTH SERVICES
LAKES MANAGEMENT UNIT**

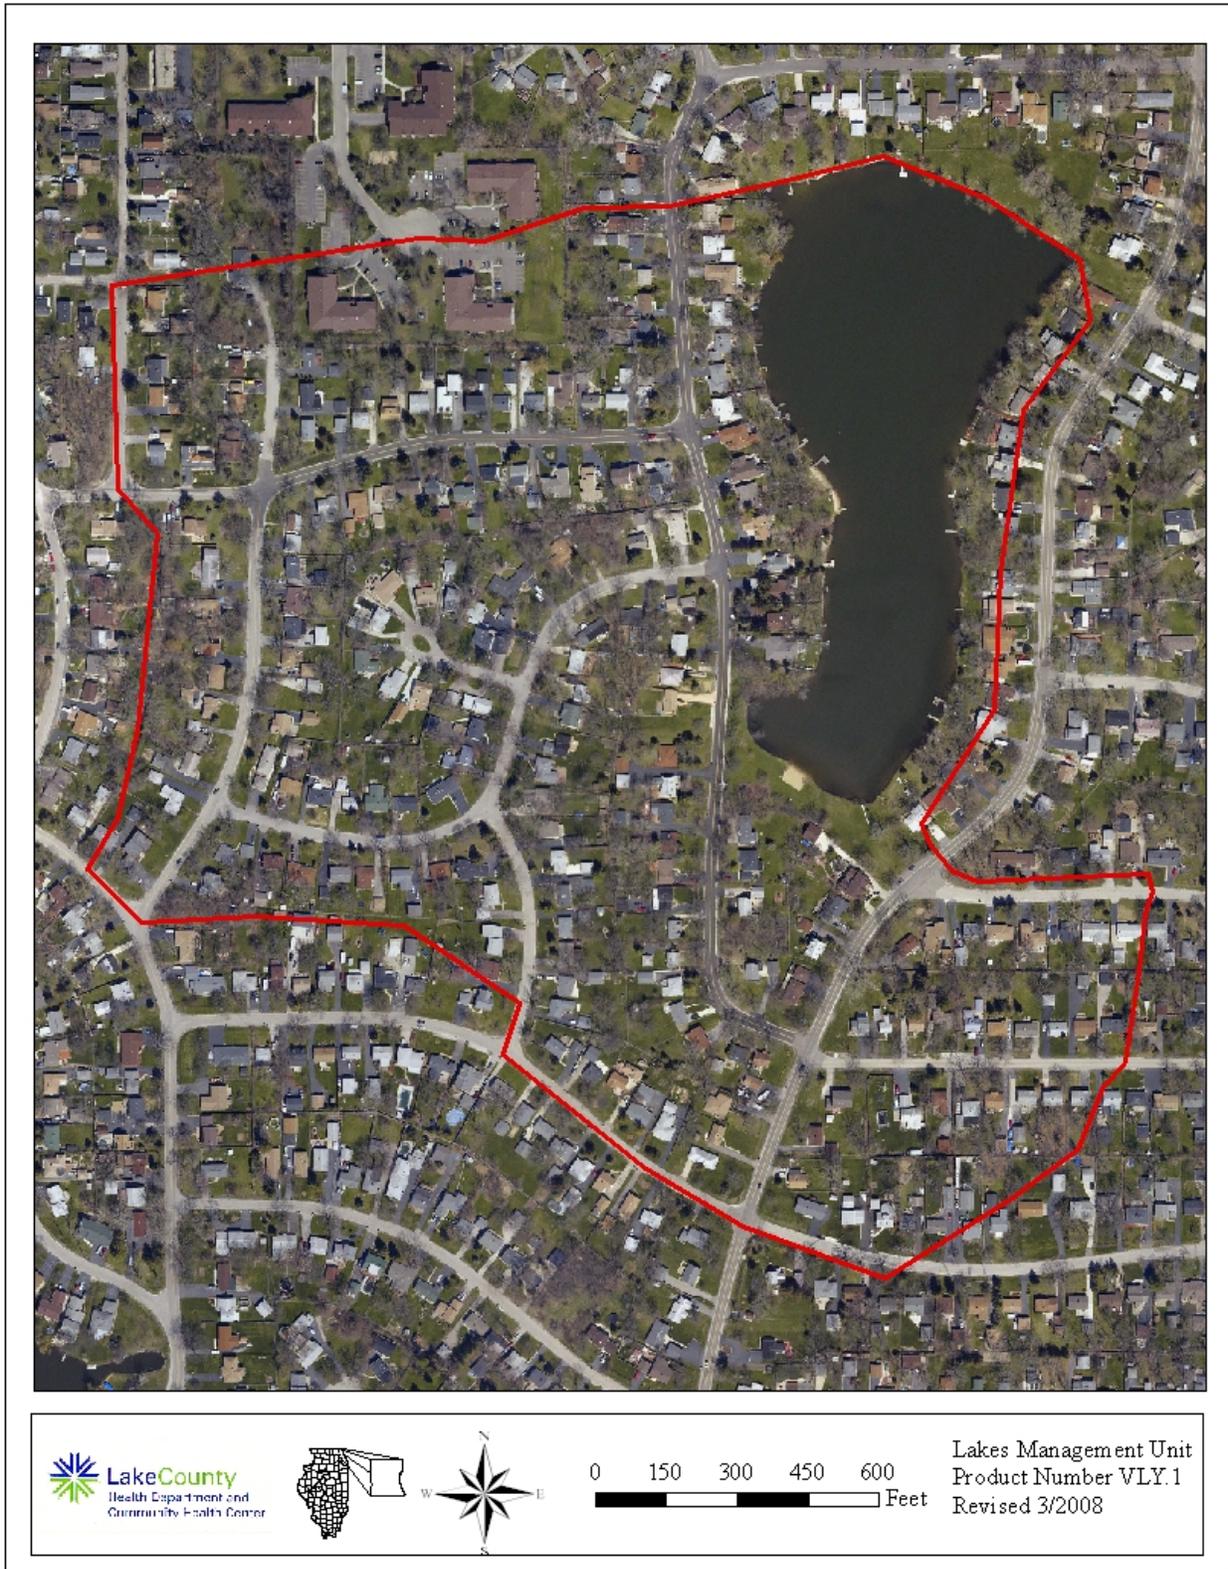
Figure 1. Approximate watershed delineation for Valley Lake, 2007.

Valley Lake receives storm water runoff from an 82.04 acre watershed (Figure 1). Single-family homes cover the largest portion of land (68%) followed by as roads (9%) and multi-family homes (5%, Figure 2). The area directly surrounding Valley Lake was mostly single-family homes, with park areas on the south and north. The large amount of impervious surfaces associated with residential areas (rooftops, driveways, and roads) increase the amount of direct storm water runoff into a lake (Table 1).

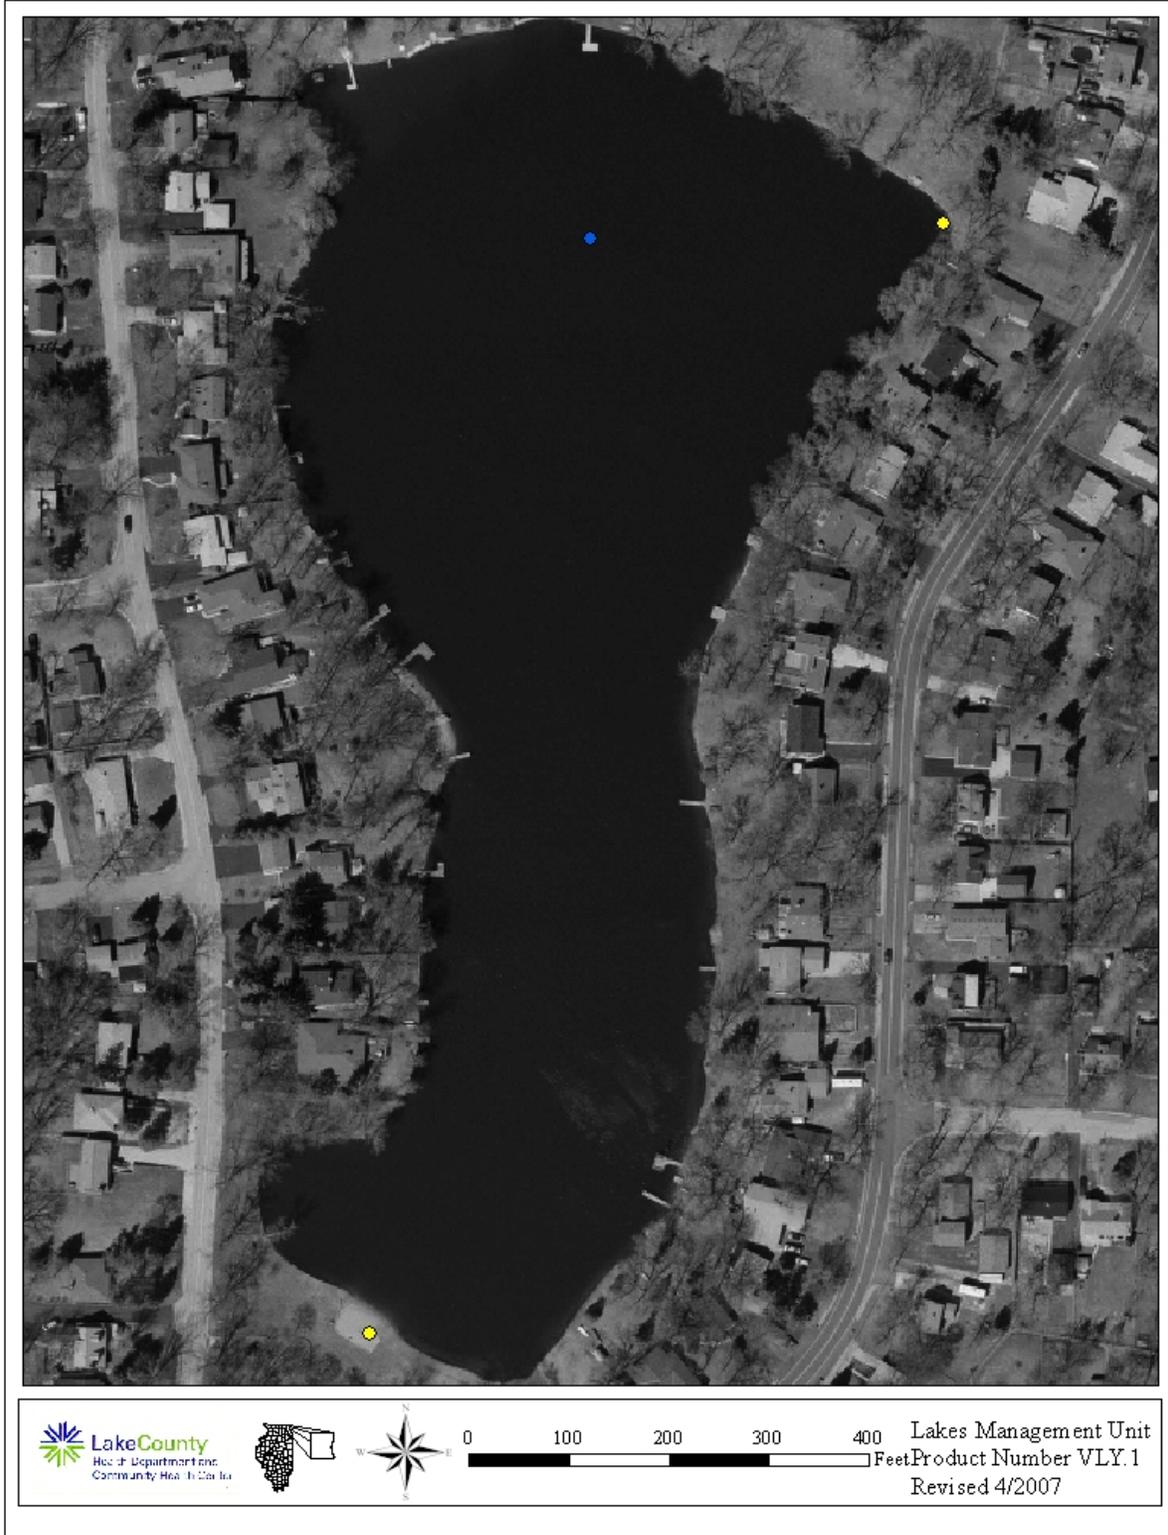
Figure 3. Access and water quality sampling sites on Valley Lake, 2007.

Water samples were taken monthly from May through September at the deepest location in the lake (Figure 3). One sample was taken from the upper water layer (epilimnion) at three feet below the surface and another sample was taken three feet off of the bottom. Both were analyzed for nutrients, solids concentration, and other physical parameters (Appendix A).

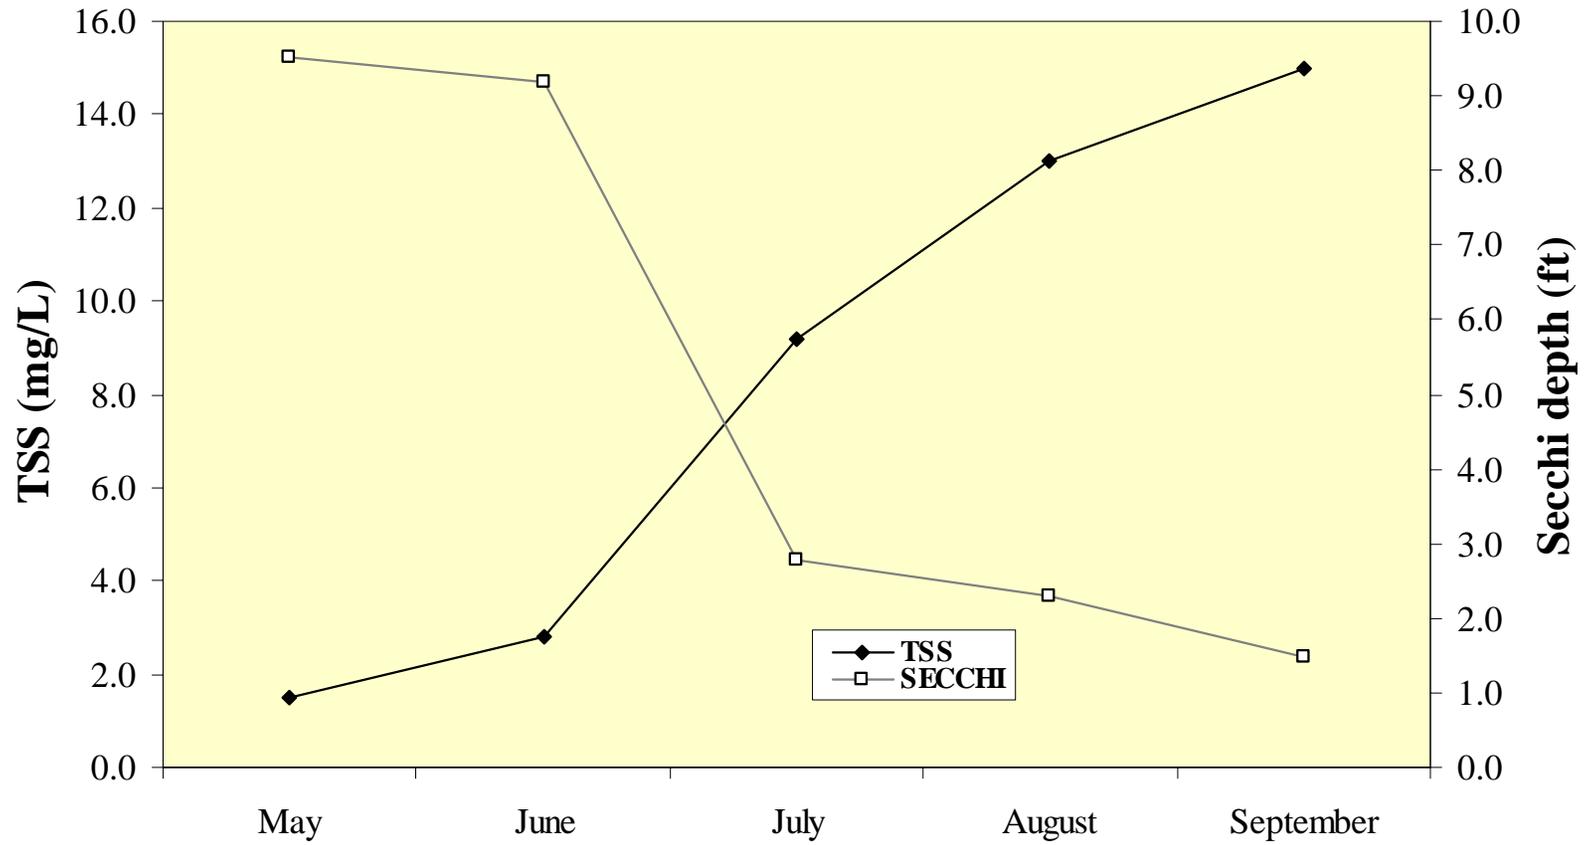
Figure 4. Total suspended solid (TSS) concentrations vs. Secchi disk depth for Valley Lake, 2007.

Secchi depth (water clarity) in Valley Lake was just above the county median (3.28 feet). The average Secchi depth in 2007 was 5.05 feet, which was an increase since the 2000 sampling season when the average was 3.19 feet. May 2007 had the deepest Secchi reading (9.51 feet) while September had the lowest reading (1.49 feet). A drastic change in water clarity occurred from June (9.19 feet) to July (2.78 feet) that can be attributed to rain fall. The Stormwater Management Commission rain gauge at Gages Lake recorded 19.75 inches of rain June to September. In addition, a blue-green algae bloom was noted in July that contributed to the low Secchi readings. These Secchi depths correlate to the amounts of TSS found at the same sampling times (Figure 4).

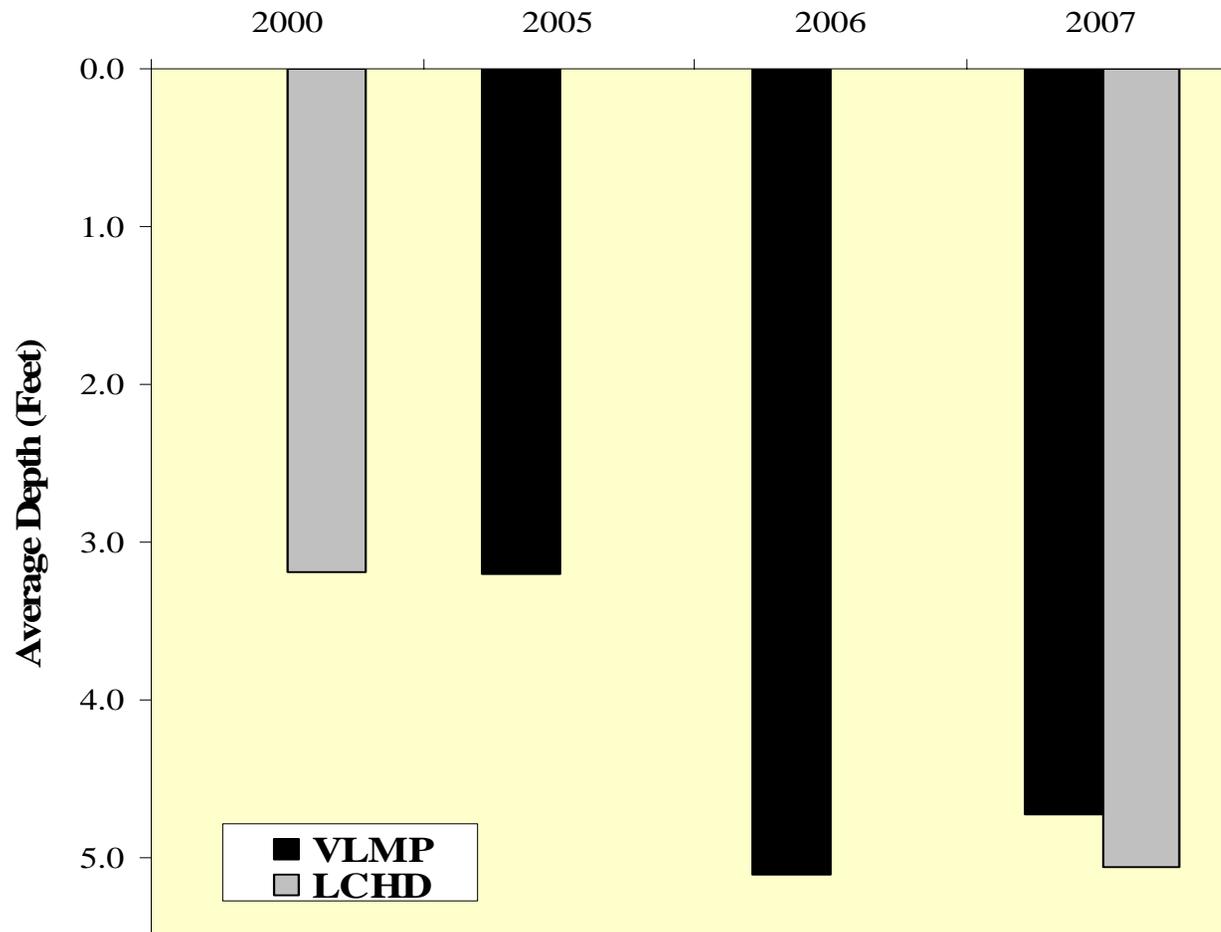
Figure 5. Comparison of average Secchi disk depths between VLMP records and LCHD records from 2000-2007 for Valley Lake

Valley Lake has participated in the Illinois Environmental Protection Agency's (IEPA) Volunteer Lake Monitoring Program (VLMP) since 2005. The VLMP Secchi depth averages over the past five years have been between 3.19 feet and 5.05 feet (Figure 5). The VLMP data

from 2005 through 2007 had an average Secchi depth of 4.34 feet while the LMU average from 2000 and 2007 was 4.12 feet. The volunteers at Valley Lake have provided exceptional and accurate data that is vital for the continued monitoring and management of this lake. The Lakes Management Unit would like to thank them for the efforts.

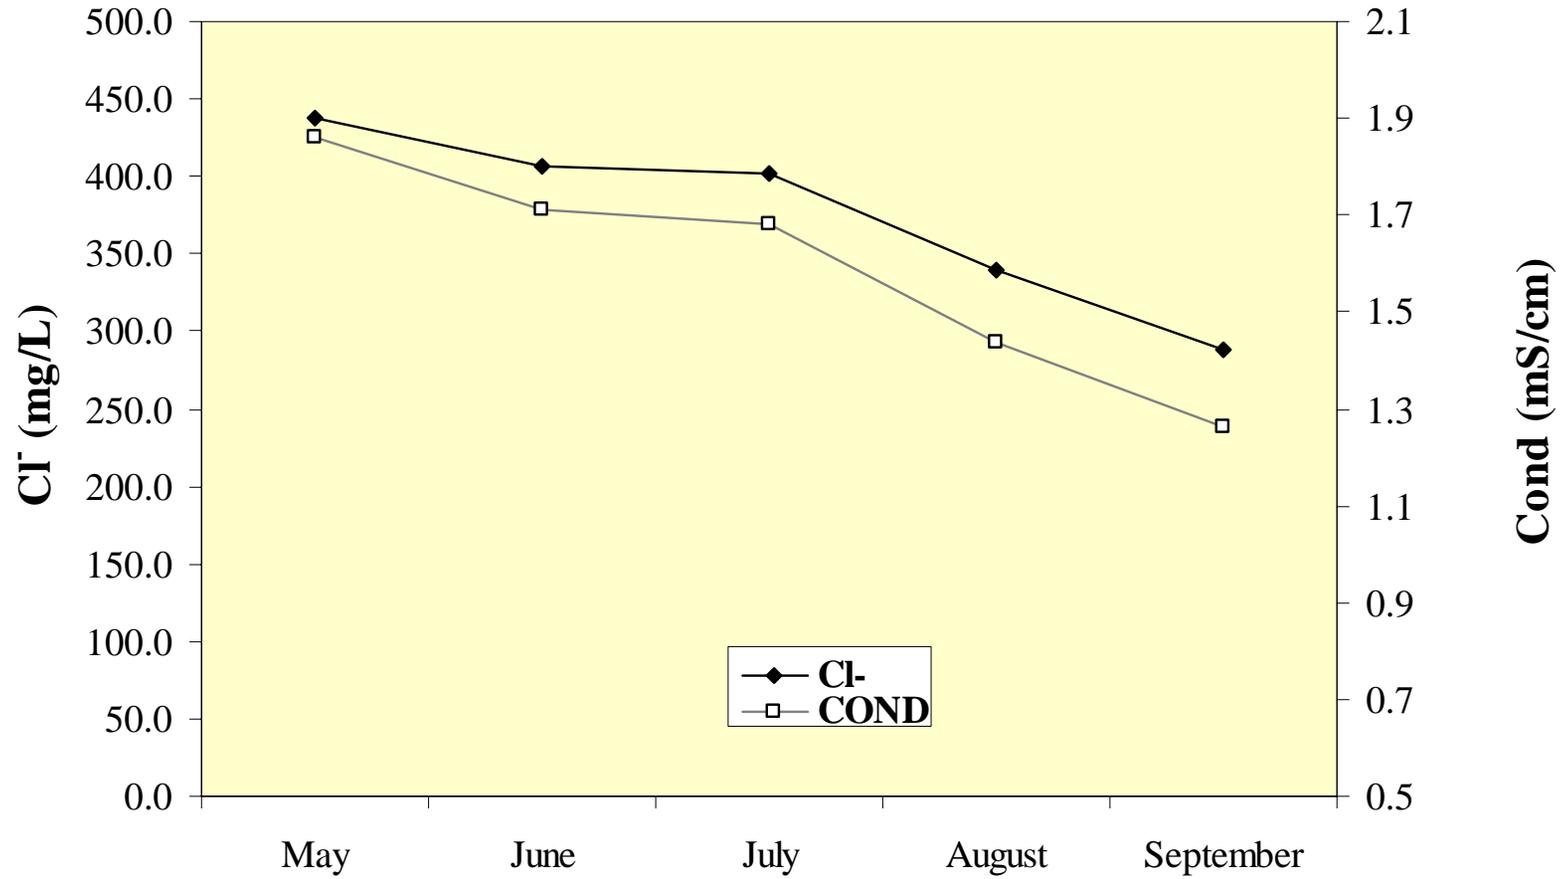
Figure 6. Chloride (Cl⁻) concentration vs. conductivity for Valley Lake, 2007.

Conductivity is the measure of dissolved ions within water. An increase in conductivity amplifies water's ability to conduct electricity. In Valley Lake, average conductivity in 2007 was 1.5912 mS/cm. This was a 35% increase from the 2000 value of 1.1754 mS/cm and almost twice the county median (0.8038 mS/cm). Almost all of the lakes in the county are experiencing similar increases in conductivity for the same reason. Road salts used in winter road management runoff into lakes and build up since aquatic organisms cannot use them. This leads to an increase in both conductivity and chloride ion (Cl^-) concentrations, which are correlated (Figure 6). The median Cl^- concentration in the county is 158 mg/L, but Valley Lake had a greater concentration (375 mg/L). Conductivity and Cl^- concentrations decreased from May to August. This was most likely due to the road salts used in winter being diluted. Both conductivity and Cl^- concentrations decreased throughout the summer, which is most likely correlated to the heavy precipitation which occurred July through August.

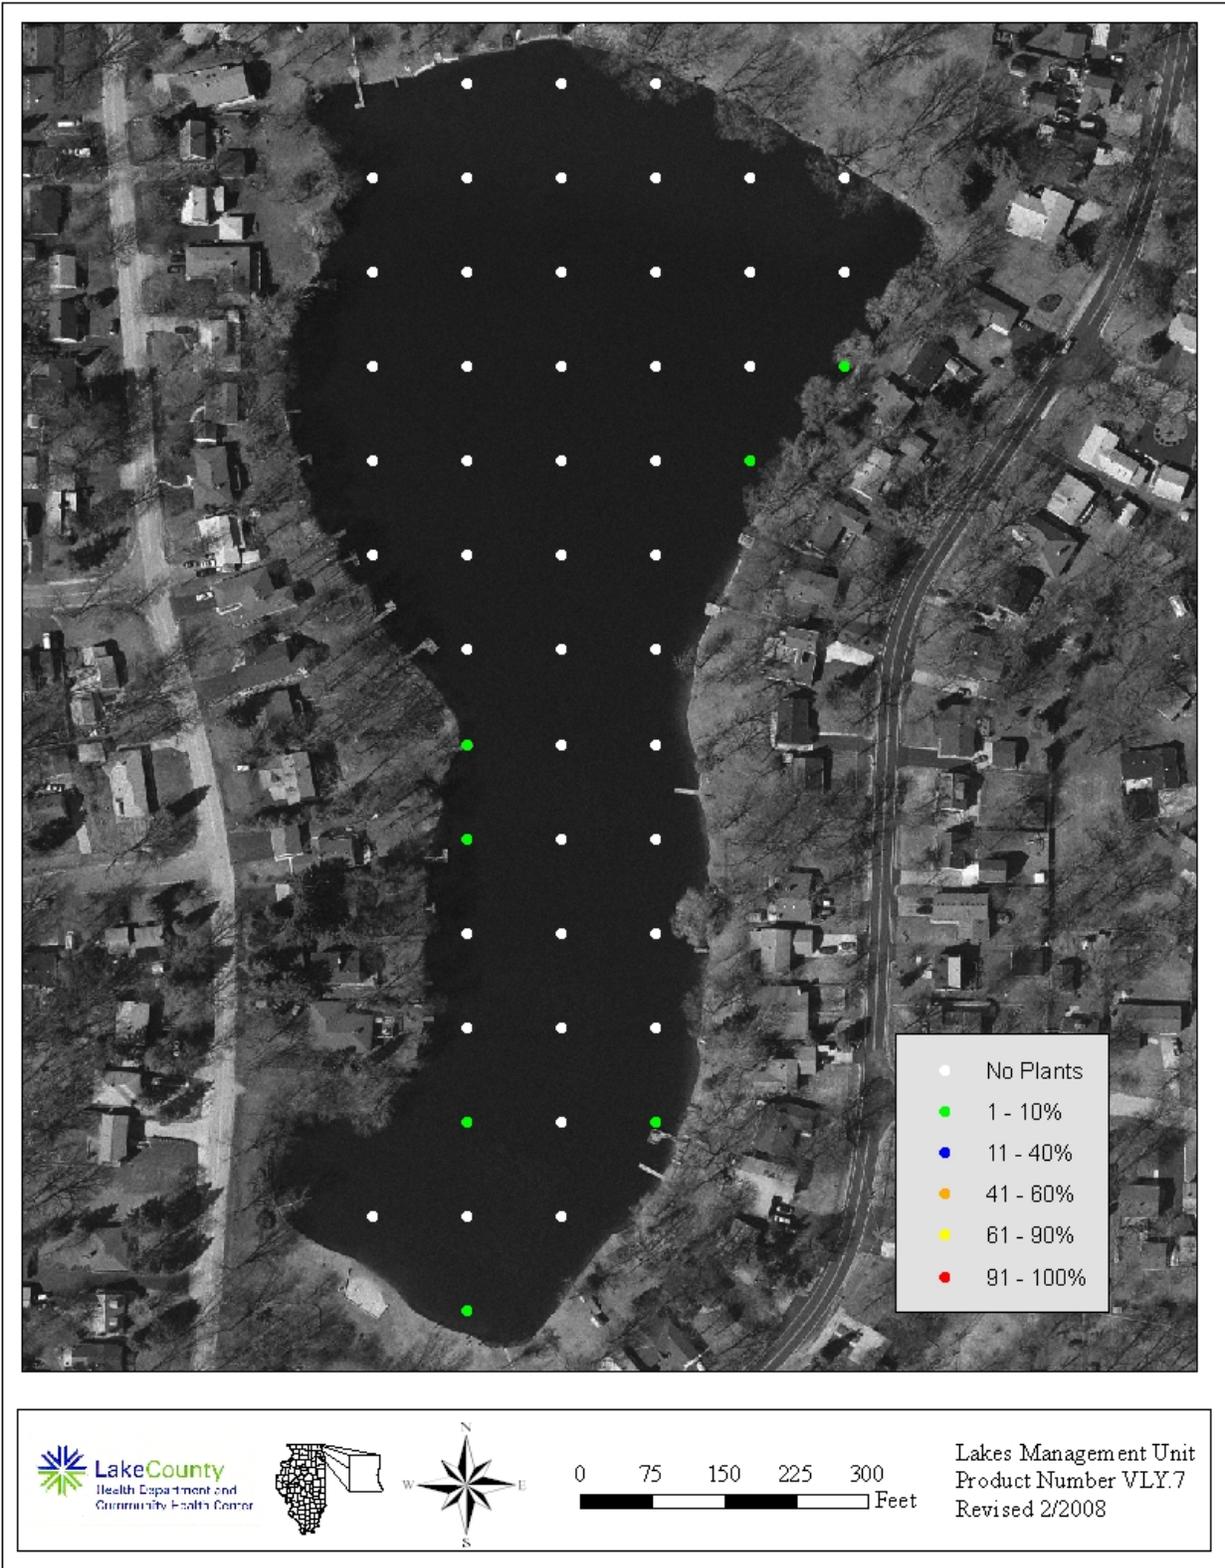
Figure 7. Aquatic plant sampling grid illustrating plant density on Valley Lake, July 2007.

An aquatic plant (macrophyte) survey was conducted in July of 2007. In previous years, the sampler, with the goal of covering most of the lake and finding all species present, chose sampling sites randomly. While this method worked well, a new sampling technique was implemented in 2005, and therefore was used this year on Valley Lake. Sampling sites were based on a grid system created by mapping software (ArcGIS), with each site located 60 meters apart. On Valley Lake, there were 52 sampling sites in 2007 (Figure 7). There were 3 aquatic plant species found with Leafy Pondweed having the highest density (10% of the sites). *Vallisneria* and *Chara* spp. (a macroalgae) were found at 6% and 2% of the sites, respectively (Table 4a). Plants need at least 1% of surface light levels in order to survive. Plants were found down to a depth of 6 feet, which relates to the 1% light level depth of 8 feet. Out of the 52 sample sites, plants were found at 7 of them (13%) (Table 4b).

These sample sites covered the entire lake, and therefore the lake had approximately 13% plant coverage, with none topped out (plants reaching and crowding the surface of the lake). This coverage, while low, was an improvement from 2000 when only *Chara* spp. was found at 8% of sample sites in May, and no other plants were found throughout the rest of the season. Ideally, a lake should have 30-40% plant coverage in order to sustain a healthy fishery, according to the Illinois Department of Natural Resources (IDNR). Valley Lake has a lower than recommended plant community. Because Valley Lake is shallow and receives direct storm water runoff from its watershed, it experiences a high nutrient and TSS load, which makes it difficult to improve water clarity. It is recommended that no herbicide treatments occur in the lake until aquatic plant densities increase. Water clarity will subsequently increase, possibly resulting in nuisance conditions as historically seen in the lake. Thus, the lake's management plan should be drafted to address these issues.

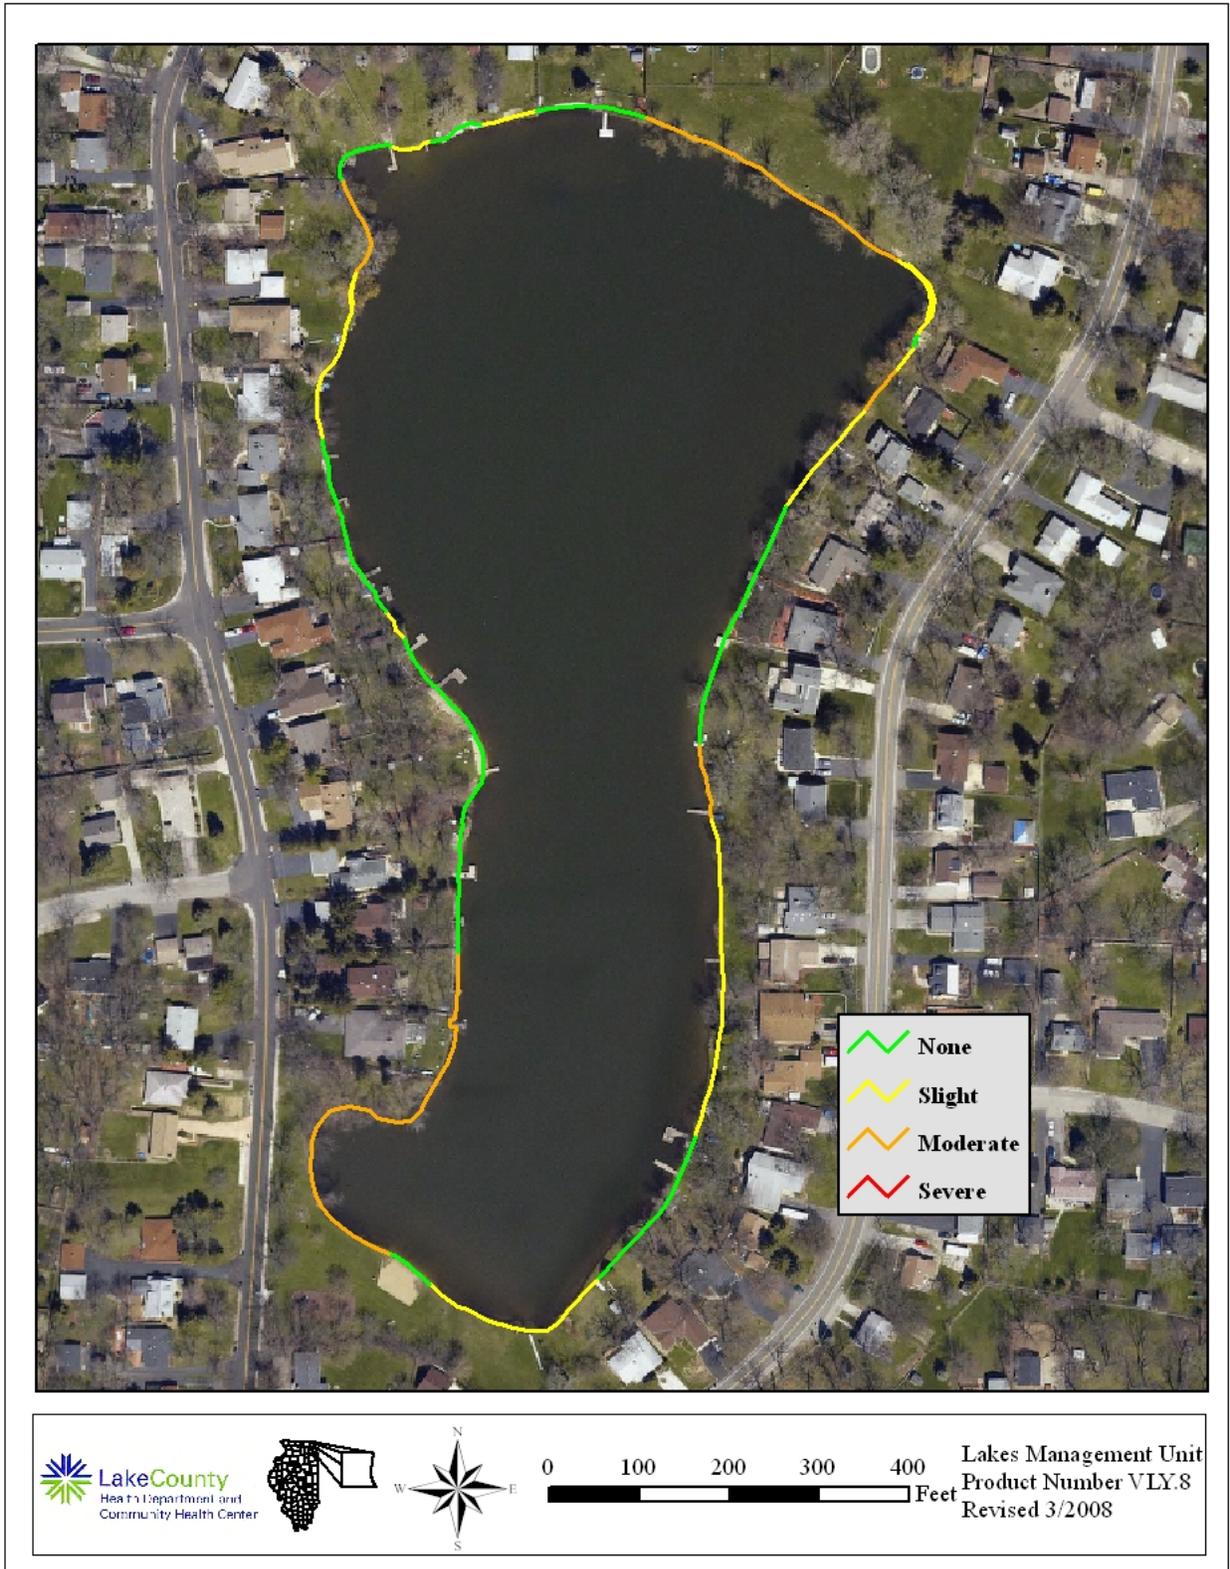
Figure 8. Shoreline erosion on Valley Lake, 2007

The shoreline was reassessed in 2007 for significant changes in erosion since 2000. Based on this assessment, some of the areas of no erosion were reclassified as slightly eroded and areas of slight were reclassified as moderate. Overall, 63% of the shoreline was eroding with 34% slight and 29% moderate. Shoreline erosion increased slightly on the lake from the initial 2000 assessment, both in overall erosion, and in severity where erosion was documented before. However, some shoreline areas improved due to the installment of rip rap or other forms of stabilization.

In 2000 an assessment was conducted to determine the condition of the shoreline at the water/land interface. The entire shoreline was developed, with 70% classified as lawn (mowed turf grass to the water's edge). The two other major shoreline types were rip-rap (7%) and seawall (5%). Beach made up 4% of the total shoreline. Approximately 61% of the shoreline was eroding with 51% classified as slight and 10% classified as moderate. The shoreline was reassessed in 2007 for significant changes in erosion since 2000. Based on this assessment, some of the areas of no erosion were reclassified as slight and areas of slight were reclassified as moderate (Figure 8). Overall, 63% of the shoreline was eroding with 34% slight and 29% moderate. Continued neglect of these shorelines could lead to further erosion, resulting not only in a loss of property, but additional soil inputs into the water that negatively affect water quality.

It is much easier and less costly to mitigate slightly eroding shorelines than those with severe erosion. Repairing these shorelines by installing riparian buffer strips with native plants will help restore the quality of Valley Lake in a variety of ways. First, the new native plants can stabilize the shoreline to prevent future erosion. Second, there will be an increase in habitat for wildlife to a shoreline that is otherwise limited. Thirdly, buffer habitat will help filter pollutants and nutrients before entering the lake, increasing water quality.

There are areas around the lake with erosion. These eroded areas should be remediated to prevent additional loss of shoreline and prevent continued degradation of the water quality through sediment inputs. When possible, the shorelines should be repaired using natural vegetation instead of riprap or seawalls (Appendix D3).
