2016 LAKE CARINA SUMMARY REPORT

LAKE COUNTY HEALTH DEPARTMENT

Lake Carina, 2016

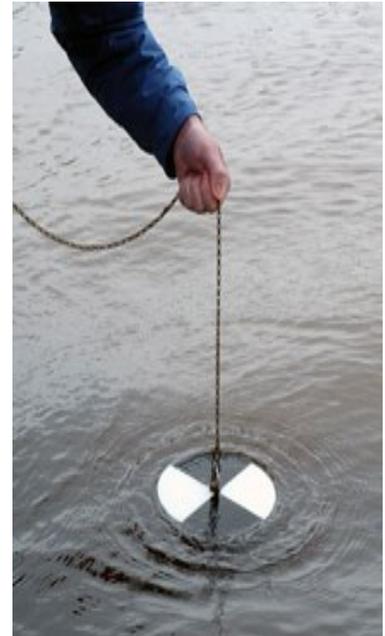
Lake Carina Secchi depth was 16.96 ft., which is above the Lake County median Secchi depth of 2.98 ft.

The 2016 average water clarity in Lake Carina, based on Secchi depth, was 16.96 ft. This is a 28.4% increase since the 2007 water quality sampling, which had a Secchi depth of 13.21 ft. Compared to other lakes in Lake County, Lake Carina is well above the median Lake County Secchi depth of 2.98 ft. Lake Carina is considered a borrow pit and these types of lakes typically have higher water clarity and lower nutrient levels than other lakes in the county. As seen in Figure 3, Secchi depth on Lake Carina has increased since the lake had started being sampled by LCHD in 2001 meaning overall water clarity is improving. Lake Carina had exceptionally clear water clarity, with secchi disk readings reaching the bottom in May.

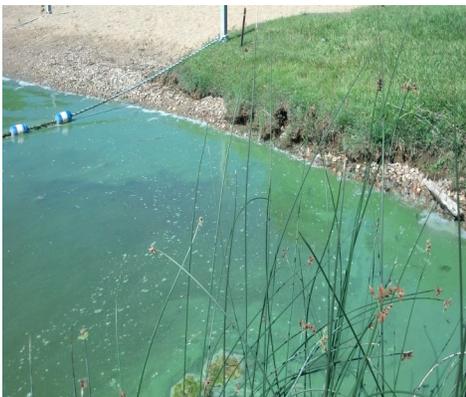
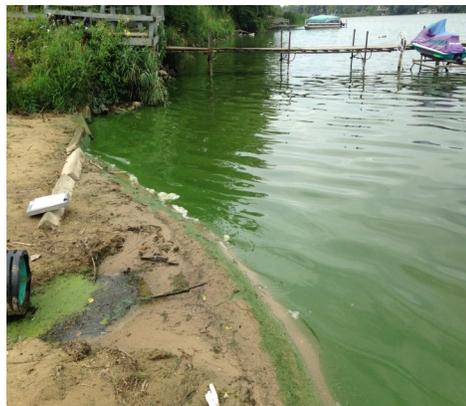
Aphanizomenon Sp.

In 2016, there was a small blue green algae bloom noted on Lake Carina during the August sampling date. The sample was brought back to the lab and looked at under the microscope where it was noted to anabaena species. While Lake Carina does not have a public swimming beach, many users fish from the shorelines and dogs were often cited playing in the water. It is recommended to report any potential blue-green algae blooms by calling the Lake County Health Department. Blue-green algae blooms can be toxic to pets who drink from the water as well as to human health. Also, providing lake users within the LCFP facilities information about appearance of blue-green algae would be beneficial for reporting purposes.

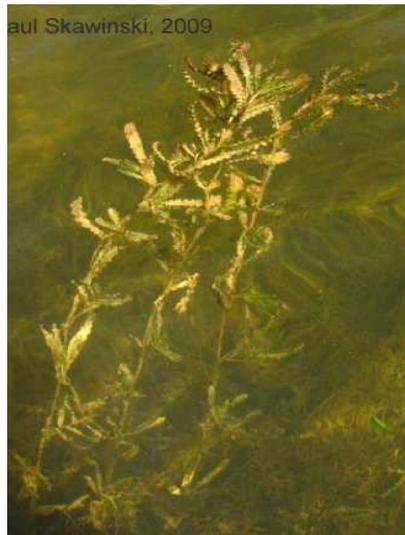
Two exotic aquatic plants species were observed in Lake Carina in the 2016 aquatic vegetation survey; Curlyleaf Pondweed (CLP) and Brittle Naiad. CLP was not found during the aquatic plant survey in July, however it was observed in the lake during the early season. In fact, Curlyleaf Pondweed was pulled up from the bottom of the lake at the sampling site during the June sampling date. It should also be noted that while Curlyleaf Pondweed was not found during the macrophyte survey, this is influenced by the time of season that LCHD conducts the plant survey. Most plants are in full capacity in middle to late of summer which is most plant surveys are conducted in July and August. Unlike many other plants, Curlyleaf Pondweed has an earlier lifecycle. It typically peaks in May and June and can be completely gone from a lake by the time the late summer plant survey is conducted. For an accurate survey of Curlyleaf Pondweed, an early season aquatic plant survey would need to be conducted.

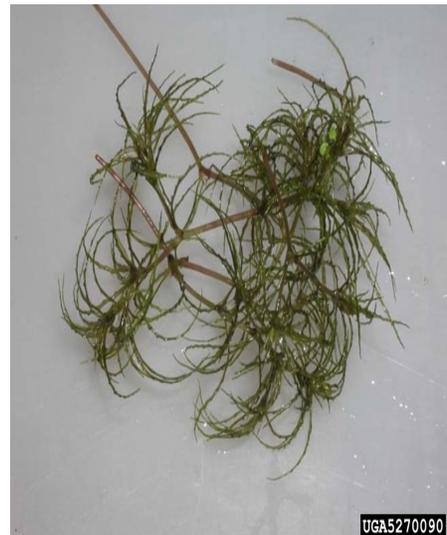
Brittle Naiad was also found in Lake Carina, although only found at 1 sample site. Brittle Naiad is native to Europe and Asia and has been introduced to the United States. Brittle Naiad can form dense mats that outcompete native species and can interfere with recreational activities such as boating, swimming, and fishing. It is currently not a problem in Lake Carina but should be observed in the future to see if Brittle Naiad expands.

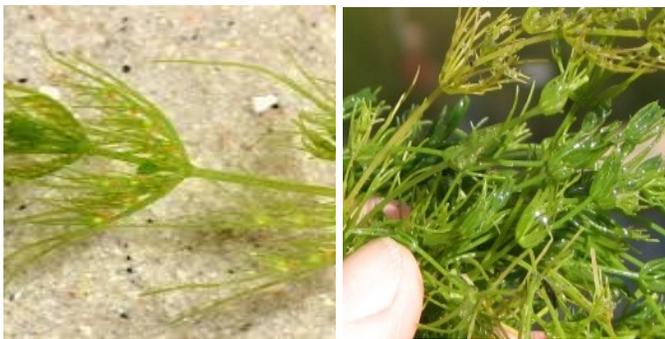
Figure 17: Chara abundance in Lake Carina, 2016

Aquatic plants provide many water quality benefits and play an important role in the lakes ecosystem by providing habitat for fish and shelter for aquatic organism. Plants provide oxygen, reduce nutrients such as phosphorus to prevent algae blooms, and help stabilize sediment. A native plant community tends to be diverse and usually does not impede lake activities such as boating, swimming and fishing. The most dominant plants found in Lake Carina in 2016 were Chara and Spiny Naiad. Chara is a macro-algae and has cylindrical whorled branches. The branches are usually covered in a calcium carbonate giving them a gritty feel and it is commonly referred to as skunkweed for its odor. It's also found in alkaline (hard) waters and can provide habitats for many micro and macro invertebrates. Chara was found at 89.3% of the sample sites as shown in Figure 17. Spiny Naiad is a submerged aquatic plant. It is readily eaten by waterfowl and seeds of the plant have been shown to germinate after digestion, meaning plans can easily be spread by waterfowl. Seeds are considered to be long-lived in the seedbank, which means short times of drawdown or low water are unlikely to be effective at removing this plant. Spiny Naiad was found at 15.% of the sampling sites.
