LAKE COUNTY, IL

2017 LAKE LINDEN SUMMARY REPORT

LAKE COUNTY HEALTH DEPARTMENT

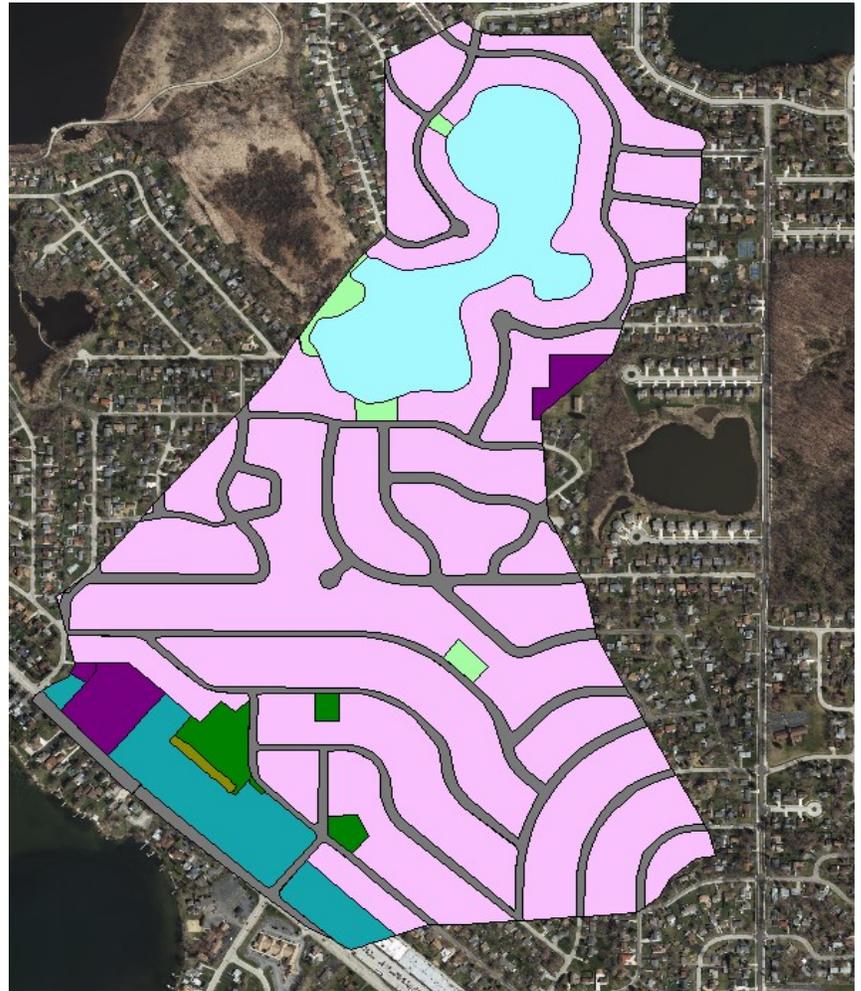
Figure 1: Lake Linden 2017 Land Use and Watershed Boundary

Lake Linden is in the North Mill Creek Sub-watershed of the Des Plaines River Watershed

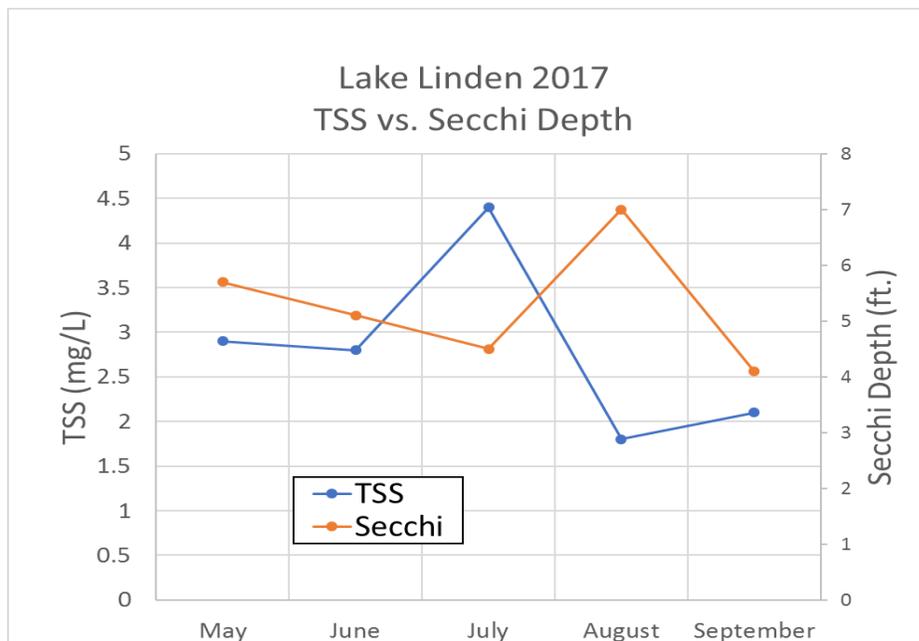
Figure 3: Total Suspended Solid Concentrations vs. Secchi Depth in Linden Lake, 2017.

2017 TSS concentrations in the epilimnion of Linden Lake averaged 2.8 mg/L, which is below the Lake County median of 8.3 mg/L. It is a 33% decrease since the 2010 sampling (4.2 mg/L). Secchi depth and TSS are inversely related and we see the highest TSS concentrations correspond with the lowest Secchi readings (July) and the lowest TSS concentrations with the highest Secchi readings (August) (Figure 3). A lake can have a TSS impairment which is based on if the median surface NVSS is greater or equal to 12 mg/L for the monitoring season. In 2017, the median surface NVSS was <1 mg/L, therefore there is no TSS impairment on Lake Linden. The highest TSS concentrations in July are likely a result of the flooding that occurred in the region during that timeframe.

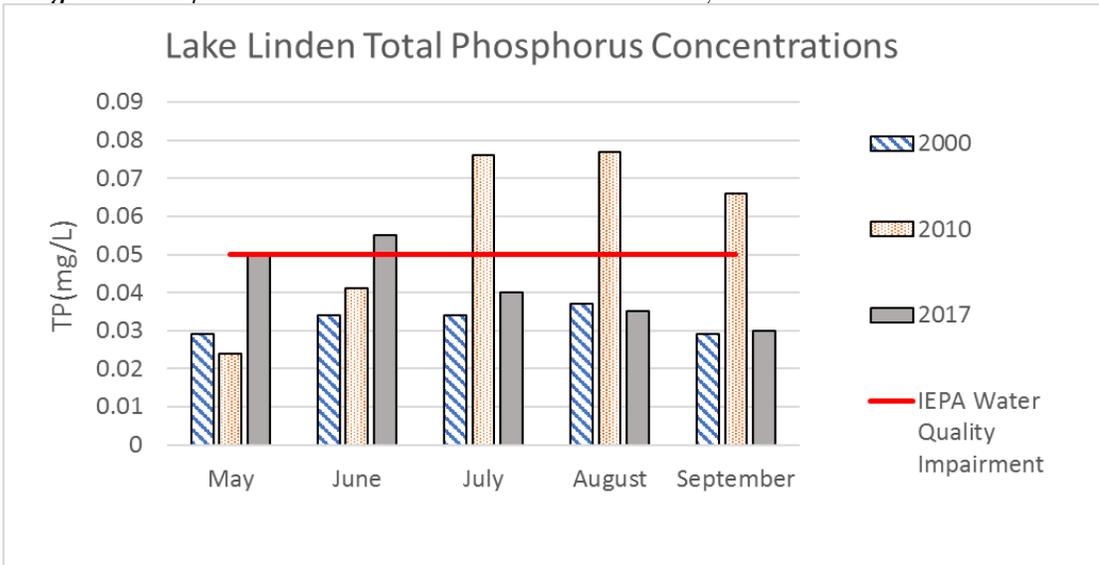
Figure 4: Phosphorus Concentrations in Lake Linden monitored by LCHD

While TP concentrations are a better overall indicator of a lake’s nutrient status because it’s concentration remains more stable than other forms of phosphorus, soluble reactive phosphorus (SRP) is another parameter included in the water chemistry analysis. SRP is a dissolved form of phosphorus that is readily available for plant and algae growth. Typically SRP values are non-detect as it is used up quickly when available. However, during anoxic conditions there is typically a spike in SRP. In Lake Linden, there are elevated SRP concentrations in July and August. Anoxic conditions occurred in July, which can explain the SRP concentration above the detection limit.

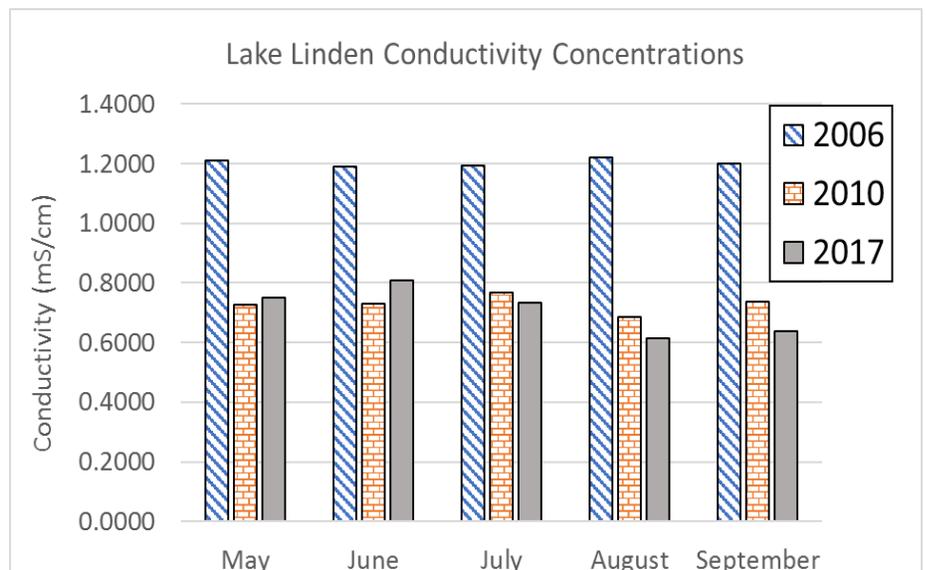
Figure 5: Conductivity Readings in Linden Lake

In 2017, Lake Linden's average conductivity was 0.7087 mS/cm. This is below the Lake County median conductivity concentration of 0.8491 mS/cm. This value is a 3% decrease since the 2010 concentrations (Figure 5).

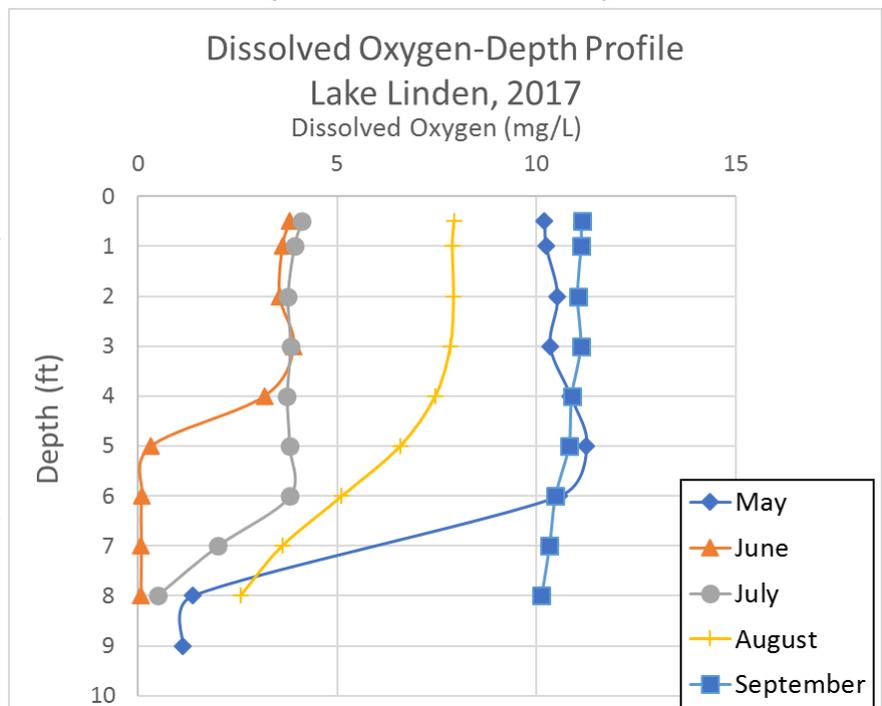
Figure 8: Lake Linden 2017 DO Profile

Anoxic conditions, where DO concentrations are <1 mg/L also occurred in June and July. This is important because the absence of oxygen (anoxia) near the lake bottom can have adverse effects in eutrophic lakes resulting in the chemical release of phosphorus from lake sediment and the

production of hydrogen sulfide (rotten egg smell) and other gases in the bottom waters (Figure 8). The anoxic conditions occurring in June and July and the fact that Lake Linden was not stratified from July-September allows nutrients that got released from anoxic conditions to be available throughout the entire water column; potentially contributing to late summer algal blooms.

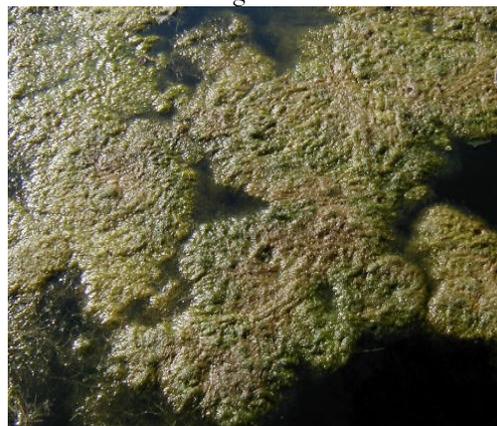
In 2017, filamentous and blue-green algae blooms were noted on Linden Lake. Filamentous algae was noted throughout the season and blue-green algae bloom was noted (September). This is typical timing of these blooms in high-nutrient lakes.

Filamentous algae bloom

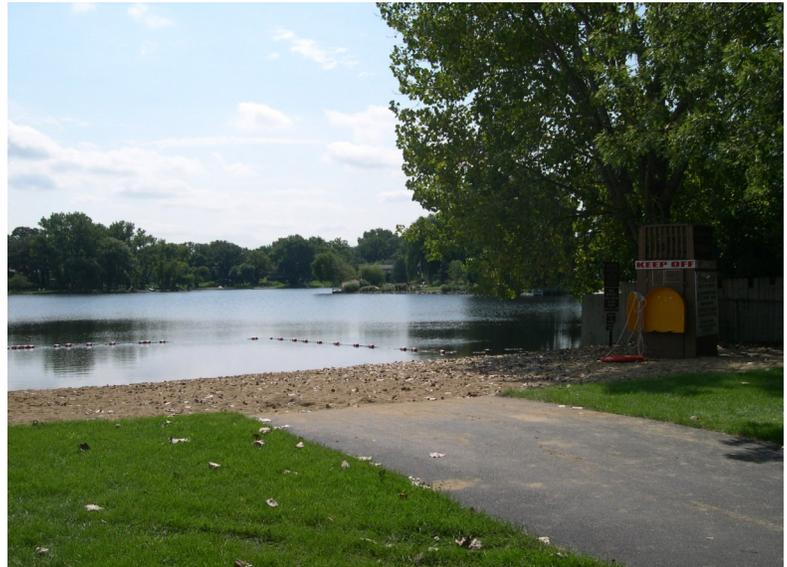
Figure 10: Meyers Beach on Lake Linden

There was one bacteria swim ban on Linden’s Landing and Meyers Beach on July 11th. This is a result of the record rainfall and flooding event that occurred July 11-12th in Lake County. Almost all beaches in Lake County were closed during this time period as a result of high *E. coli* or flooding conditions. In general, both Linden’s Landing and Meyers Beach have limited amount of beach closures.

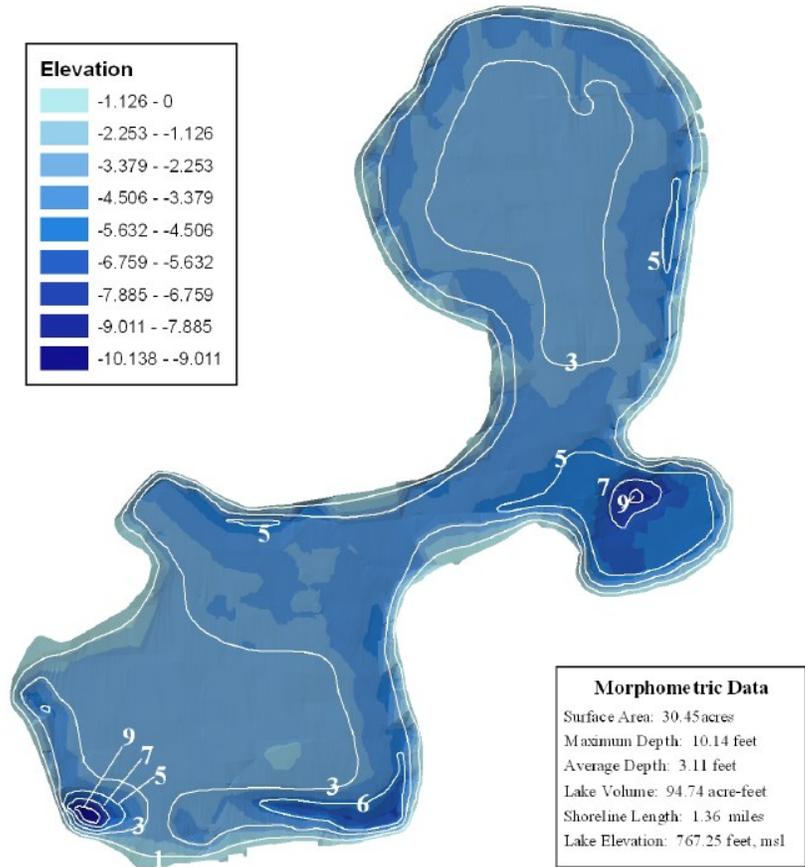
Figure 9: Bathymetric Map of Linden Lake

Linden Lake had a bathymetric survey conducted in 2011 by LCHD (Figure 9). The maximum depth was 10.14 feet and average depth was 3.1 ft. Lake volume was estimated 94.74 acre-feet. LCHD recommends updating bathymetric map every 10 years. For a complete list of the morphometric table for Linden Lake refer to Appendix B.

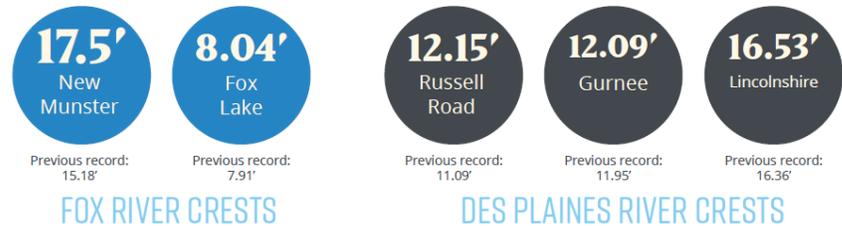
Figure 10: River crests as a result of the July Flooding in Lake County, Lake County Stormwater Management Commission

On July 11-12th, Lake County was inundated with very heavy rain. Lake county experienced rainfall amounts between 3.4 - 7.2 inches of rain in a 24-hour period. The rainfall resulted in several different kinds of flooding countywide. Flash flooding and sewer backups began as the heavy rain overwhelmed storm-water infrastructure. River flooding began in the Fox, Des Plaines, and Skokie rivers and established record crest levels (Figure 10). Many lakes experienced high lake levels and increased nutrient levels. Linden Lake’s water level rose approximately 3.60 inches between June and July and did not appear to be heavily impacted by the flood. The main impact were beach closures.

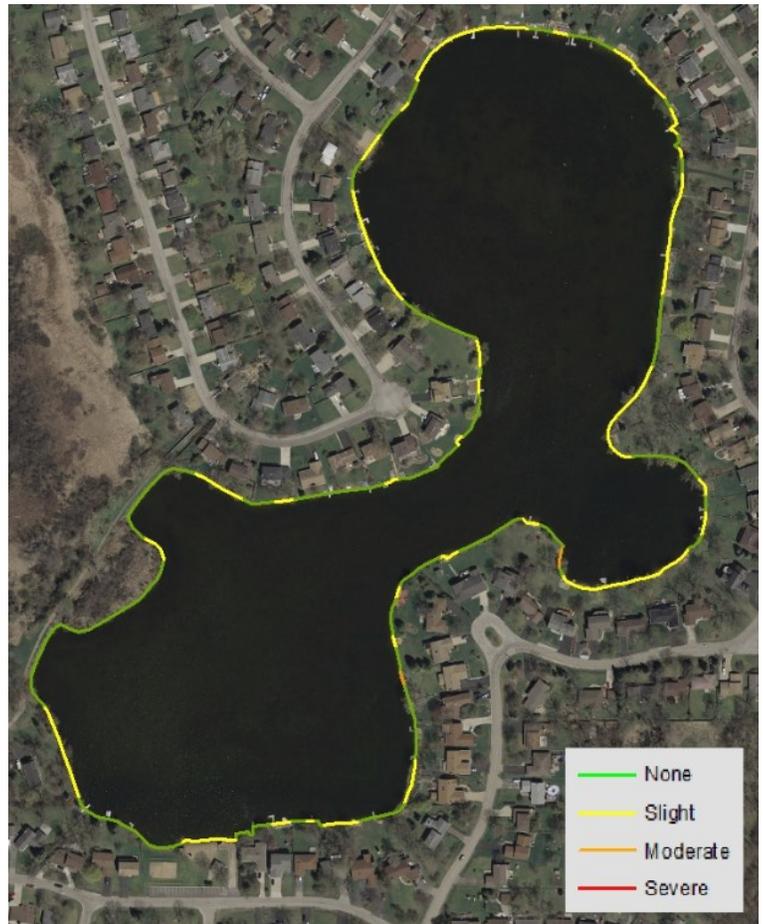
Figure 11: Shoreline Erosion Condition Linden Lake, 2017

A shoreline erosion assessment was conducted on Linden Lake 2017 (Figure 11). Linden Lake was divided into reaches, and the shoreline evaluated for none, slight, moderate and severe erosion based on exposed soil and tree/plant roots, failing infrastructure and undercut banks. Based on the 2017 data, 54% of Linden’s Lake shoreline has no erosion. Out of the 46% that had erosion, 45% were slight, and 1% was moderate. Figures 12-13 represent the some typical shoreline conditions on Linden Lake. Many homeowners have created artificial shorelines to minimize erosion including riprap and seawalls.

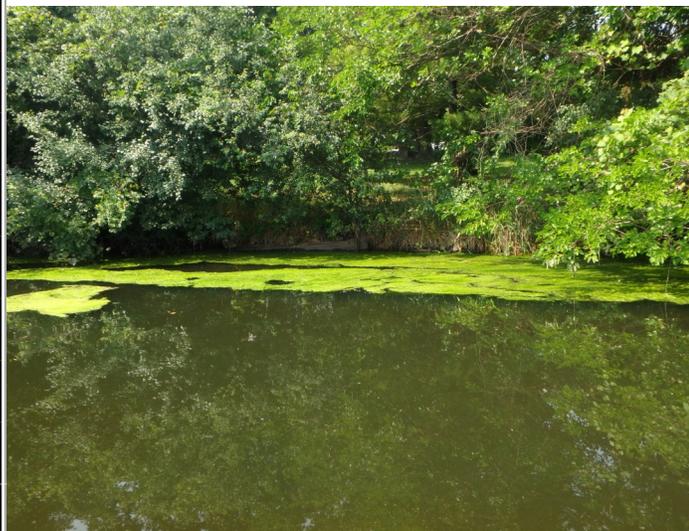
Figure 12: example of slight shoreline erosion on Lake Linden

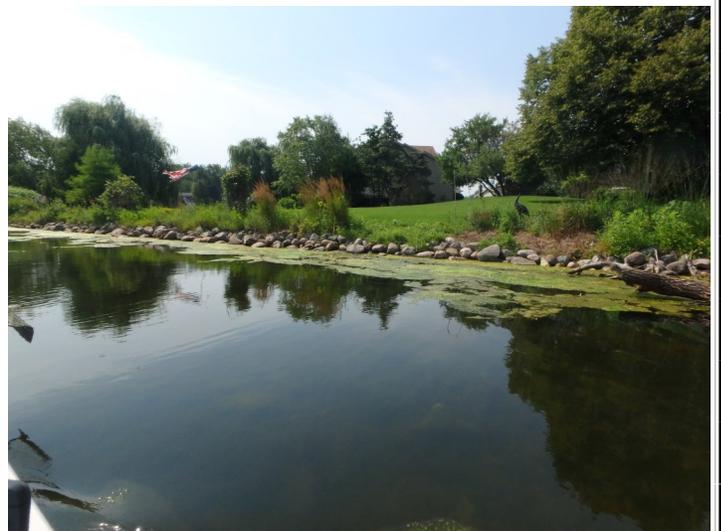
Figure 13: Example of riprap located along shoreline to minimize erosion

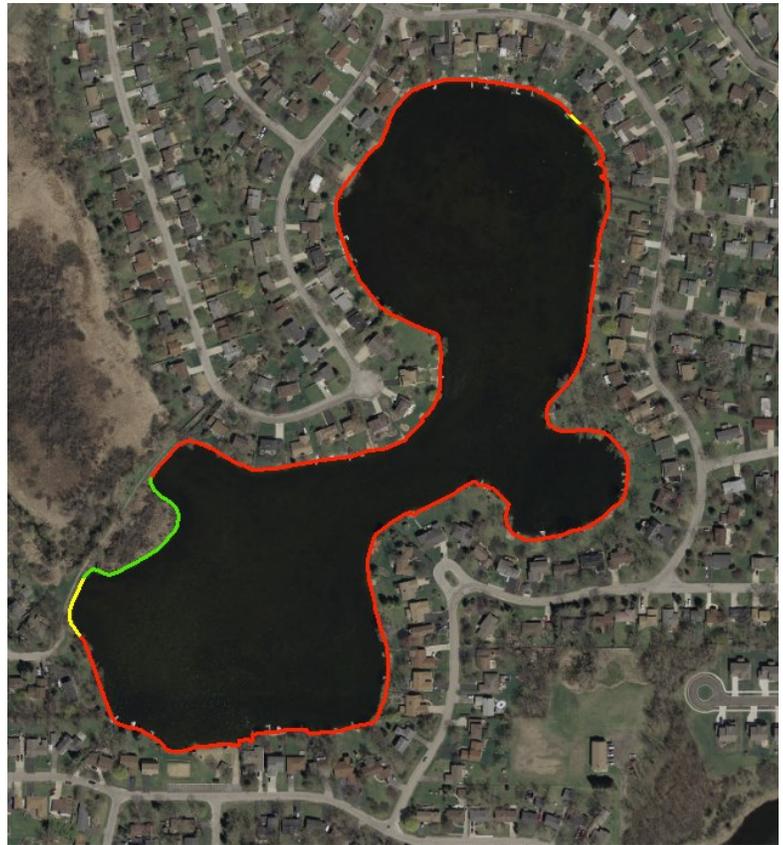
Figure 14: Shoreline Buffer Condition on Linden Lake

A shoreland buffer condition of Linden Lake was assessed by looking at the land within 25 feet of the lake's edge on aerial images in ArcGIS. Shoreland buffer's were classified into three categories; poor, fair or good based on the amount of unmowed grasses, forbs, tree trunks and shrubs, and impervious surfaces within that 25 foot range. In 2017, Lake Linden had 90% of the shoreline with poor buffer, 3% with fair, and 7% with good buffer (Figure 14). Lake Linden could benefit from homeowners installing native plant buffers on their property. Figures 15-16 represent that the typical buffer conditions around Linden Lake. For a complete list of buffer condition by reach, refer to Appendix B.

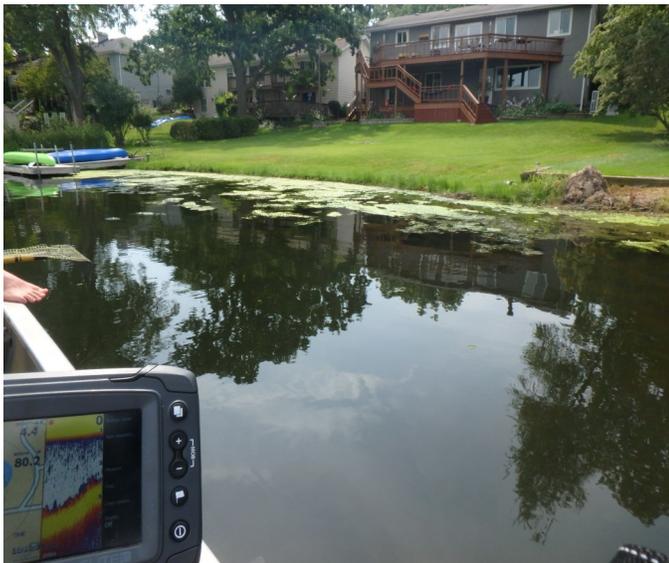
Figure 15: example of mowed grass straight to waters edge. Areas like this could benefit from a shoreline buffer.

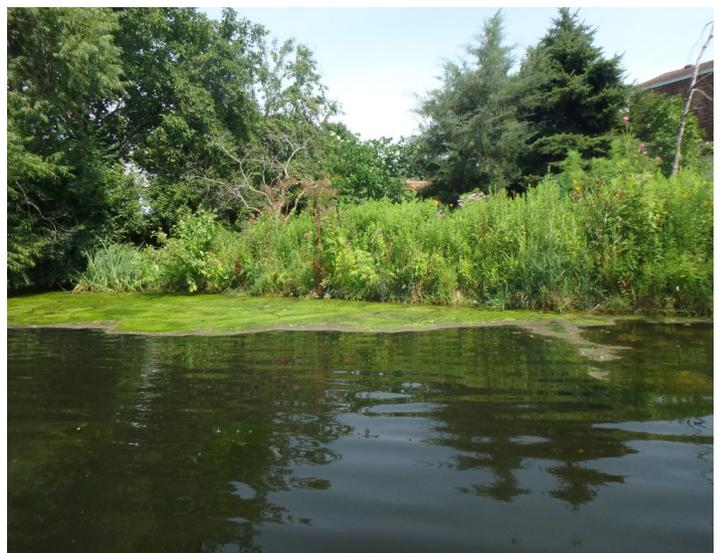
Figure 16: Tree/shrub buffer on the west side of Lake Linden.

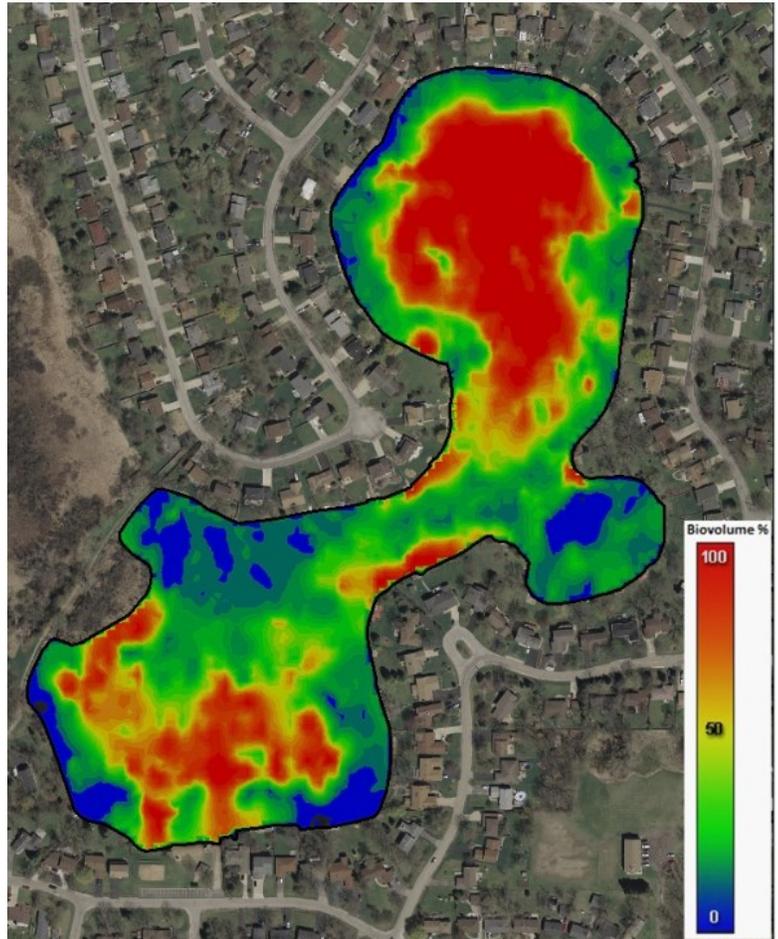
Figure 17: Plant Biovolume Linden Lake, August 2017

There were a total of 2 aquatic plant species and one macro-algae found in Linden Lake. Chara, a macro-algae, was the most dominant species found at 64.7 % of the sampling sites. The next most abundant plant was Water Stargrass observed at 44.1% of the sampling sites. The last plant was Duckweed observed at 2.9% of the sites. The plant community is similar to the 2010 sampling with the most dominant species were also Chara and Water Stargrass. For a complete list of aquatic plant species and density found in Linden Lake, refer to the aquatic plant table found in Appendix B.

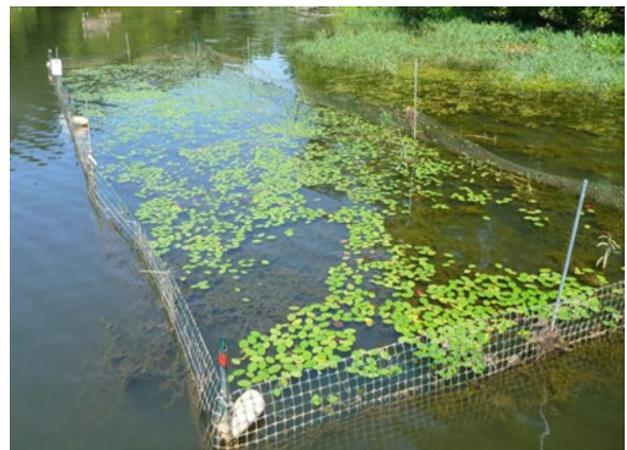
Figure 18: Example of transplanted plant enclosure

Lake Linden could benefit from aquatic plant restoration to increase plant diversity. Some aquatic plants are more easily transplanted. In Lake County, there has been success with transplanting American Pondweed and Vallisneria—both of which might do well in Lake Linden. Potential location for restoration activities could be the southwest bay. There is a over 500 ft of shoreline with no houses, and aquatic plants could be planted in the littoral zone, or not treating this area to encourage plant growth.

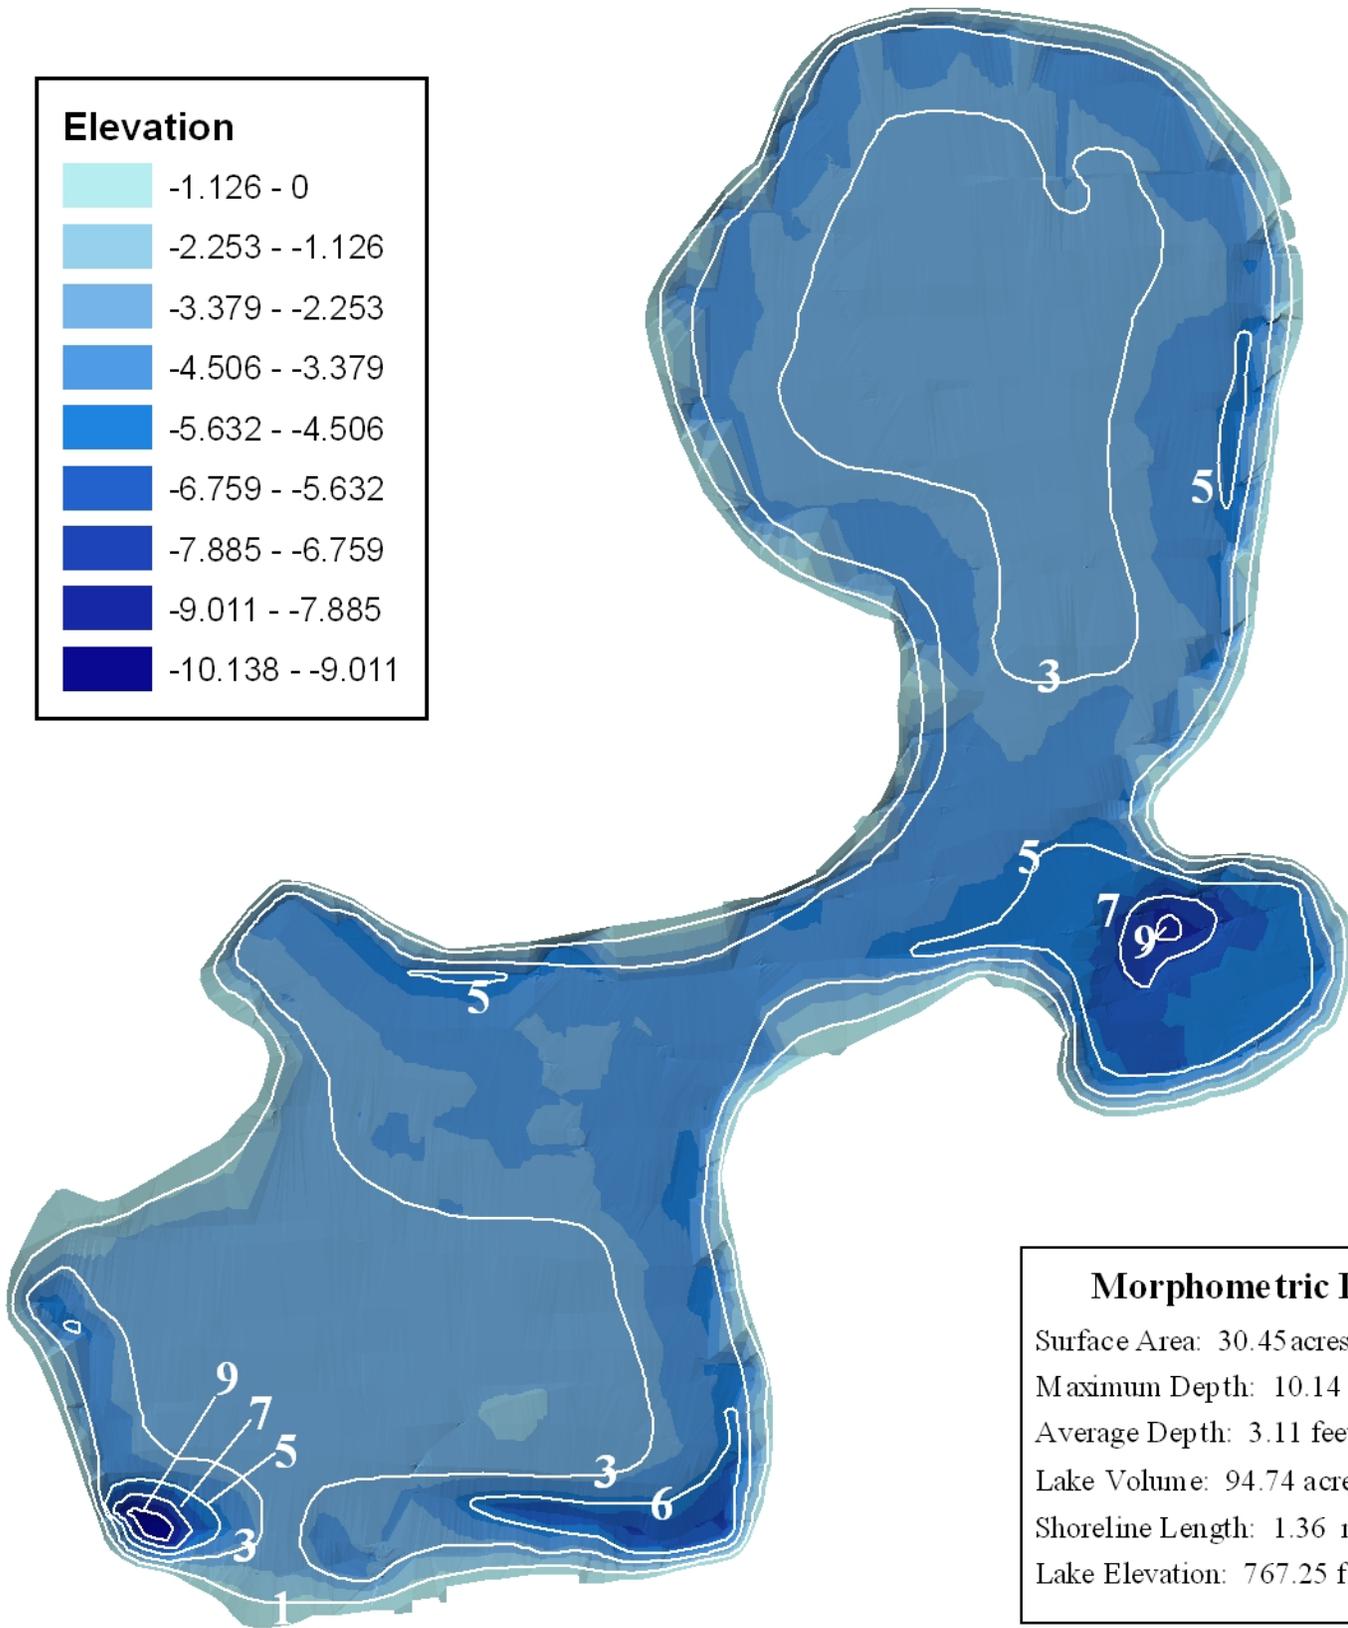
Bathymetric Map of Linden Lake, Lake County, IL

Surface Area:	30.45 acres
Maximum Depth:	10.14 feet
Average Depth:	3.11 feet
Lake Volume:	94.74 acre-feet
Shoreline Length:	1.36 miles
Lake Elevation:	767.25 feet, msl
