2017 HASTINGS LAKE SUMMARY REPORT

LAKE COUNTY HEALTH DEPARTMENT

Hastings Lake 2017

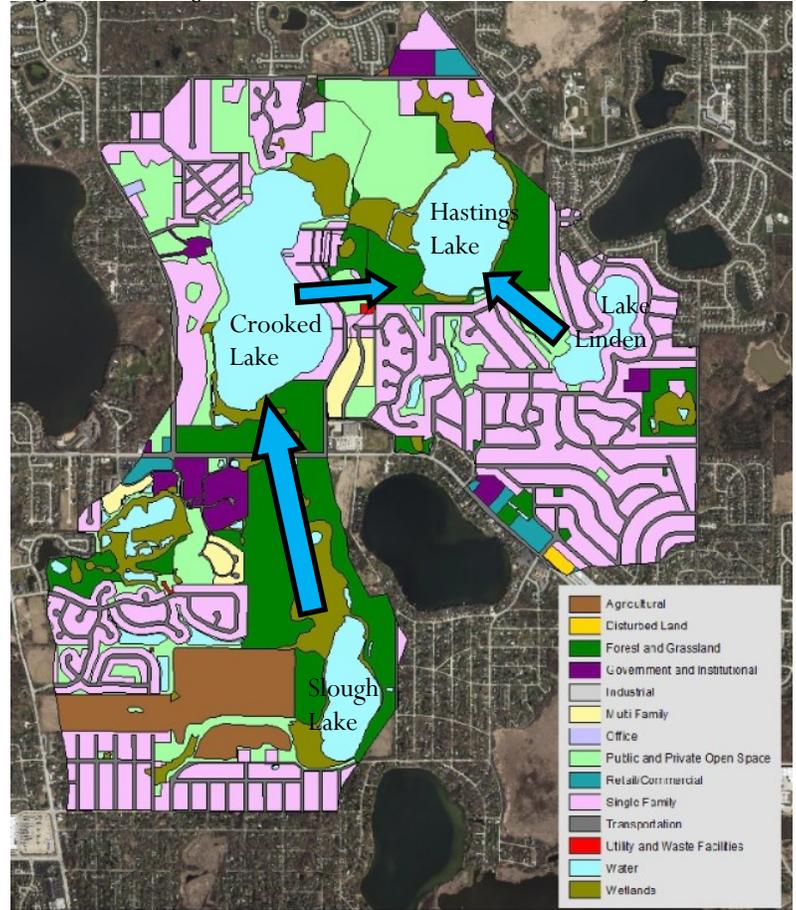
Figure 1: Hastings Lake 2017 Land Use and Watershed Boundary

Hastings Lake is in the North Mill Creek Sub-watershed of the Des Plaines River Watershed

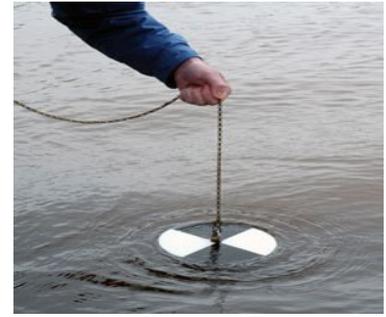
Figure 2: Hastings Lake Secchi Depth by Year

Hastings Lake average Secchi depth was 4.18 ft., which is above the Lake County median Secchi depth of 3.00 ft.

The 2017 average water clarity for Hastings Lake based on Secchi Depth was 4.18 feet. This is a 17.1% increase since the 2010 water quality sampling, which had a Secchi Depth of 3.52 feet. As seen in Figure 2, Secchi depth on Hastings Lake fluctuates, with 2006 and 2017 being better water clarity. The fluctuation in water clarity is also correlated to aquatic plant coverage on the lake. Average seasonal water clarity on Hastings Lake is greater than the Lake County Median Secchi depth.

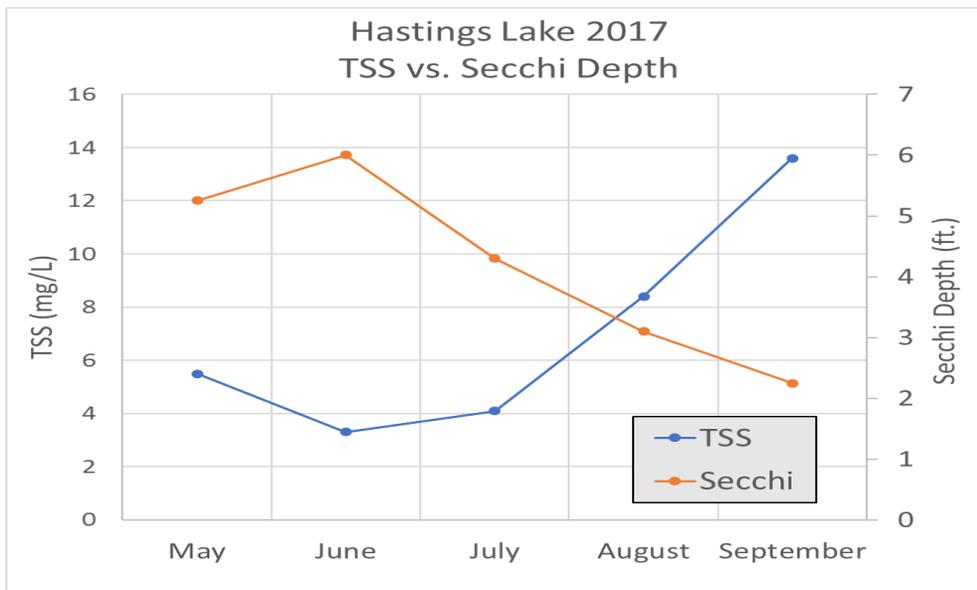
Figure 3: Total Suspended Solid Concentrations vs. Secchi Depth in Hastings Lake, 2017.

2017 TSS concentrations in the epilimnion of Hastings Lake averaged 7.0 mg/L, which is below the Lake County median of 8.3 mg/L. It is also an increase in TSS since 2010. Algae blooms were noted in August and September and these are the months with the highest TSS concentrations and lowest Secchi readings. Secchi depth and TSS are inversely related (Figure 3). The hypolimnetic TSS concentration average 5.0 mg/L (Table 2). A lake can have a TSS impairment which is based on if the median surface NVSS is greater or equal to 12 mg/L for the monitoring season. In 2017, the median surface NVSS was 2.39 mg/L, therefore there is no TSS impairment on Hastings Lake.

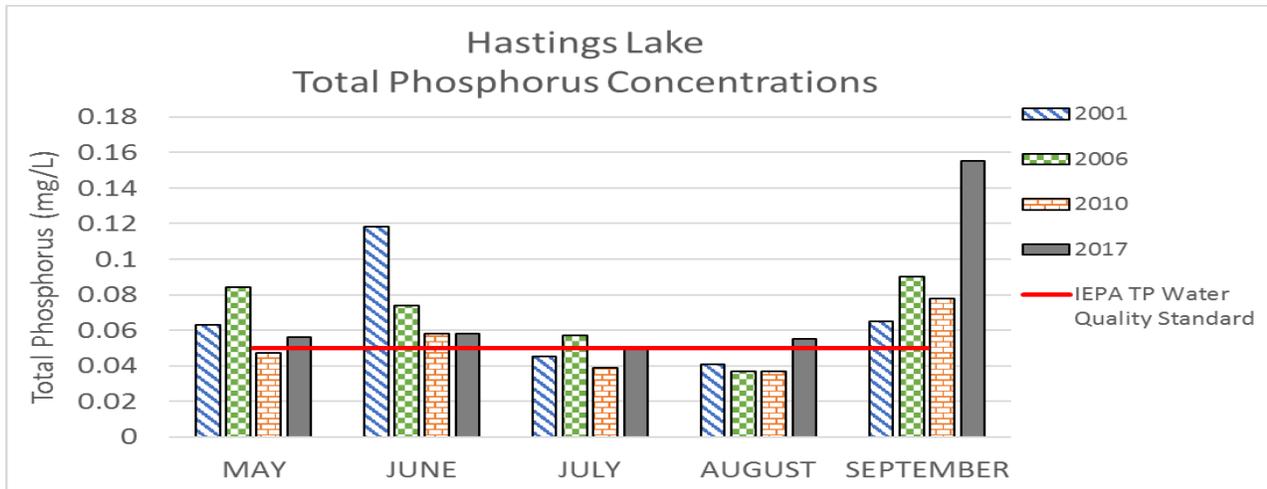
Figure 4: Phosphorus Concentrations in Hastings Lake monitored by LCHD

While TP concentrations are a better overall indicator of a lake's nutrient status because it's concentration remain more stable than other forms of phosphorus, soluble reactive phosphorus (SRP) is another parameter included in the water chemistry analysis. SRP is a dissolved form of phosphorus that is readily available for plant and algae growth. SRP can vary throughout the season and is dependent on how plants and algae absorb and release it. SRP can give an indication of how much phosphorus is available for uptake but does not indicate how much phosphorus is present in the water column. Typically SRP values are below the detection limit, however in Hasting's Lake SRP was above the detection limit in the epilimnion in every month.

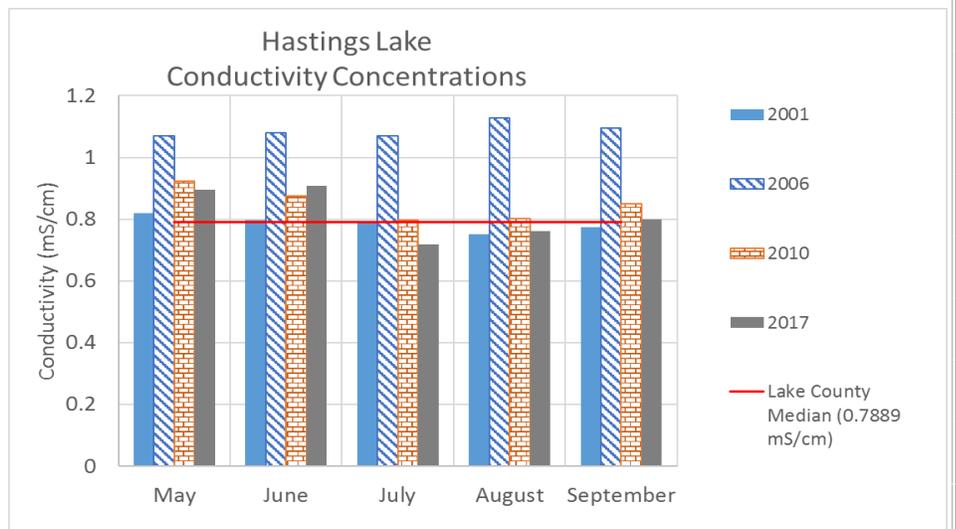
Figure 5: Conductivity Concentrations in Hastings Lake

In 2017, Hastings Lake average conductivity concentration was 0.8162 mS/cm. This is slightly higher than the Lake County median conductivity concentration of 0.8491 mS/cm. This value is a 4% decrease since the 2010 concentrations (Figure 5).

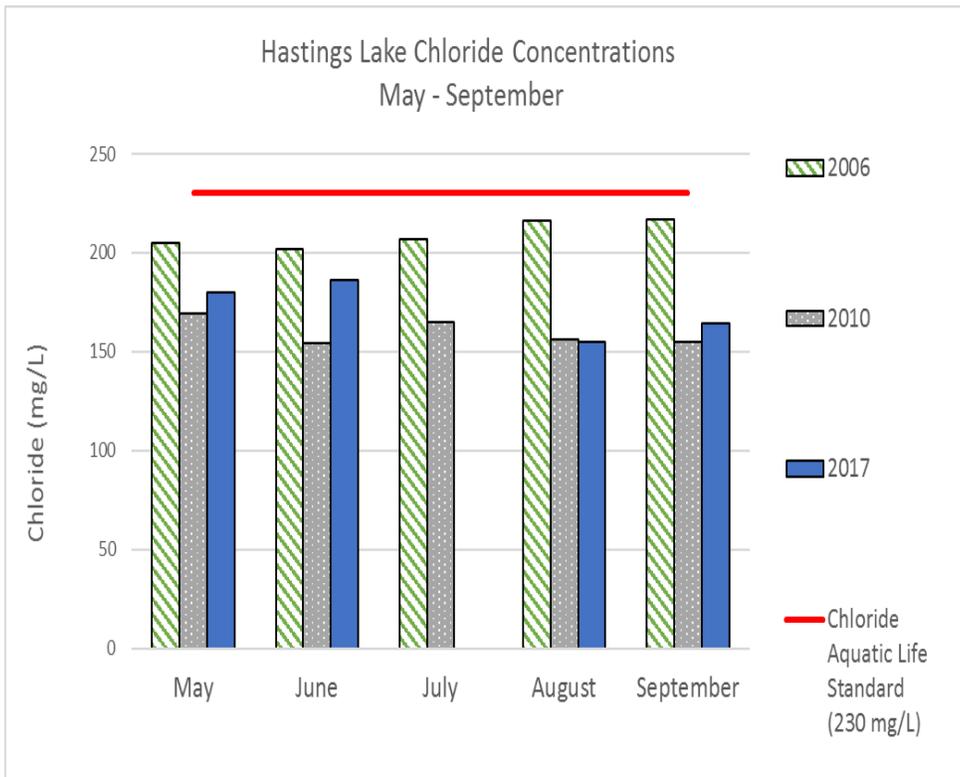
Figure 6: Hastings Lake Chloride Concentrations

One of the most common dissolved solids is road salt used in winter road deicing. Most road salt is sodium chloride, calcium chloride, potassium chloride, magnesium chloride or ferrocyanide salts. Hasting Lake’s chloride concentration averaged 171 mg/L which is above the Lake County median of 127 mg/L (Figure 6). The United States Environmental Protection agency has determined that chloride concentrations higher than 230 mg/L can disrupt aquatic systems. While Hasting’s Lake chloride concentration is below the aquatic life criteria, recent research has indicated organisms can get stressed at values lower than 230 mg/L. Chloride ions do not break down and accumulate within a watershed. High chloride concentrations may make it difficult for many of our native plant species to survive while many of our invasive species such as Eurasian Watermilfoil, Cattail, and Common Reed are tolerant to high chloride levels. Chloride concentrations did increase since the and 2010 sampling.

The LCHD-ES and Lake County Stormwater Management Commission (LCSMC) have been holding annual trainings targeting deicing maintenance personnel for both public and private entities to hopefully reduce the amount of chloride being introduced into our environment while maintaining safe passageways. Almost all deicing products contain chloride so it is important to read an follow product labels for proper application. For instance, at 10°F Fahrenheit, rock salt is not at all effective in melting ice and will blow away before it melts anything. Additionally calling your local township office to ask them if they are taking actions to minimize deicers on their properties or supporting changes in their deicing policy to minimize salt usage is encouraged. Since Hasting’s Lake has such a large watershed, chlorides is a concern and efforts should be made in the watershed for efficient de-icing practices.

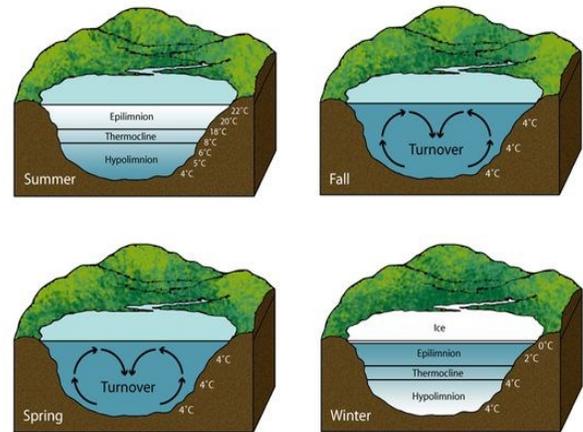
Figure 7: Lake Turnover / Stratification diagram

Lake stratification is a result of variations in density caused by temperature (or salinity) and can prevent warm and cold water from mixing. A lake's water quality and ability to support fish are affected by the extent to which the water mixes. Lakes that experience stratification have the water column divided in three zones: epilimnion (warm surface layer), thermocline (transition zone between warm and cold water) and hypolimnion (cold bottom water) (Figure 7). Stratification traps nutrients released from bottom sediments in the hypolimnion and prevents mixing. Lakes in lake county are either dimictic or polymictic. Dimictic means there are only two lake turnovers (spring and fall), whereas polymictic means that the thermocline is never that strong so the lake can go mix multiple times throughout the season.

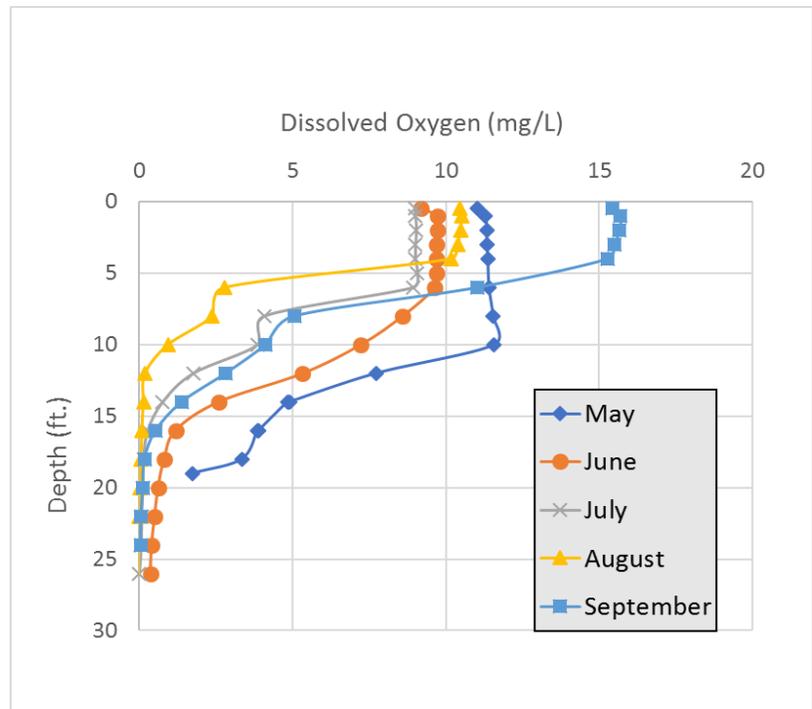
Figure 8: Hastings Lake 2017 DO Profile

A dissolved oxygen (DO) concentration of 5.0 mg/L is considered adequate to support a fishery since fish can suffer oxygen stress below this concentration. Dissolved oxygen (DO) dropped below 5 mg/L in the hypolimnion of the lake which is not uncommon for glacial stratified lakes. (Figure 8).

Anoxic conditions, where DO concentrations are <1 mg/L, occurred June - September. Typically in deeper, thermally stratified lakes, oxygen production is greatest in the epilimnion, where sunlight drives photosynthesis, and oxygen consumption is greatest near the bottom of a lake, where organic matter accumulates and decomposes. The oxygen difference between the top and bottom water layers can be dramatic, with plenty of oxygen near the surface, but practically none near the bottom. This is important because the absence of oxygen (anoxia) near the lake

bottom can have adverse effects in eutrophic lakes resulting in the chemical release of phosphorus from lake sediment and the production of hydrogen sulfide (rotten egg smell) and other gases in the bottom waters (Figure 8). Volume of Hastings lake that was anoxic ranged from 7.8% (June) to 34.7% (August) when DO dropped below 1 mg/L at depths greater than 10 ft.

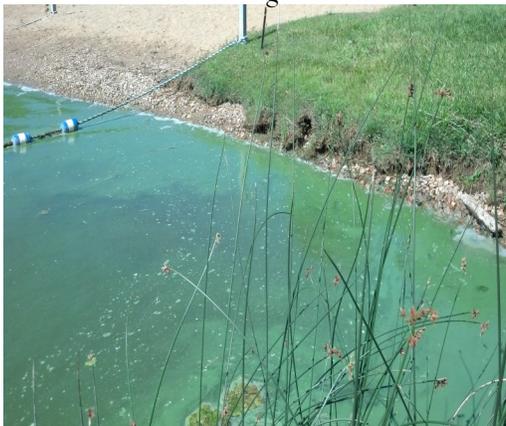
Blue-Green Algae Bloom

In 2017, filamentous and blue-green algae blooms were noted on Hastings Lake. Filamentous algae was noted early in the season (May) and Blue-Green Algae blooms were noted later in the season (September). This is typical timing of these blooms in high-nutrient lakes.

While Hastings Lake does not have a public swimming beach, the Lake County Forest Preserve District should educate themselves and LCFPD users on blue-green algae blooms. It is recommended to report any potential blue-green algae blooms by calling the Lake County Health Department so that the bloom can be tested. Blue-green algae blooms can be toxic to pets who drink from the water as well as to human health. Also, there should be a clear communication protocol amongst the LCFPD to disseminate information regarding the presence of blue-green algae.

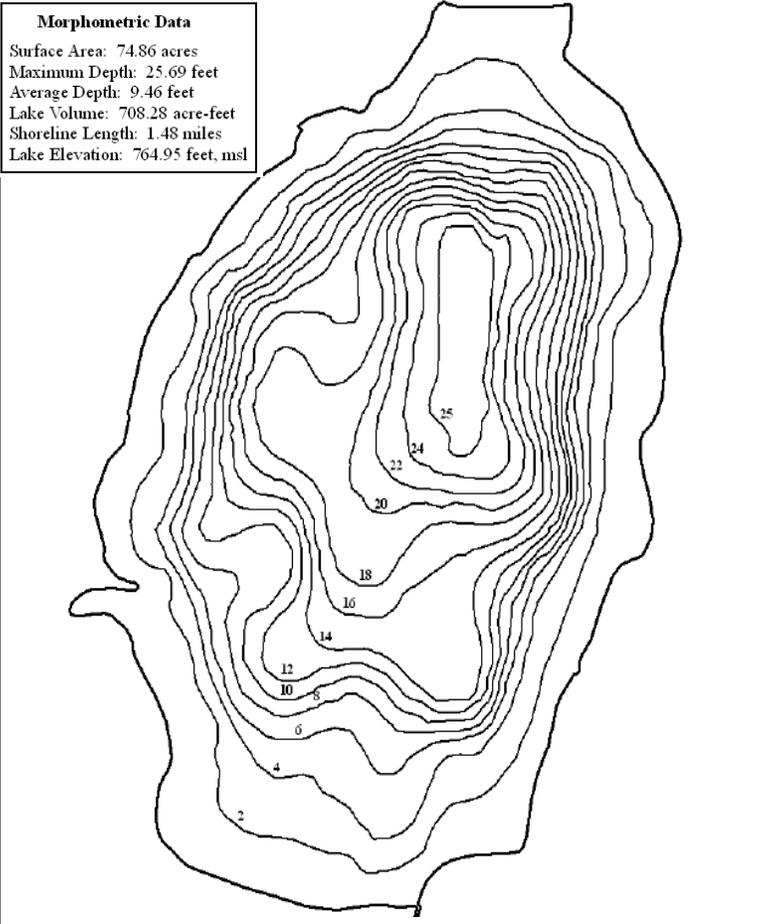
Figure 9: Bathymetric Map of Hastings Lake

Hastings Lake had a bathymetric survey conducted in 2008 by LCHD (Figure 9). The maximum depth was 25.69 ft. and average depth was 9.46 ft. Lake volume was estimated 708.28 acre-feet. LCHD recommends updating bathymetric map every 10 years. For a complete list of the morphometric table for Hastings Lake refer to Appendix B.

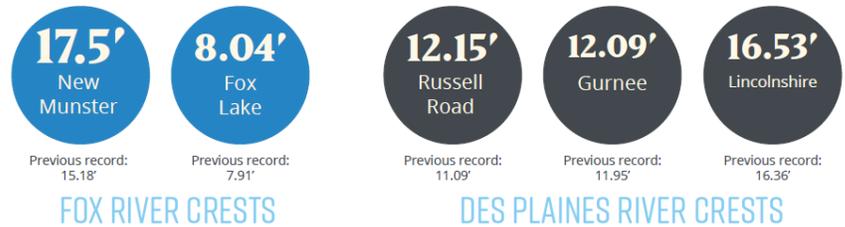
Figure 10: River crests as a result of the July Flooding in Lake County, Lake County Stormwater Management Commission

On July 11-12th, Lake County was inundated with very heavy rain. Lake County experienced rainfall amounts between 3.4 - 7.2 inches of rain in a 24-hour period. The rainfall resulted in several different kinds of flooding countywide. Flash flooding and sewer backups began as the heavy rain overwhelmed storm-water infrastructure. River flooding began in the Fox, Des Plaines, and Skokie rivers and established record crest levels (Figure 10). Many lakes experienced high lake levels and increased nutrient levels. Hasting's Lake water level rose 1 foot between June and July.

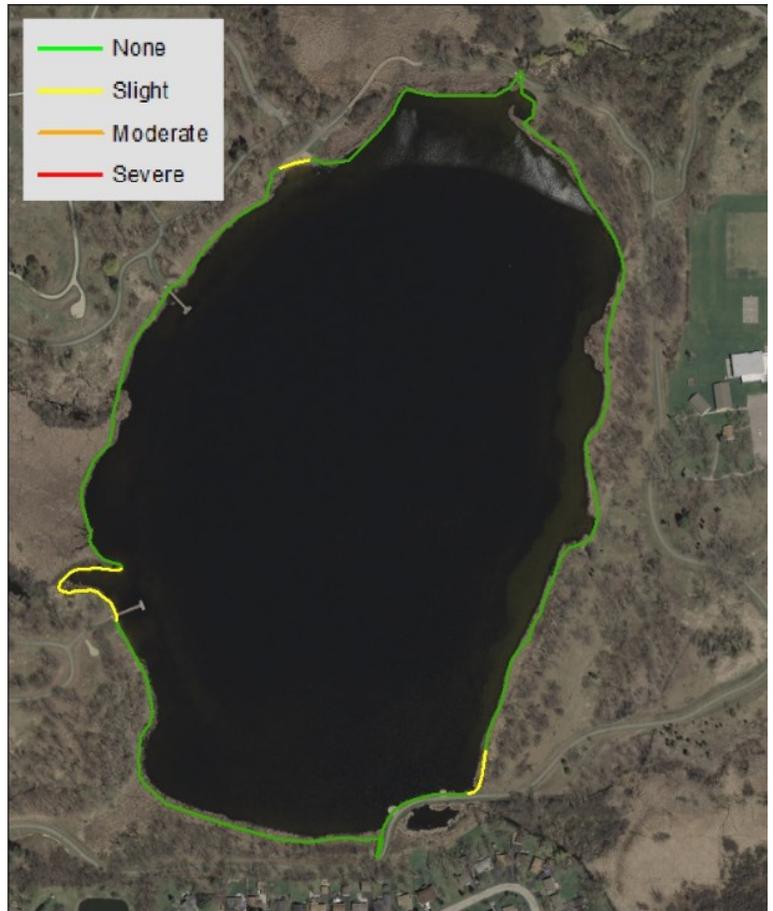
Figure 11: Shoreline Erosion Condition Hastings Lake, 2017

A shoreline erosion assessment was conducted on Hastings Lake 2017 (Figure 11). Hastings Lake was divided into reaches, and the shoreline evaluated for none, slight, moderate and severe erosion based on exposed soil and tree/plant roots, failing infrastructure and undercut banks. Based on the 2017 data, 93% of Hasting’s Lake shoreline has no erosion and only 7% with some degree of erosion. There is little erosion on Hastings Lake, likely a result of the increase of emergent plants established around the lake shoreline. Figures 12-13 represent the some typical shoreline conditions on Hastings Lake.

Where erosion is occurring, tends to be public access points (near piers/fishing area) and in the back channel where wave energy may be greater. To see the complete dataset of shoreline erosion broken down by

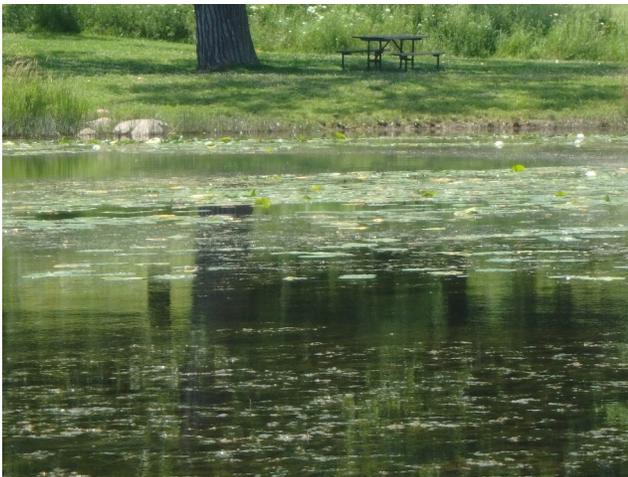
Figure 12: example of slight shoreline erosion on Hastings Lake near accessible lake areas

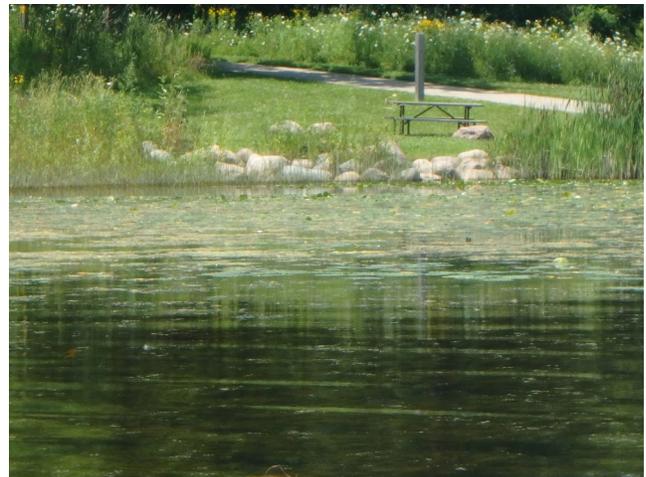
Figure 13: Example of riprap located along shoreline to minimize erosion

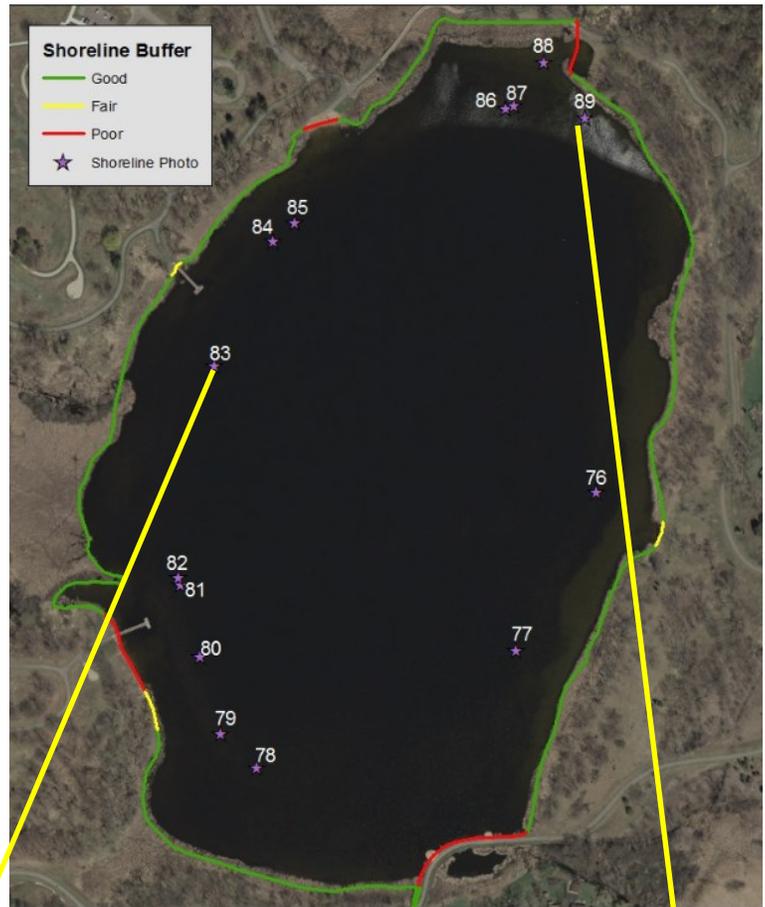
Figure 14: Shoreline Buffer Condition on Hastings Lake

A shoreland buffer condition of Hastings Lake was assessed by looking at the land within 25 feet of the lake's edge on aerial images in ArcGIS. Shoreland buffer's were classified into three categories; poor, fair or good based on the amount of unmowed grasses, forbs, tree trunks and shrubs, and impervious surfaces within that 25 foot range. In 2017, Hastings Lake had 5% of the shoreline with poor buffer, 5% with fair, and 90% with good buffer (Figure 14). Figures 15-16 represent that the typical buffer conditions around Hastings Lake. For a complete list of buffer condition by reach, refer to Appendix B.

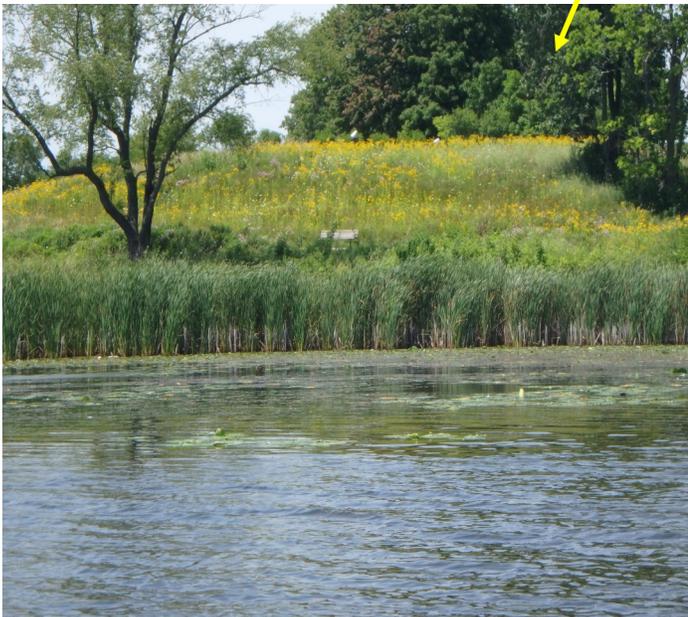
Figure 15: Example of good buffer coverage with native plants in bloom around Hastings Lake.

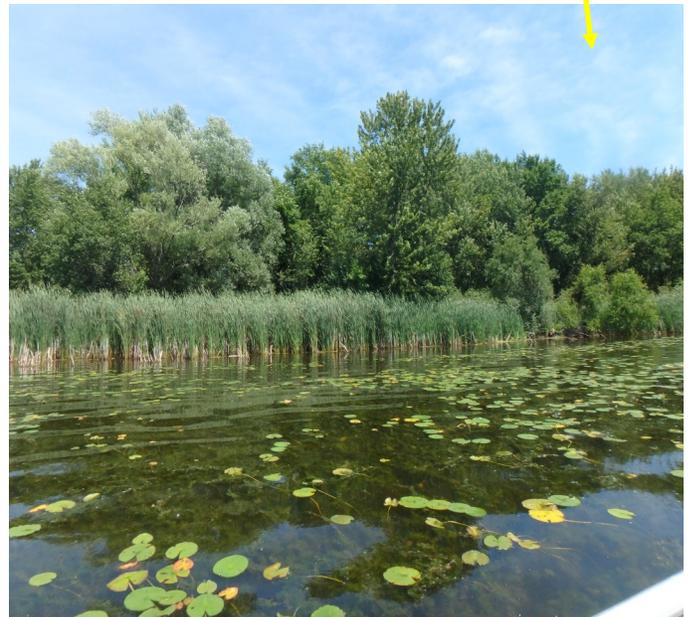
Figure 16: Buffer of emergent plants and forest / shrubs.

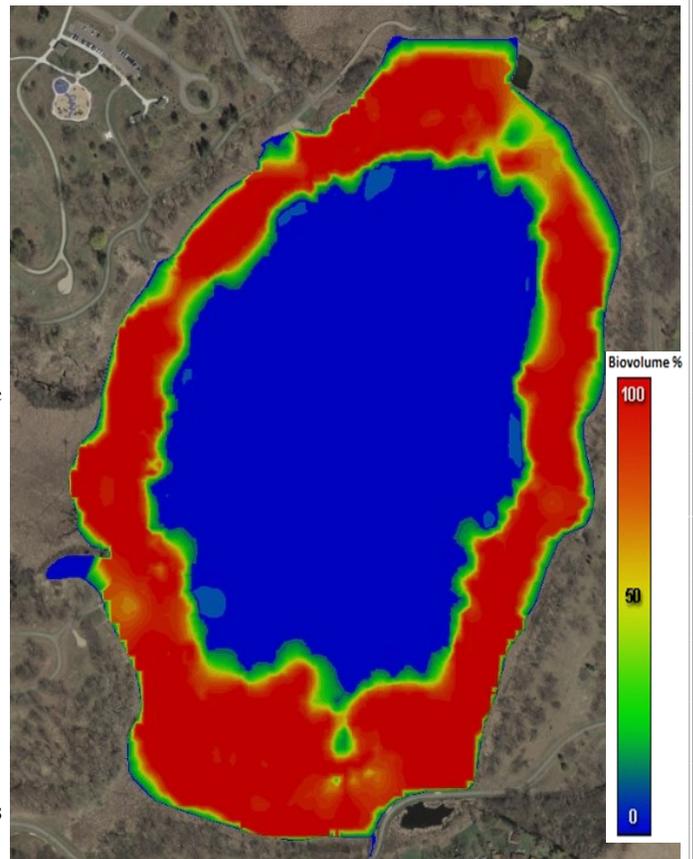
Figure 17: Plant Biovolume Hastings Lake, August 2017

There were a total of 7 aquatic plant species and one macro-algae found in Hastings Lake. Eurasian Watermilfoil was the most dominant plant species found at 46% of the sampling sites (Table 4). The next most abundant plant was White Water Lily observed at 30% of the sampling sites. The number of plant species (diversity) decreased since the 2010 sampling. In 2010, EWM and White Water Lily were still the most abundant plants observed. Flatstem Pondweed as observed in 2010 but not in 2017. For a complete list of aquatic plant species and density found in Hastings Lake, refer to the aquatic plant table found in Appendix B.

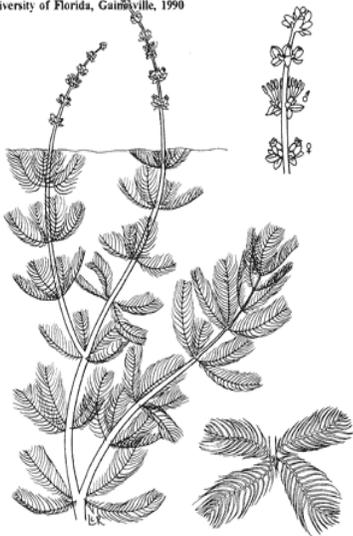
Figure 18: Hastings Lake Eurasian Watermilfoil Plant Rake Density, 2017

Unfortunately, EWM is a dominant species in Hastings Lake found at 46% of the sampling sites. This is roughly the same abundance as 2010. Populations were most dense in the northern and southern portions (Figure 18).

An aquatic plant management plan is critical to maintaining the health of the lake and a balanced aquatic plant community. The plan should be based on the management goals of the lake and involve usage issues, habitat maintenance/restoration, and limitations of the lake. The primary focus of the plan must include the removal of invasive species largely targeting EWM. Follow up is critical to achieve long-term success.

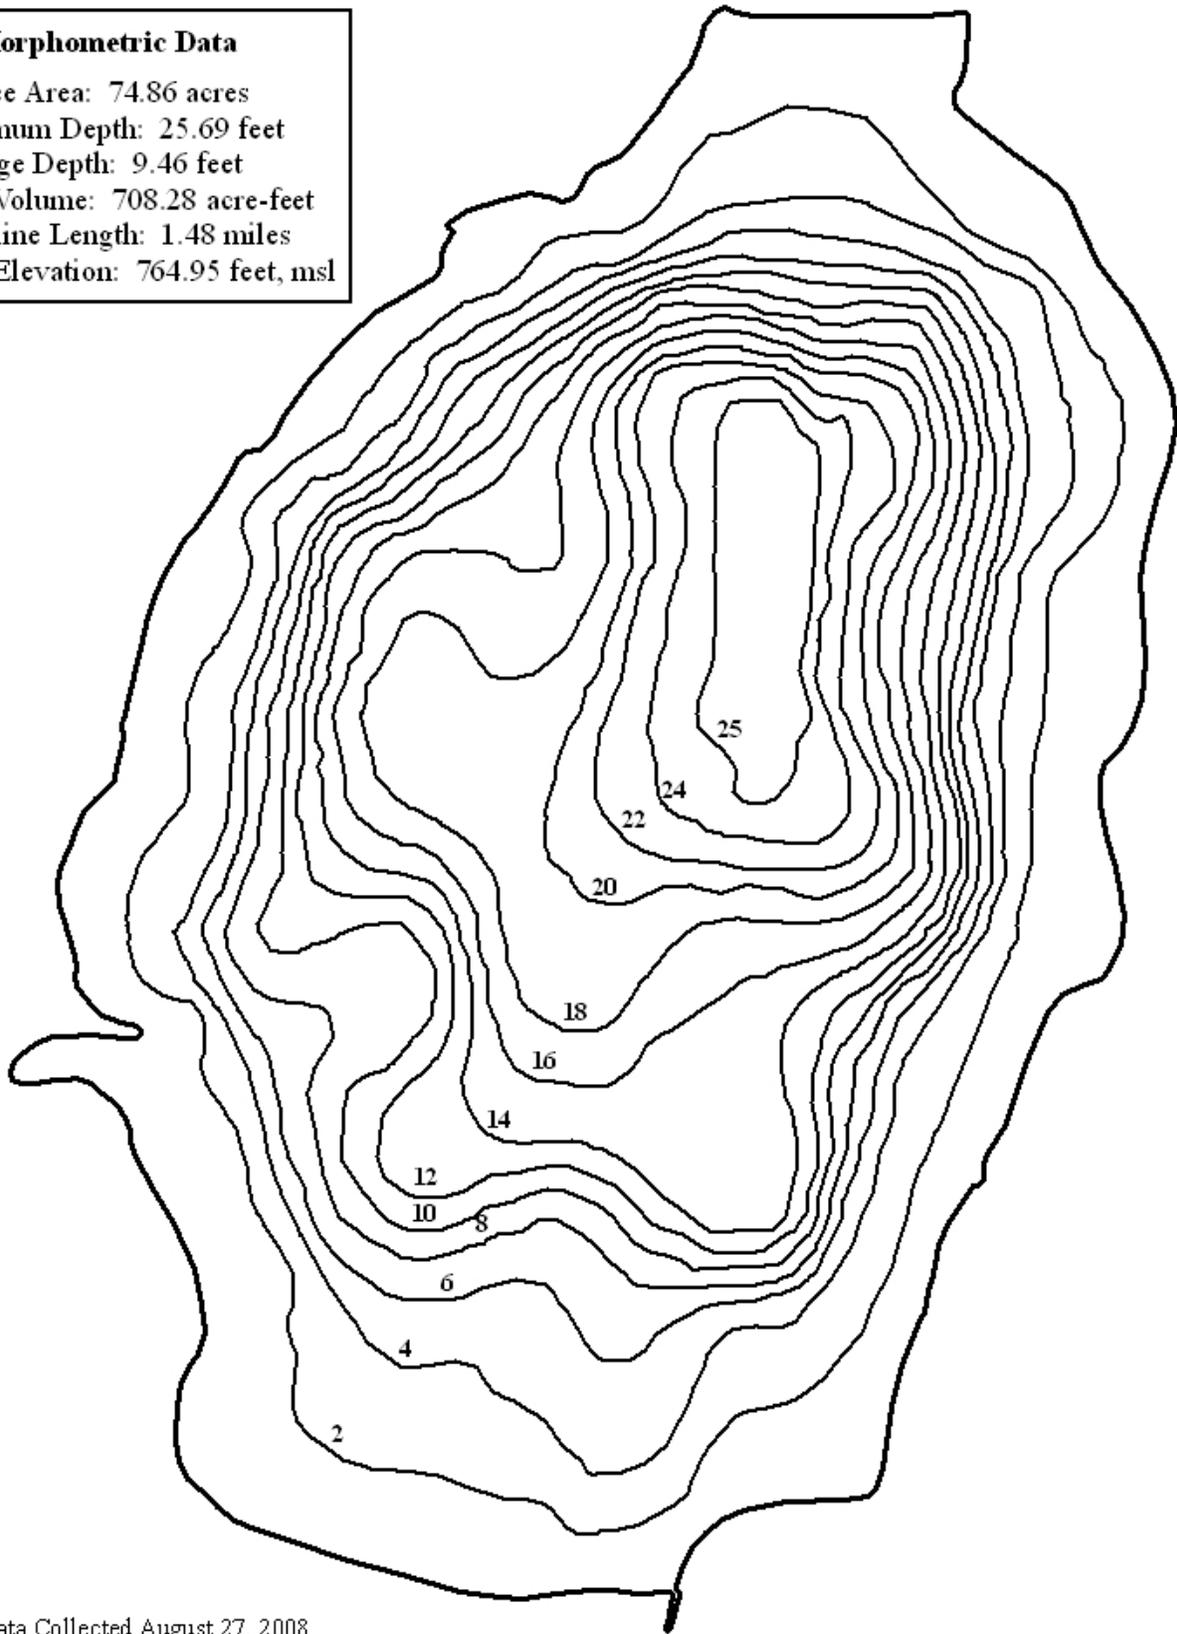
Bathymetric Map of Hastings Lake, Lake County, IL

Surface Area: 74.86 acres
Maximum Depth: 25.69 feet
Average Depth: 9.46 feet
Lake Volume: 708.28 acre-feet
Shoreline Length: 1.48 miles
Lake Elevation: 764.95 feet, msl
