**2006 SUMMARY REPORT
of
Lake Linden**

Lake County, Illinois

**LAKE COUNTY HEALTH DEPARTMENT
ENVIRONMENTAL HEALTH SERVICES
LAKES MANAGEMENT UNIT**

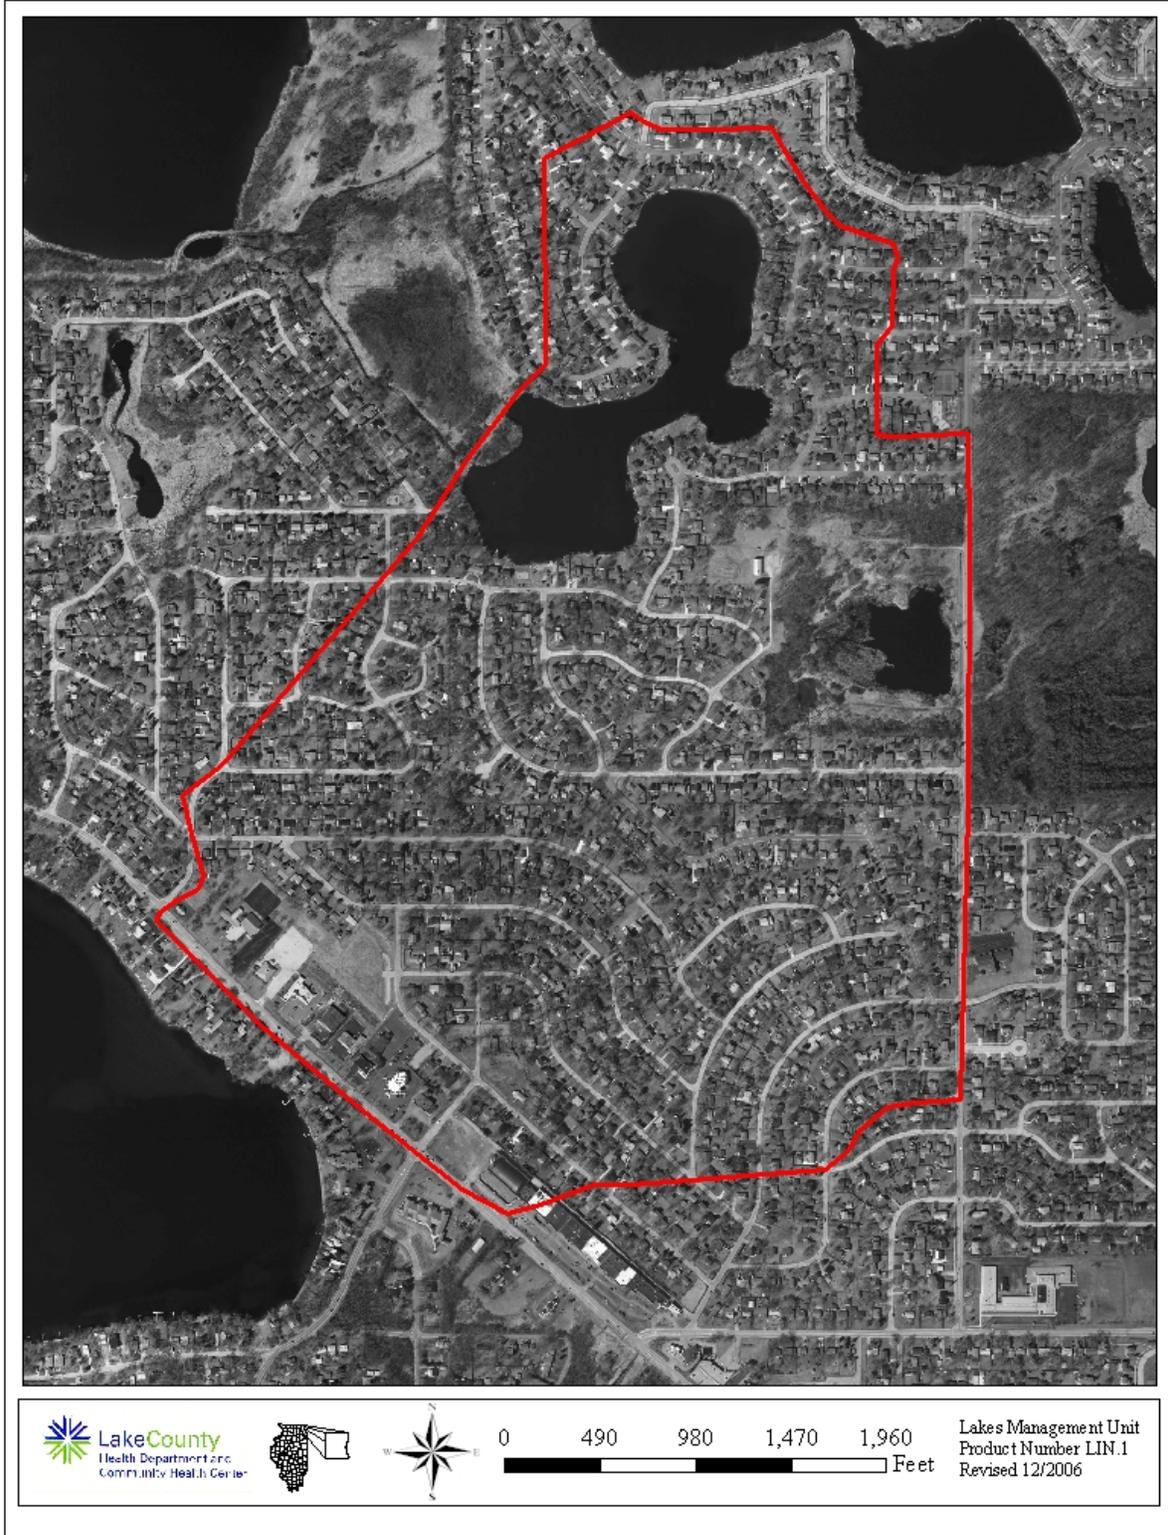
Figure 1. Approximate watershed delineation of Lake Linden, 2006.

Lake Linden has a small watershed area (Figure 1) with single family homes covering the most area (62%). Transportation (roads) also covers a large portion of land (14%), as well as water and retail/commercial (4%) (Figure 2). The large amount of impervious surfaces associated with residential areas (rooftops, driveways, and roads) increase the amount of direct storm water runoff into a lake (Table 1).

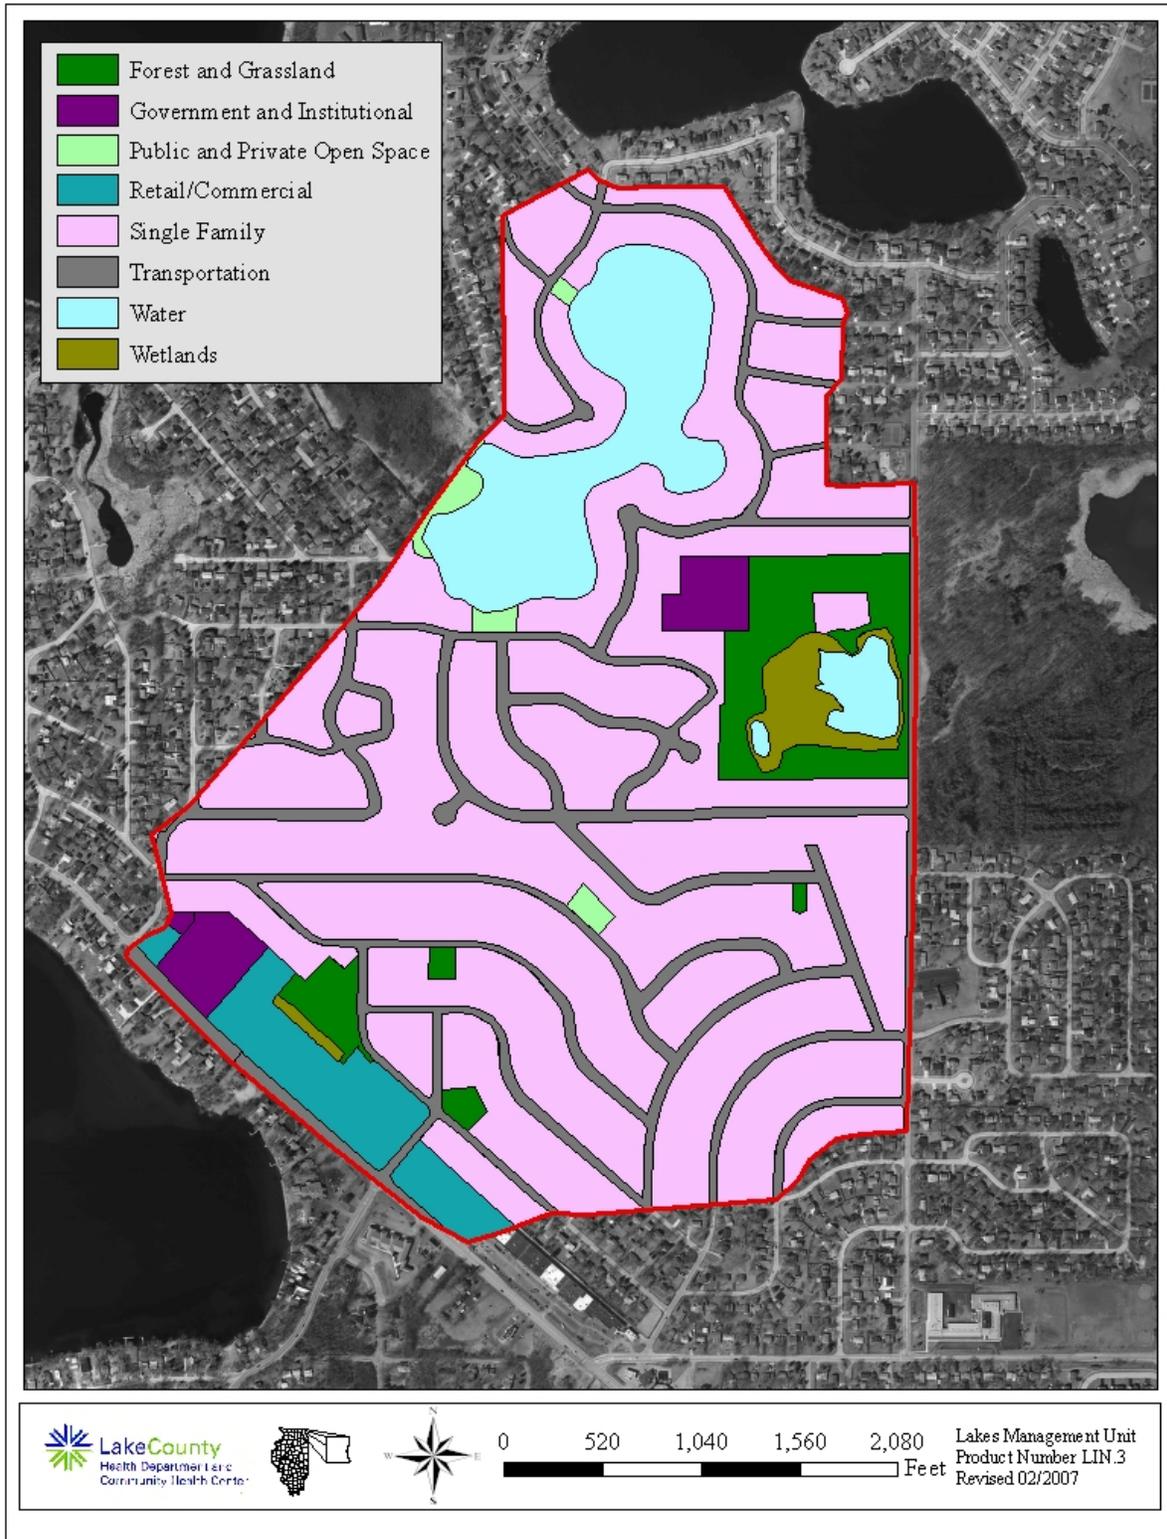
Figure 2. Approximate land use within the Lake Linden watershed, 2006.

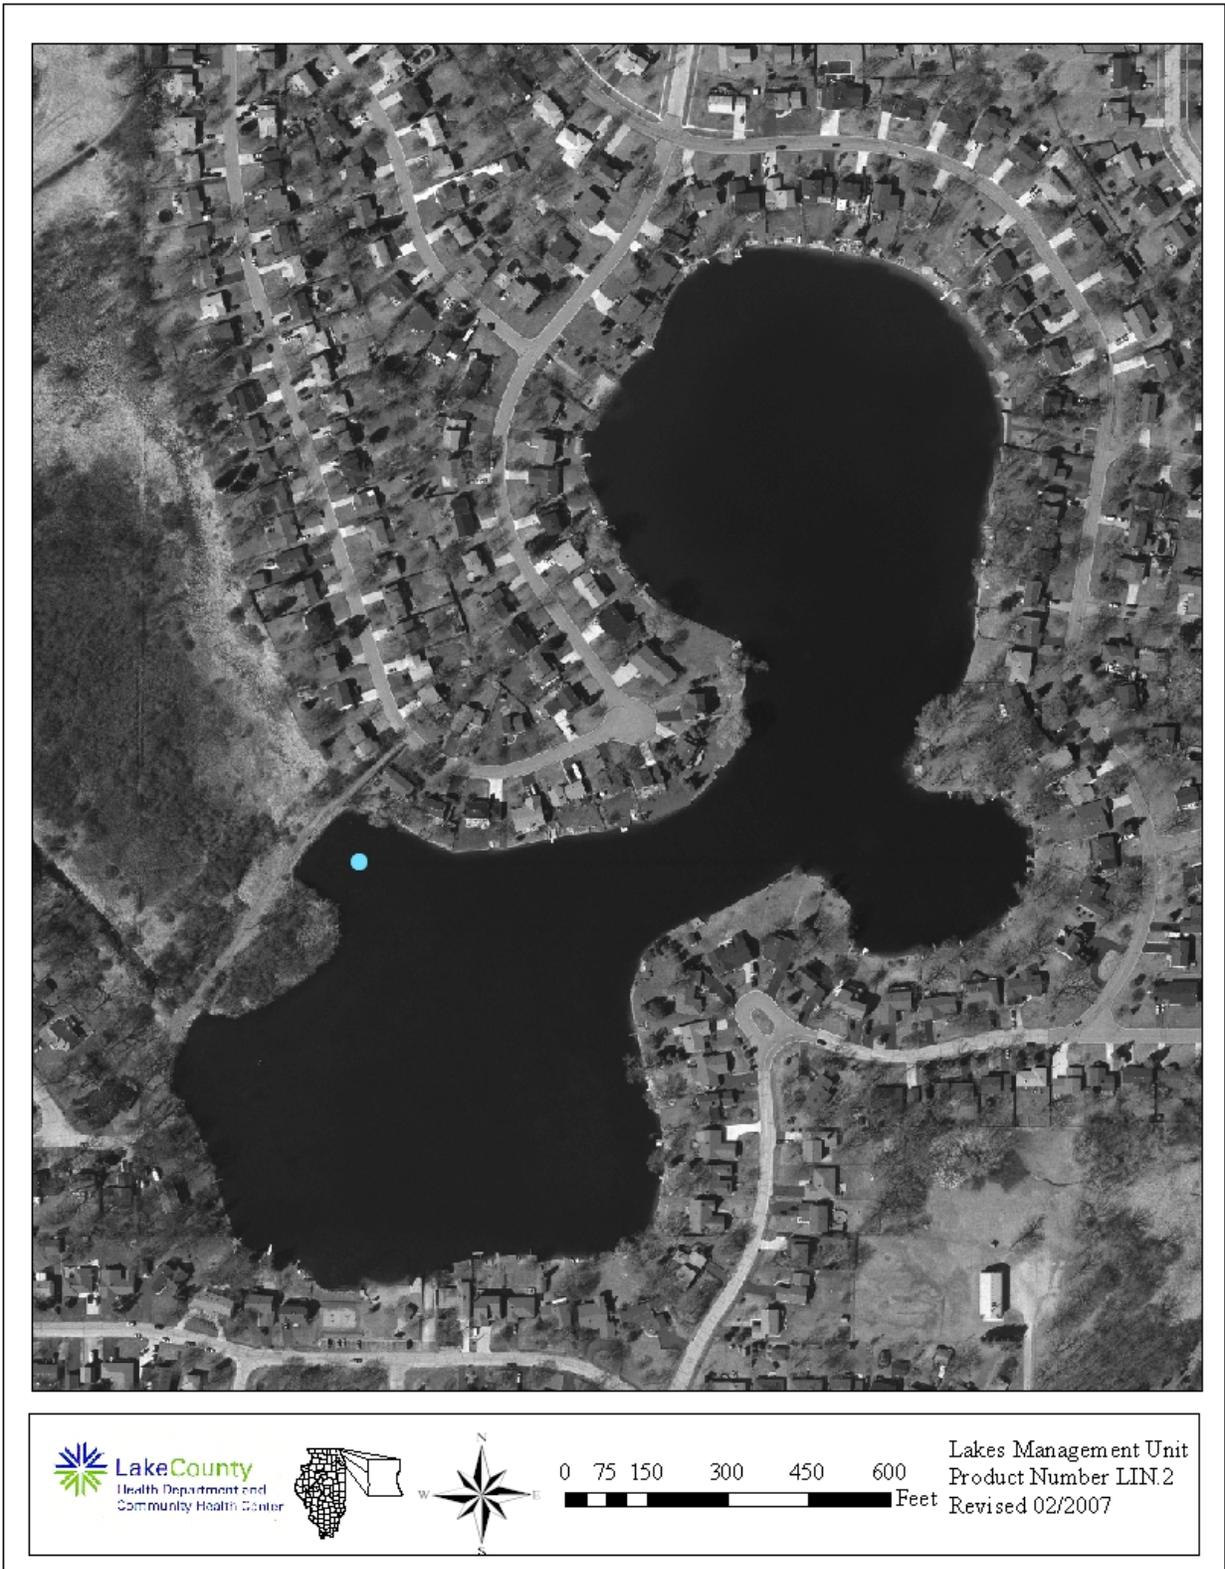
Figure 3. Water quality sampling point on Lake Linden, 2006.

Water samples were collected monthly from May through September at the deepest location in the lake (Figure 3) (Appendix B). One sample was taken from the upper water layer at three feet and analyzed for nutrients, solids concentration, and other physical parameters (Appendix A). During May and June, a second sample three feet from the bottom was taken because water level was higher than later in the season (Appendix C). Due to Lake Linden's shallow nature, wind and wave action kept the water well mixed.

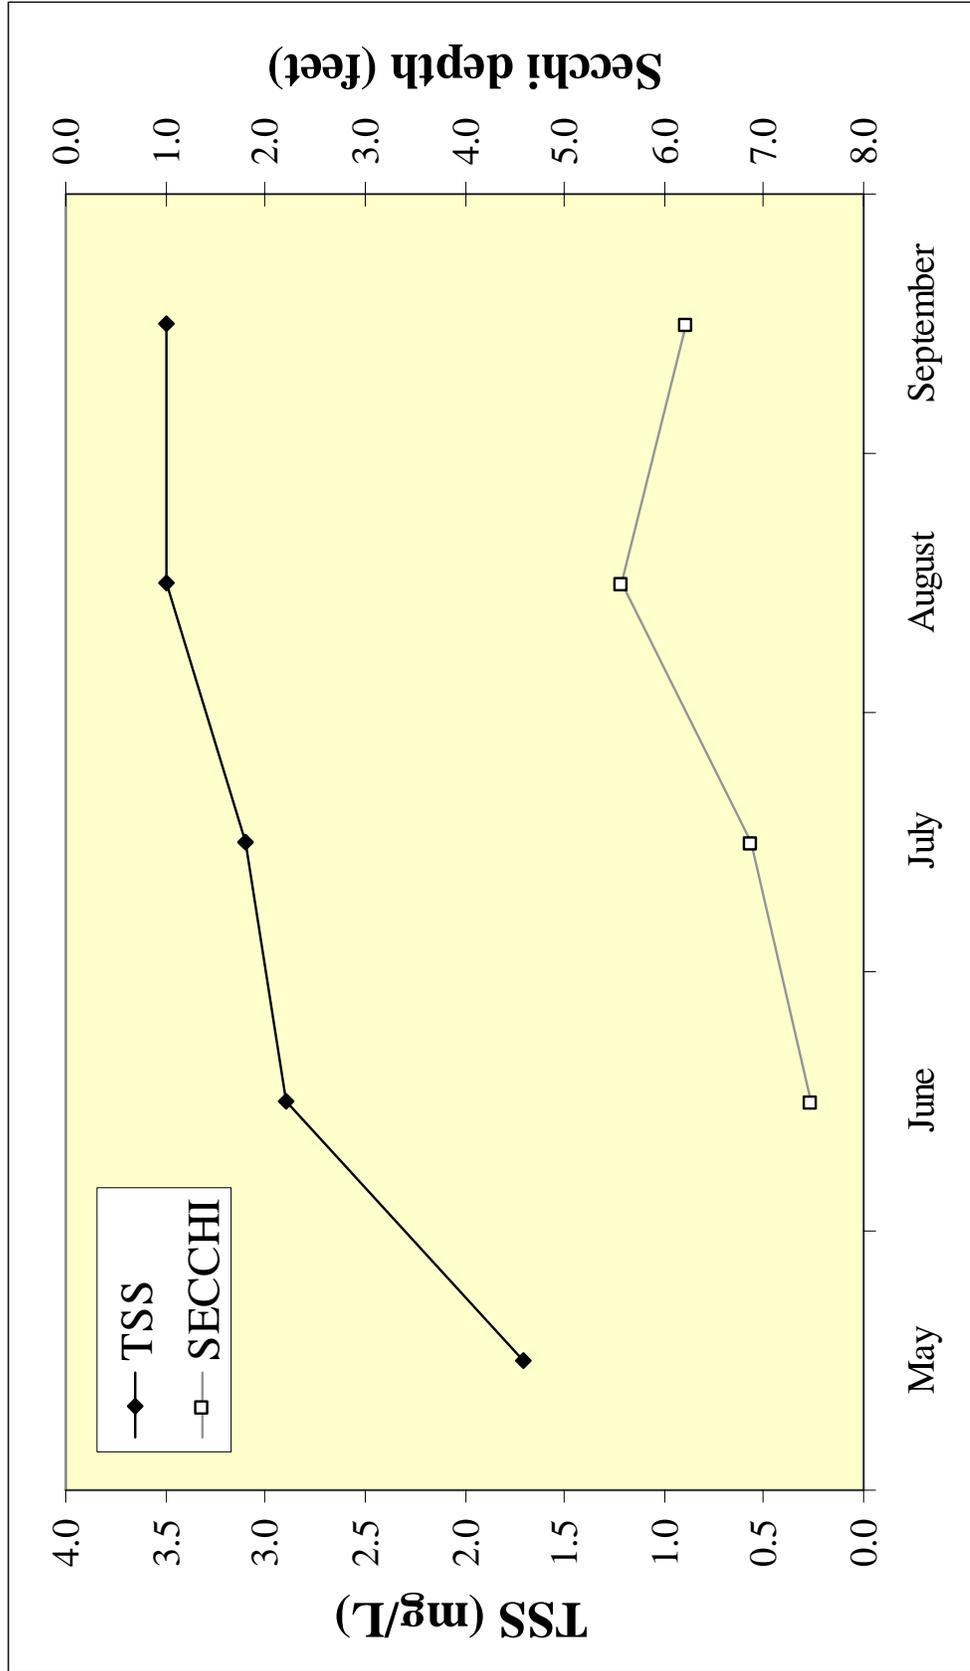
Figure 4. Total suspended solids (TSS) concentration vs. Secchi depth for Lake Linden, 2006.

Total suspended solids (TSS) are made up of any type of solid particles in the water column, including algal cells and sediment. The average epilimnetic TSS concentration for Lake Linden in 2006 was 2.9 mg/L, which was similar to the concentration in 2002 (2.3 mg/L). The 2006 TSS concentration was below the county median of 7.9 mg/L (Appendix E). Water clarity and TSS concentrations are positively correlated. The Secchi depth (water clarity) average in Lake Linden was 6.54 feet, which was double the County median (3.27 feet) (Figure 4). Water clarity has increased since 2002 when the average Secchi depth was 5.87 feet. An accurate reading was unable to be taken in May since the Secchi disk reached the bottom and was still able to be seen. August had the lowest reading (5.57 feet), probably due to plant die-off. The Volunteer Lake Monitoring Program (VLMP) has been continuously active on the lake since 1993. This program has been very successful and should continue in the future in order to detect any changes in water clarity trends. The VLMP average Secchi depth for the 2006 season was 6.5 feet, which is very close to the average found by the LCHD. The differences between the VLMP data and LCHD-Lake Management Unit (LMU) data can be mostly attributed to discrepancies between samplers. Also, time of day and the number of readings the averages are compiled from have an affect (Figure 5).

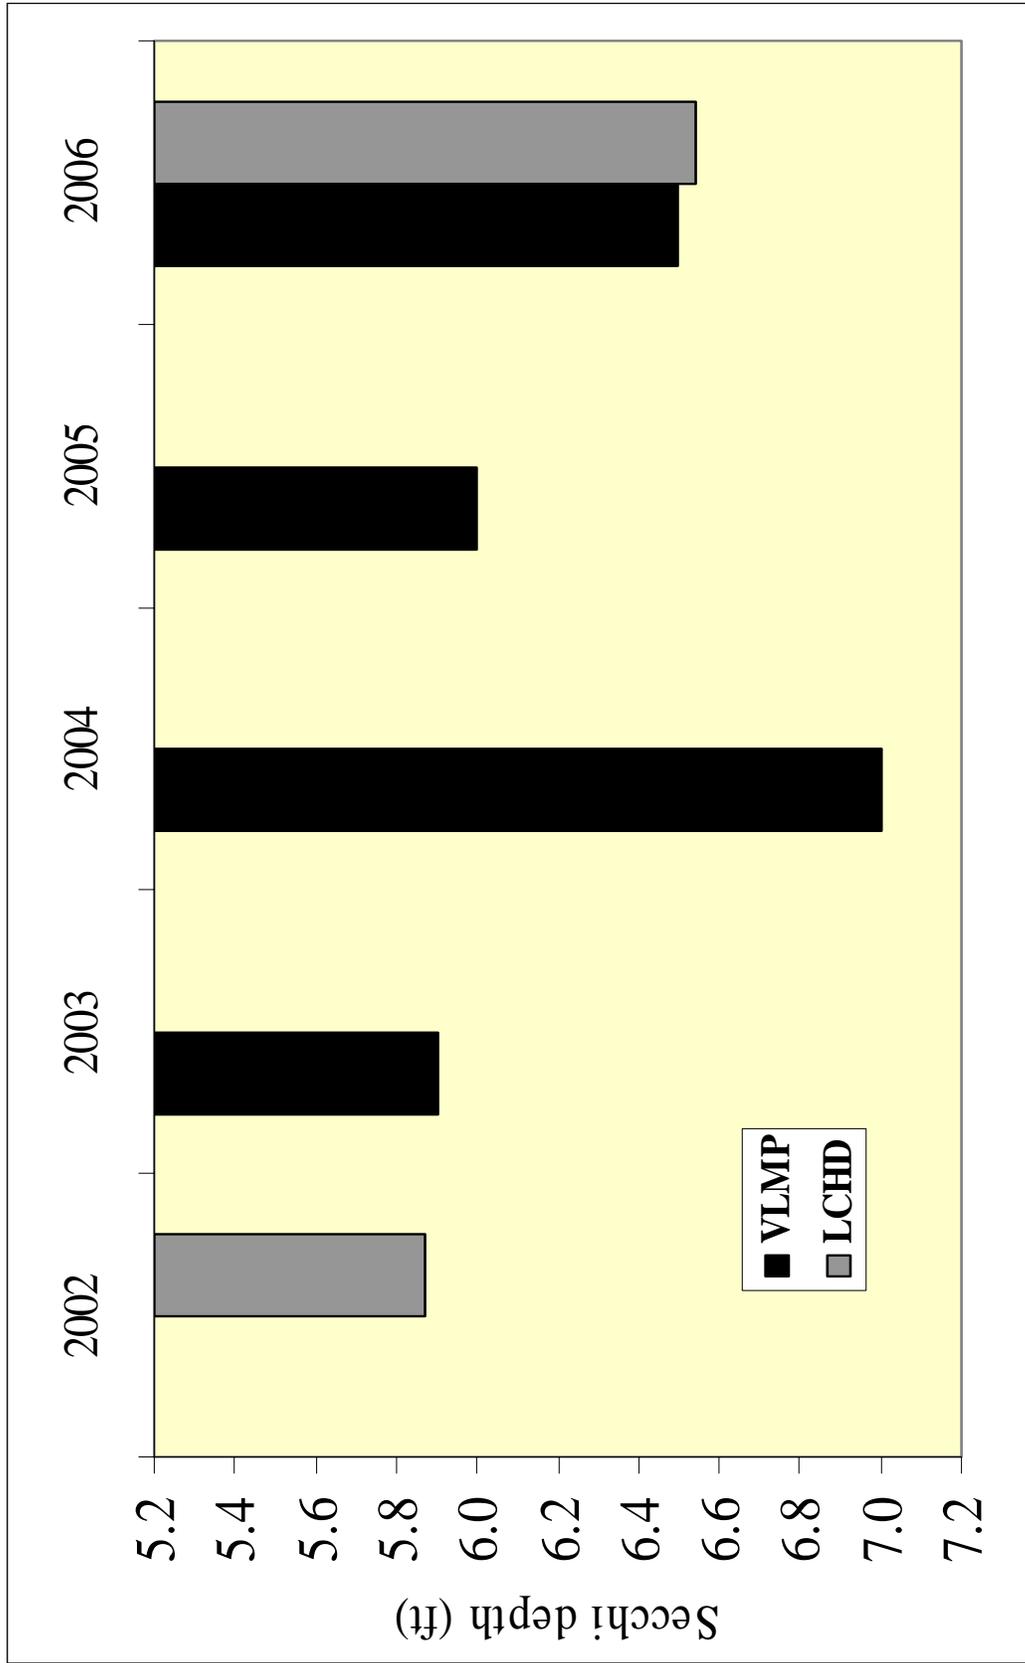
Figure 5. Comparison of Secchi depths between VLMP records and LCHD records for Lake Linden, 2002-2006.

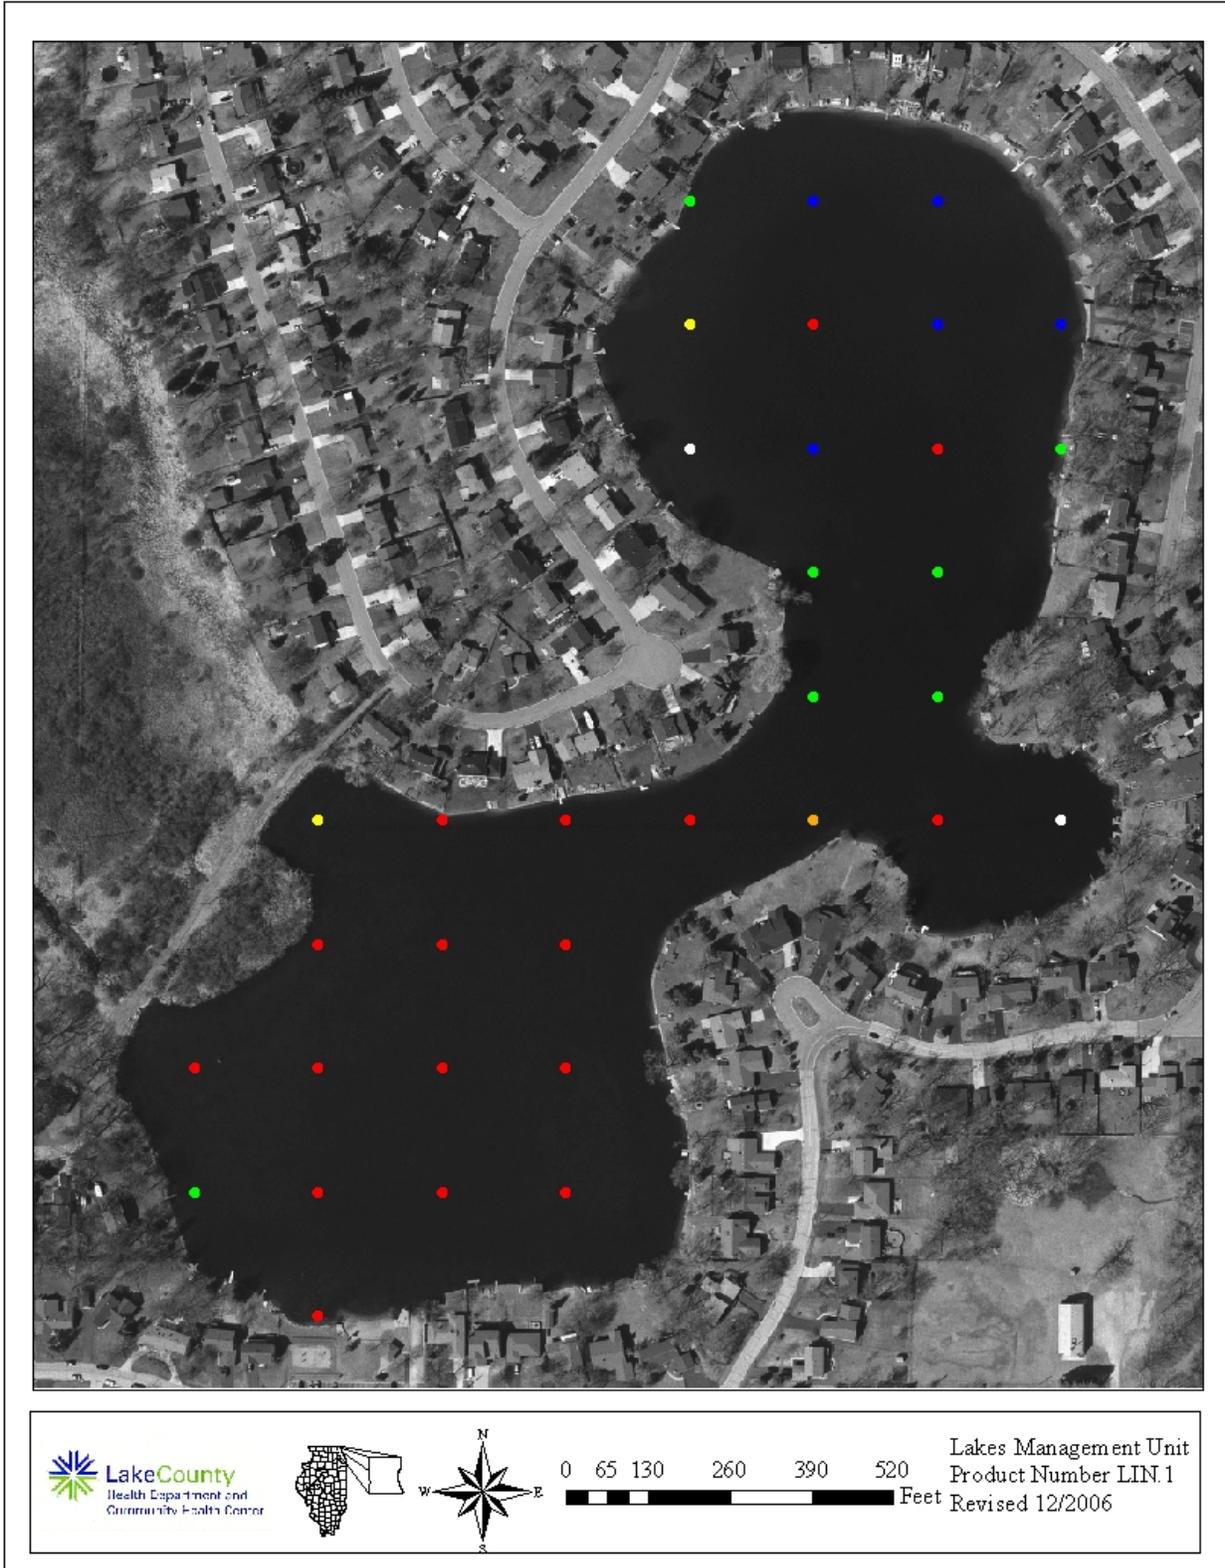
The plant sampling sites covered the entire lake and therefore the lake has approximately 94% plant coverage, with none of the area topped out (plants reaching and crowding the surface of the lake). *Chara* spp. was the dominant species and covered approximately 85% of the lake, and is not a good species for fish habitat. Ideally, a lake should have 30-40% plant coverage for a healthy game fishery, according to the Illinois Department of Natural Resources. Because *Chara* spp. is a macroalgae, Lake Linden has a lower than recommended plant community. The high-density macroalgae community helps utilize the nutrient load that Lake Linden experiences from fertilizers and stormwater runoff, and helps to keep the water clarity at a decent level. If macroalgae were reduced, microscopic algal populations may increase and cloud the water.

Figure 6. Aquatic plant sampling grid that illustrates plant density in July on Lake Linden, 2006.

The plant coverage on Lake Linden was very small (only 9%), while the macroalgae community covered 85% of the lake. This is due to the high amount of chemicals used to treat the growth of aquatic plants. While macroalgae helps utilize nutrients from storm water runoff, it does not provide a healthy fish habitat. Revitalization of native aquatic plants is recommended (See Appendix D3 for more details).

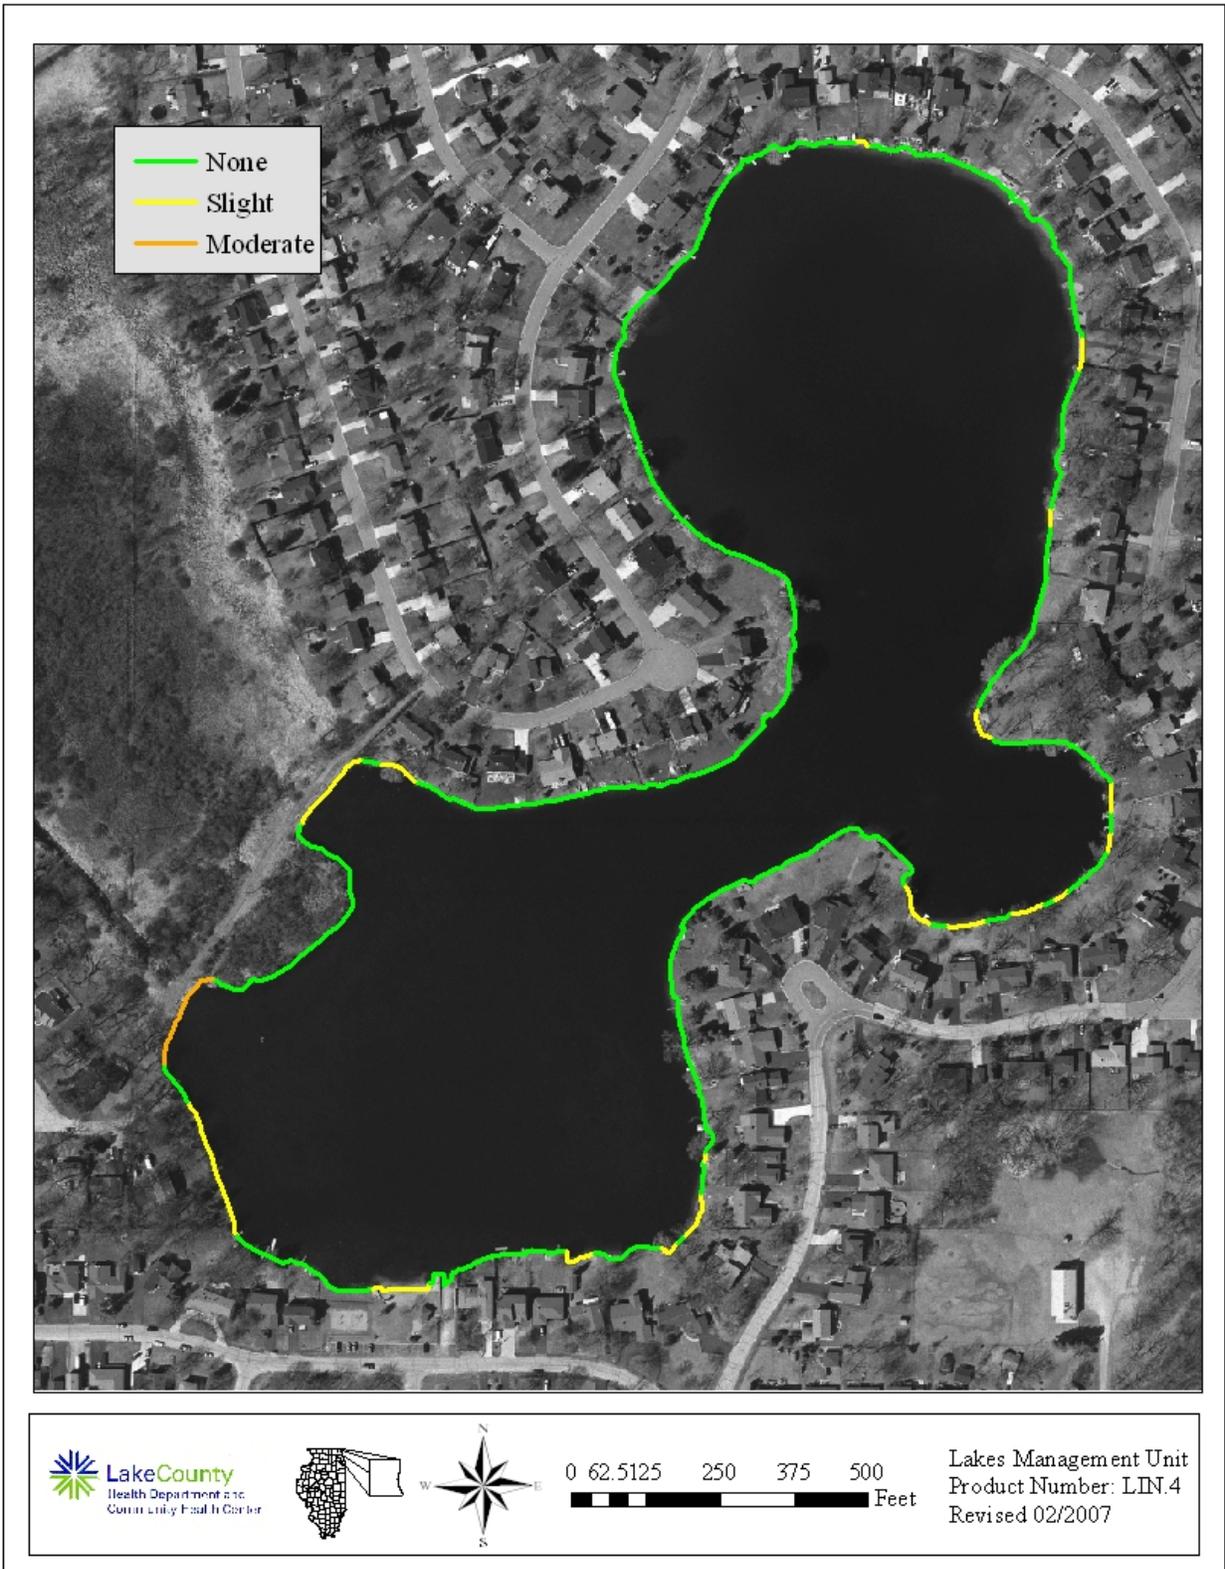
Shoreline erosion increased on the lake from the initial 2002 assessment. Areas by the park on the southwest side are of specific concern. Exotic shoreline plant species such as Buckthorn and Purple Loosestrife were observed as well.

In 2002, a complete shoreline assessment was performed in July. This assessment found 100% of Lake Linden's shoreline was developed, with rip rap and seawall being the most common land use (29.3 % and 28.6%, respectively). Other shoreline types found were beach, shrub, buffer and lawn. In 2002, approximately 8% of the shoreline was eroded to some degree. A reassessment of shoreline erosion in 2006 found areas of slightly and moderately eroded shoreline at the park on the southwest side (Figure 7). The remaining shoreline had small sections of slightly eroded shoreline scattered throughout.

Figure 7. Approximate shoreline erosion on Lake Linden, 2006.

While some residents have installed buffer strips along their lakefront, many areas of manicured lawn remain. The roots of lawn grass do not provide the stabilization needed to hold sediment in place. The Lakes Management Unit recommends that more buffer strips be installed to prevent further erosion, especially at the noted sites at the park. A possible cause of erosion can be improperly installed seawall and rip rap. Rip rap needs to consist of large rocks with a liner underneath that holds the rock to the shoreline and also prevents erosion between the rocks. Otherwise, rock can be carried out into the lake by wave action. If seawall was installed improperly, undercutting can occur and can be costly to repair. The low amount of water level fluctuation was one reason that further erosion did not occur, as the water level in 2006 did not fluctuate by more than three inches from month to month.
