**2008 SUMMARY REPORT
of
Echo Lake**

Lake County, Illinois

**LAKE COUNTY HEALTH DEPARTMENT
ENVIRONMENTAL HEALTH SERVICES
LAKES MANAGEMENT UNIT**

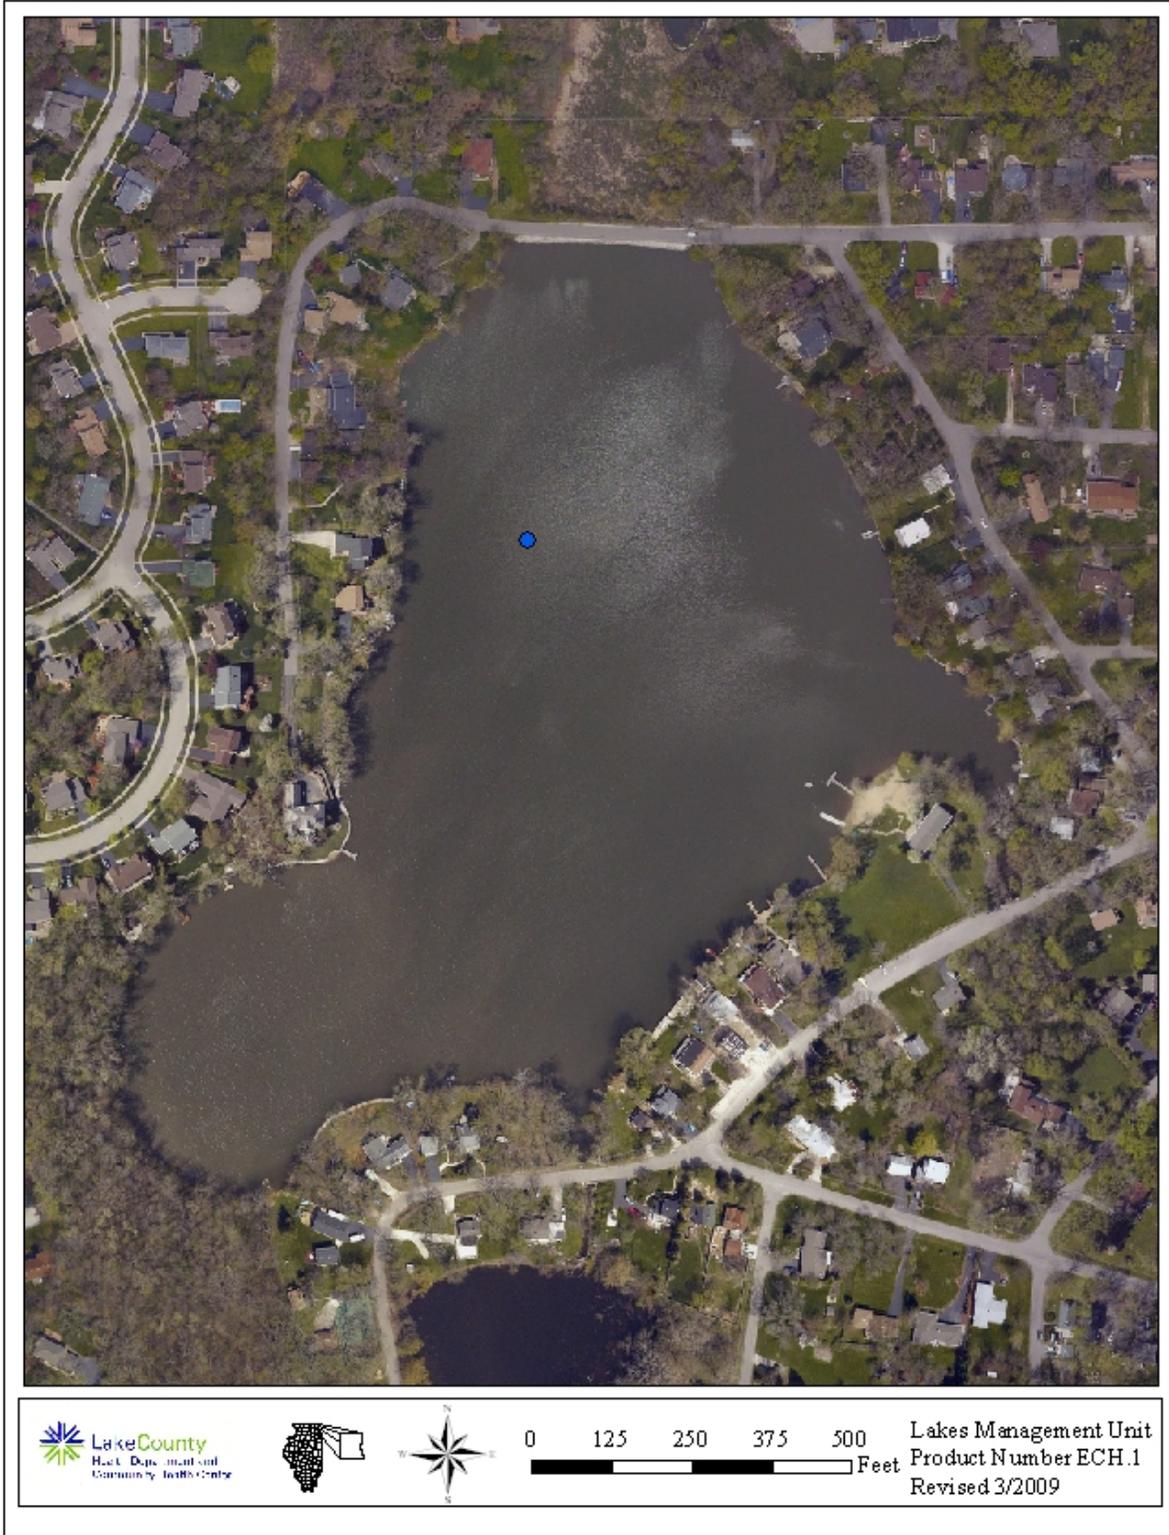
Figure 1. Water quality sampling site on Echo Lake, 2008.

Water samples were collected from May through September in Echo Lake at the deepest point located near the middle of the lake (Figure 1). Samples were taken at 3 feet below the surface and approximately 3 feet above the lake bottom when the lake was stratified; then analyzed for various water quality parameters (Appendix A). Water level was taken from a pier on the east side of the lake each month during sampling and north of the lake at the outflow. Echo Lake is within the Flint Creek watershed which the Lakes Management Unit (LMU) sampled the lakes in its entirety in 2008. This watershed also includes Lake Zurich, Grassy Lake, Honey Lake, Flint Lake, and Lake Louise. Due to the downstream location of the lake within its watershed lake levels could be susceptible to rain events. However, a significant fluctuation in lake levels was not observed during the sampling season. In order to accurately monitor water levels it is recommended that a staff gauge be installed and levels measured and recorded frequently (daily or weekly).

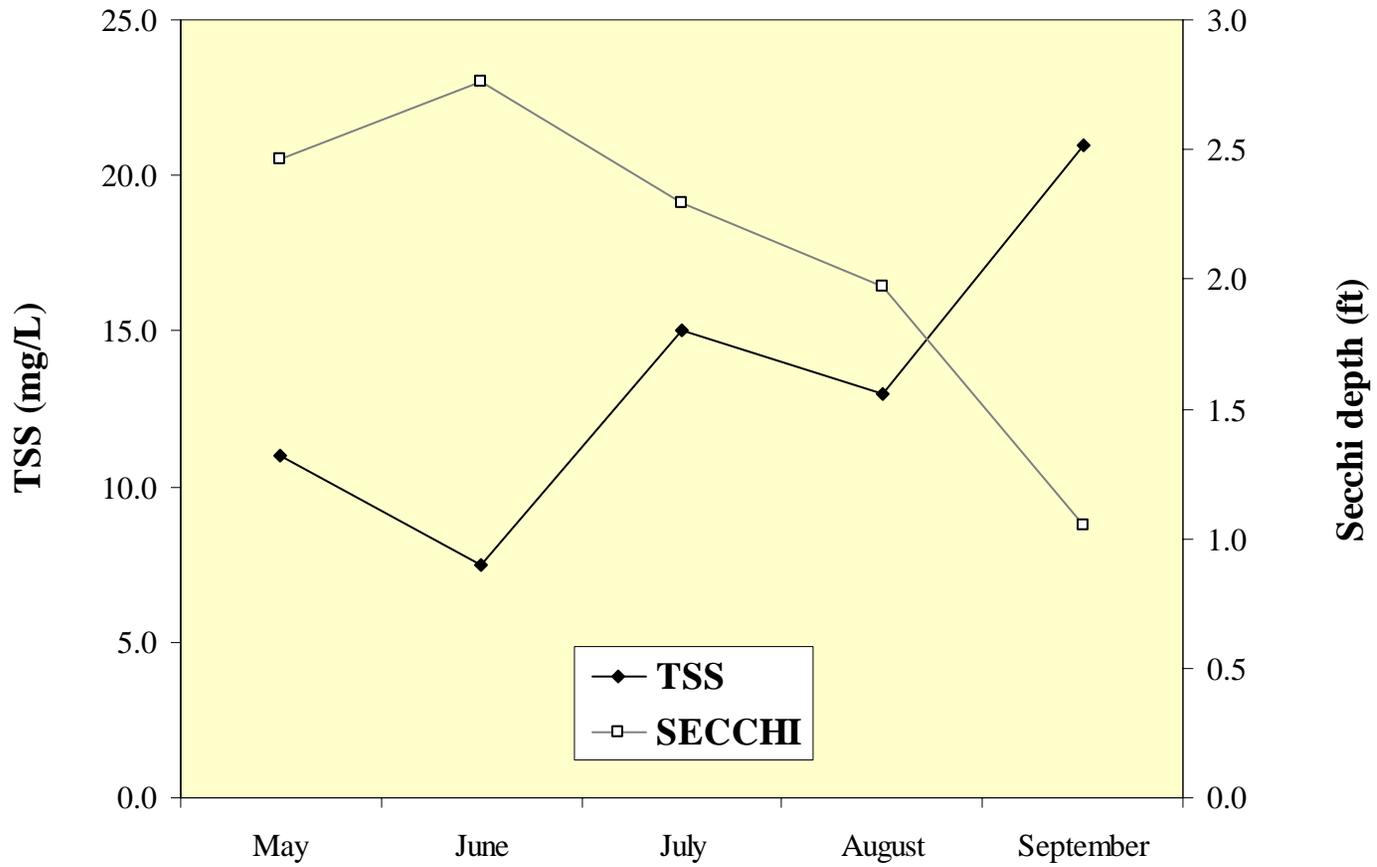
Figure 2. Total suspended solid (TSS) concentrations vs. Secchi depth for Echo Lake, 2008.

Historically Echo Lake has had below average water quality for Lake County, many water quality parameters remain above county medians, and water quality has deteriorated significantly since 2000. The total suspended solid (TSS) concentrations averaged 13.5 mg/L (Table 1), which is higher than the county median of 8.2 mg/L (Appendix E). High TSS values are typically correlated with poor water clarity (Secchi disk depth) and can be detrimental to many aspects of the lake ecosystem such as the plant and fish communities. As a result of high TSS concentrations, the average Secchi depth for the season was low (2.11 feet). In September there was a considerable decrease in the Secchi depth corresponding to an increase in TSS (Figure 2). This was most likely due to the moderate rain event prior to sampling. In 2000 the water quality was slightly better; the TSS average was 9.7 mg/L and Secchi disk average was 3.77 feet. Echo Lake had a Secchi depth less than Lake Zurich and Honey Lake but greater than Grassy Lake (Table 2). This was the same trend for the TSS within the Flint Creek watershed. This may be due to the absence of aquatic macrophytes, wind/wave action, Common Carp disturbing the bottom, and its shallow nature. Lake Zurich, which is at the top of the watershed, with abundant macrophytes and the presence of Zebra Mussels that filter the water lowering the TSS values had the highest average Secchi depth (10.40 feet) and lowest average TSS (2.7 mg/L) within the Flint Creek watershed.

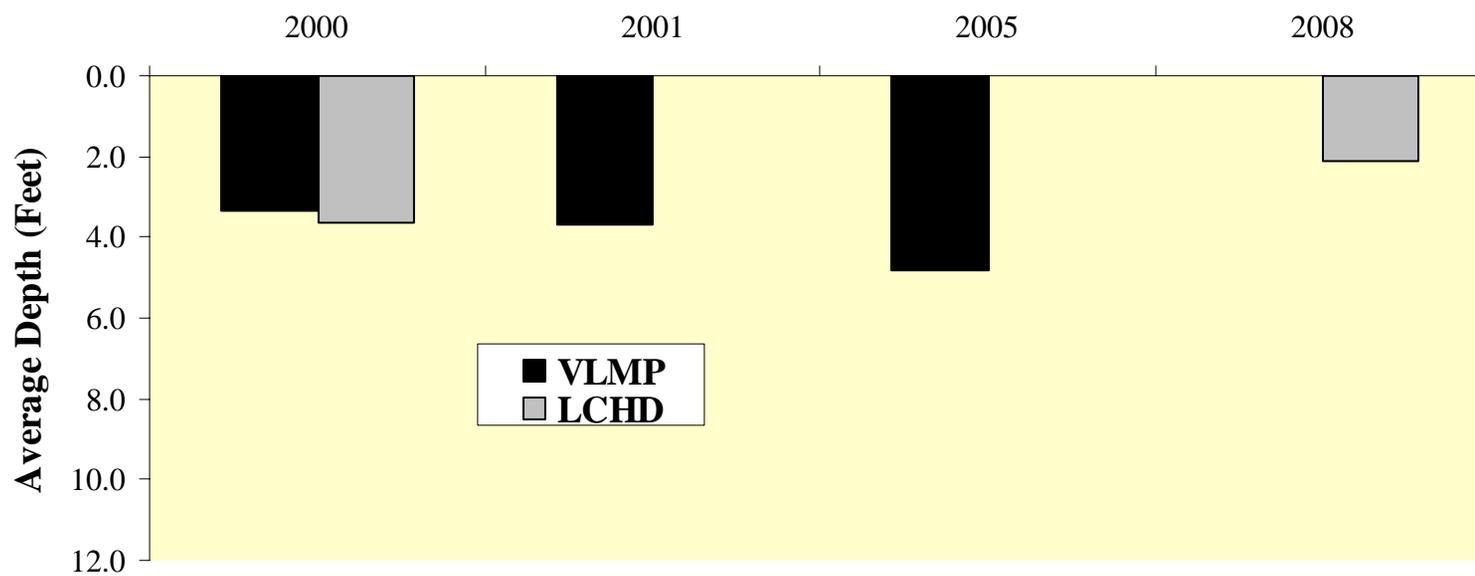
Figure 3. Secchi disk averages from VLMP and LCHD records for Echo Lake.

Echo Lake has participated in the Illinois Environmental Protection Agency's (IEPA) Volunteer Lake Monitoring Program (VLMP) in 2000, 2001, and 2005. The VLMP Secchi depth averages over the past eight years have been between 2.11 feet (2008) and 4.83 (2005) feet (Figure 3).

The VLMP data from 2000 through 2005 had an average Secchi depth of 3.94 feet while the LMU average from 2000 and 2008 was 2.89 feet. This program provided beneficial information on the annual water clarity trends in the lake. However, the lake currently lacks a volunteer. It is strongly recommended that Echo Lake become an annual member of the VLMP program.

Echo Lake participated in the VLMP since in 2000, 2001, and 2005 providing valuable data during the years the LMU did not sample the lake. No VLMP has been in place since 2005. It is strongly recommended that the association find volunteers to staff these positions (Appendix D4). It is also recommended that a permanent staff gauge be installed to monitor the lake water level.

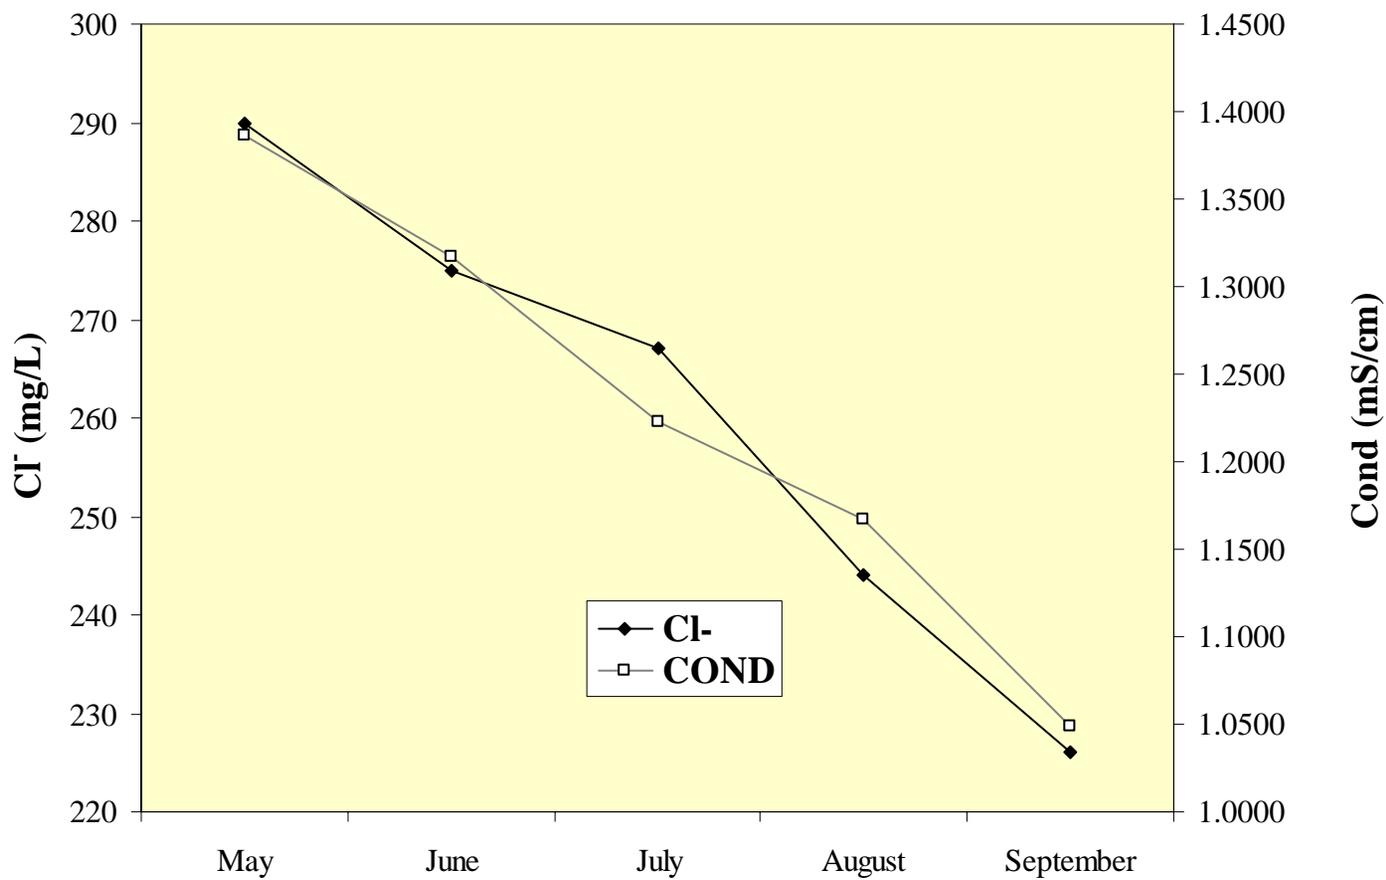
Figure 6. Chloride (Cl⁻) concentration vs. conductivity for Echo Lake, 2008.

Conductivity readings, which are correlated with chloride concentrations (Figure 6), have been increasing throughout the past few years in the county. Road salts consist of sodium chloride, calcium chloride, potassium chloride, magnesium chloride or ferrocyanides which are detected when chlorides are analyzed. The average conductivity reading for Echo Lake was

1.2284 mS/cm. This is above the county median of 0.8195 mS/cm, this value is a 38% increase since 2000 (0.8872 mS/cm). Chloride concentrations averaged 260 mg/L for the season and the county median was 166 mg/L. A study done in Canada reported 10% of aquatic species were harmed by prolonged exposure to chloride concentrations greater than 220 mg/L. Additionally, shifts in algal populations were associated with chloride concentrations as low as 12 mg/l. Shifts from green algae to blue-greens, which are less palatable to zooplankton. The Flint Creek watershed had a range of chloride values from 171 mg/L (Lake Louise) to 296 mg/L (Honey Lake). It appears that the road salt is compounding in many lakes in the county, including Echo Lake. Some lakes in the county have seen a doubling of conductivity readings in the past 5-10 years. Alternatives to road salt should be considered. While alternatives may contain chloride, they tend to work faster at lower temperatures and therefore require less application to achieve the same result that common road salt.

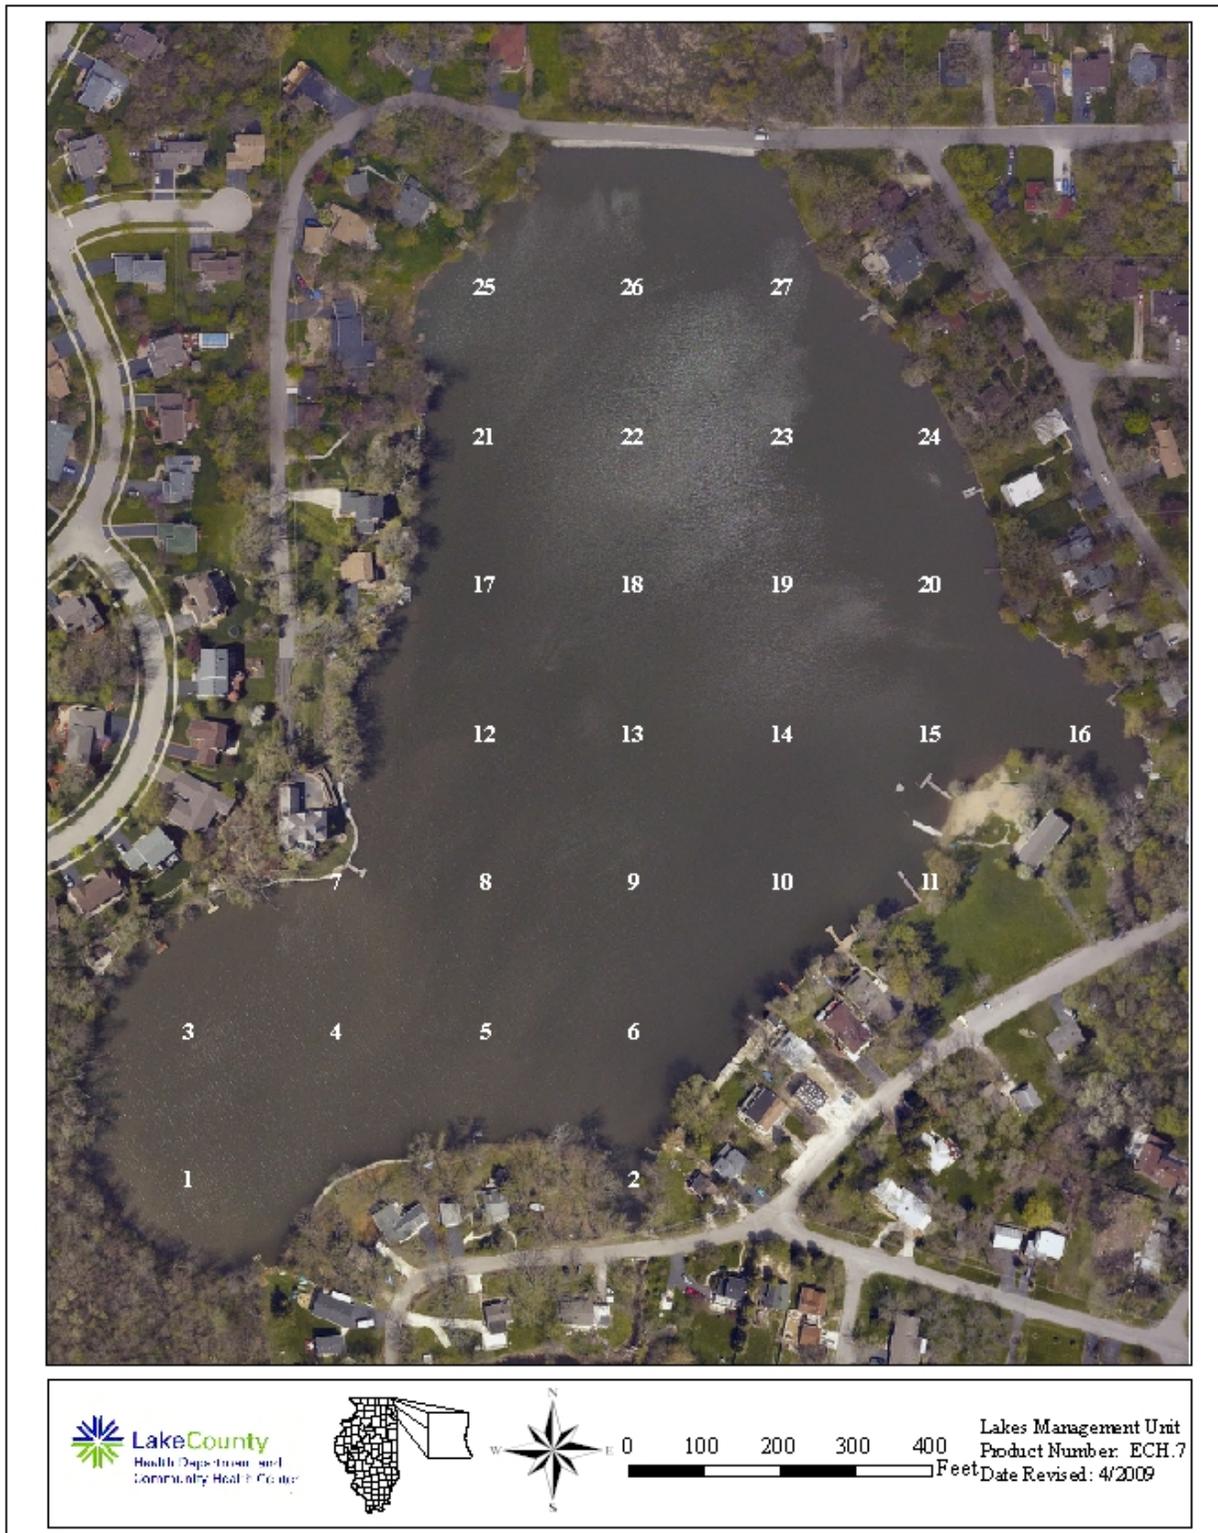
Figure 7. Aquatic plant sampling grid for Echo Lake June, 2008.

Plant sampling was conducted on Echo Lake in June. There were 27 points sampled based on a computed generated grid system with points 60 meters apart (Figure 7). Aquatic plants were not found at any of these sites. In an effort to eliminate sampling bias and to document any existing aquatic plant populations a perimeter assessment and meandering survey within the entire lake was also conducted. The meander method is random and covers areas that could have small amounts of vegetation while the perimeter survey consisted of the areas near the shorelines. During these combined sampling procedures not one aquatic plant was found. Historically Echo Lake has had an overabundance of plants. In 2000 95% of the lake bottom (23 acres) had plant coverage; the plant community then was dominated by Coontail and Curlyleaf Pondweed (exotic/invasive) both species are commonly found in nuisance plant populations in Lake County lakes. To maintain a healthy sunfish/bass fishery, the optimal plant coverage is 30% to 40% across the lake bottom. In May 2008, a Sonar application was conducted by Environmental Aquatics to target Curlyleaf and Coontail. In 2008 no algaecide treatments were applied. The treatment/treatments resulted in a transfer in the vegetative community from an unfavorable plant-dominated lake to a lake with an absence of plants. In lakes in which this switch has occurred, it is difficult to change the lake back to one with a healthy and diverse plant

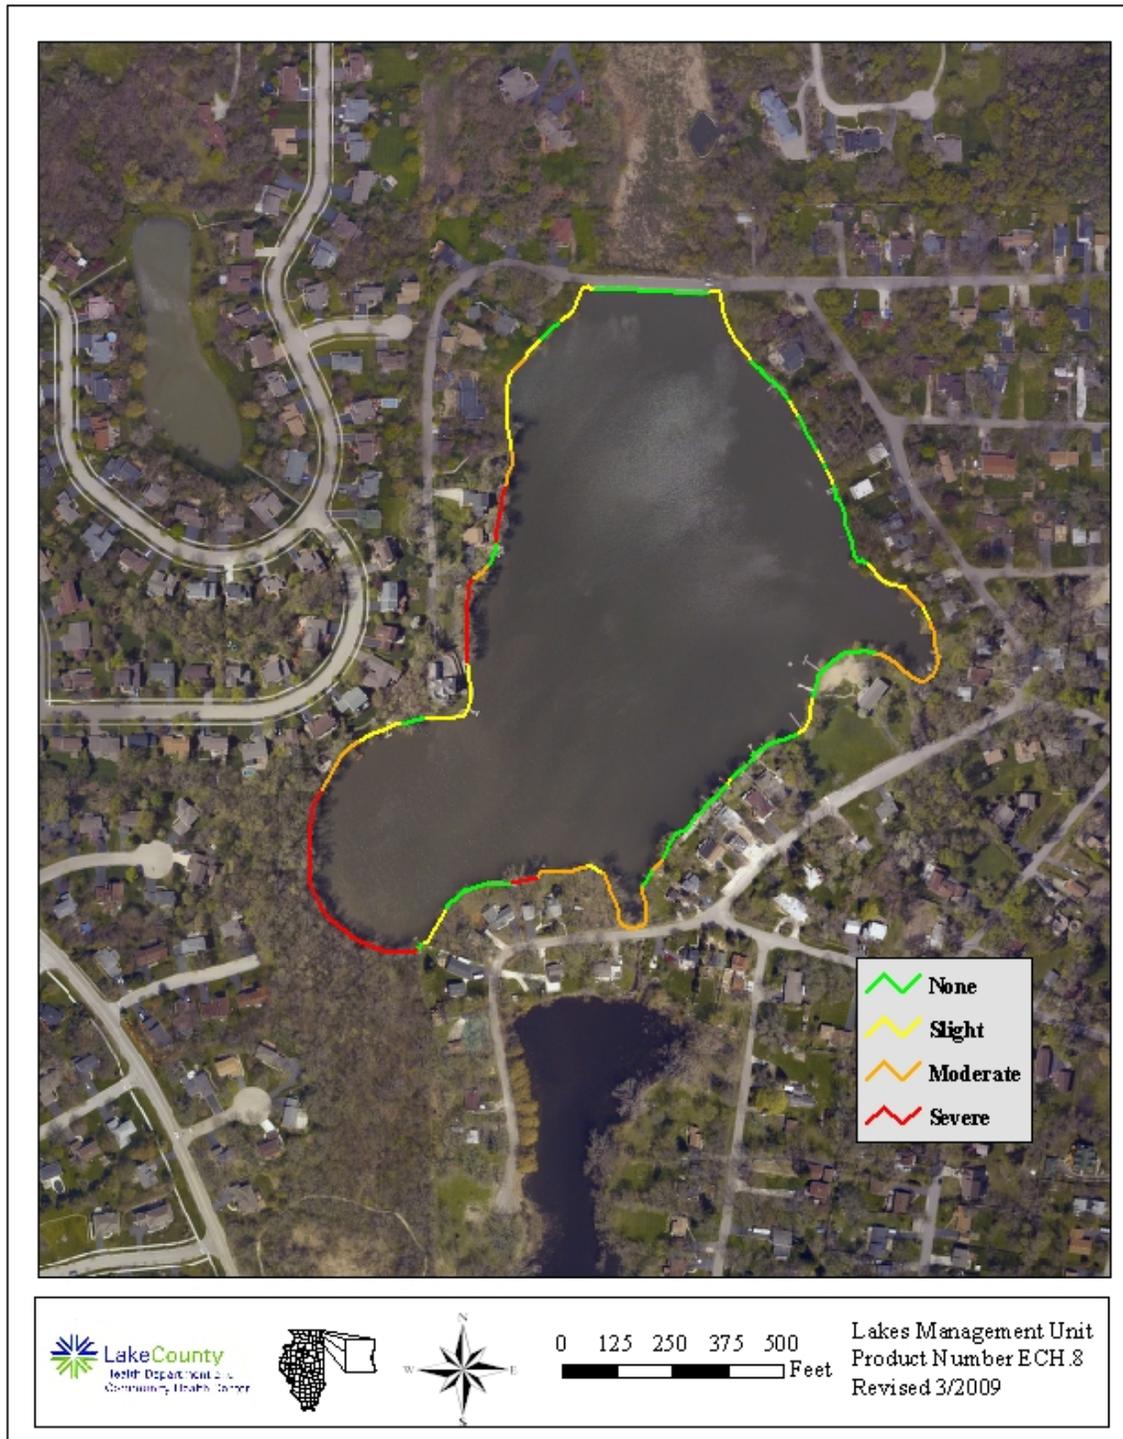
Figure 13. Shoreline erosion on Echo Lake, 2008

The shoreline was reassessed in 2008 for significant changes in erosion since 2000. Based on the 2008 assessment, there was an increase in shoreline erosion with approximately 66% of the shoreline having some degree of erosion (Figure 8). Overall, 34% of the shoreline had no erosion, 26% had slight erosion, 20% had moderate, and 19% had severe erosion. The areas of moderate and severe erosion should be addressed soon. It is much easier and less costly to mitigate slightly eroding shorelines than those with more severe erosion. If these shorelines are repaired by the installation of a buffer strip with native plants, the benefits can be three-fold. First, the erosion is repaired and the new native plants can stabilize the shoreline to prevent future erosion. Second, the addition of native plants adds habitat for wildlife to a shoreline that is otherwise limited in habitat. Thirdly, buffer habitat can help filter pollutants and nutrients from the near shore areas and keep geese and gulls from congregating, as it is not desirable habitat for them.

There was an increase in shoreline erosion with approximately 66% of the shoreline having some degree of erosion since 2000. Overall, 34% of the shoreline had no erosion, 26% had slight erosion, 20% had moderate, and 19% had severe erosion. All of the eroded areas should be remediated to prevent additional loss of shoreline and prevent continued degradation of the water quality through sediment inputs. When possible, the shorelines should be repaired using natural vegetation instead of riprap or seawalls (Appendix D2).
