**2009 SUMMARY REPORT
of
Ozaukee Lake**

Lake County, Illinois

**LAKE COUNTY HEALTH DEPARTMENT
ENVIRONMENTAL HEALTH SERVICES
ENVIRONMENTAL SERVICES**

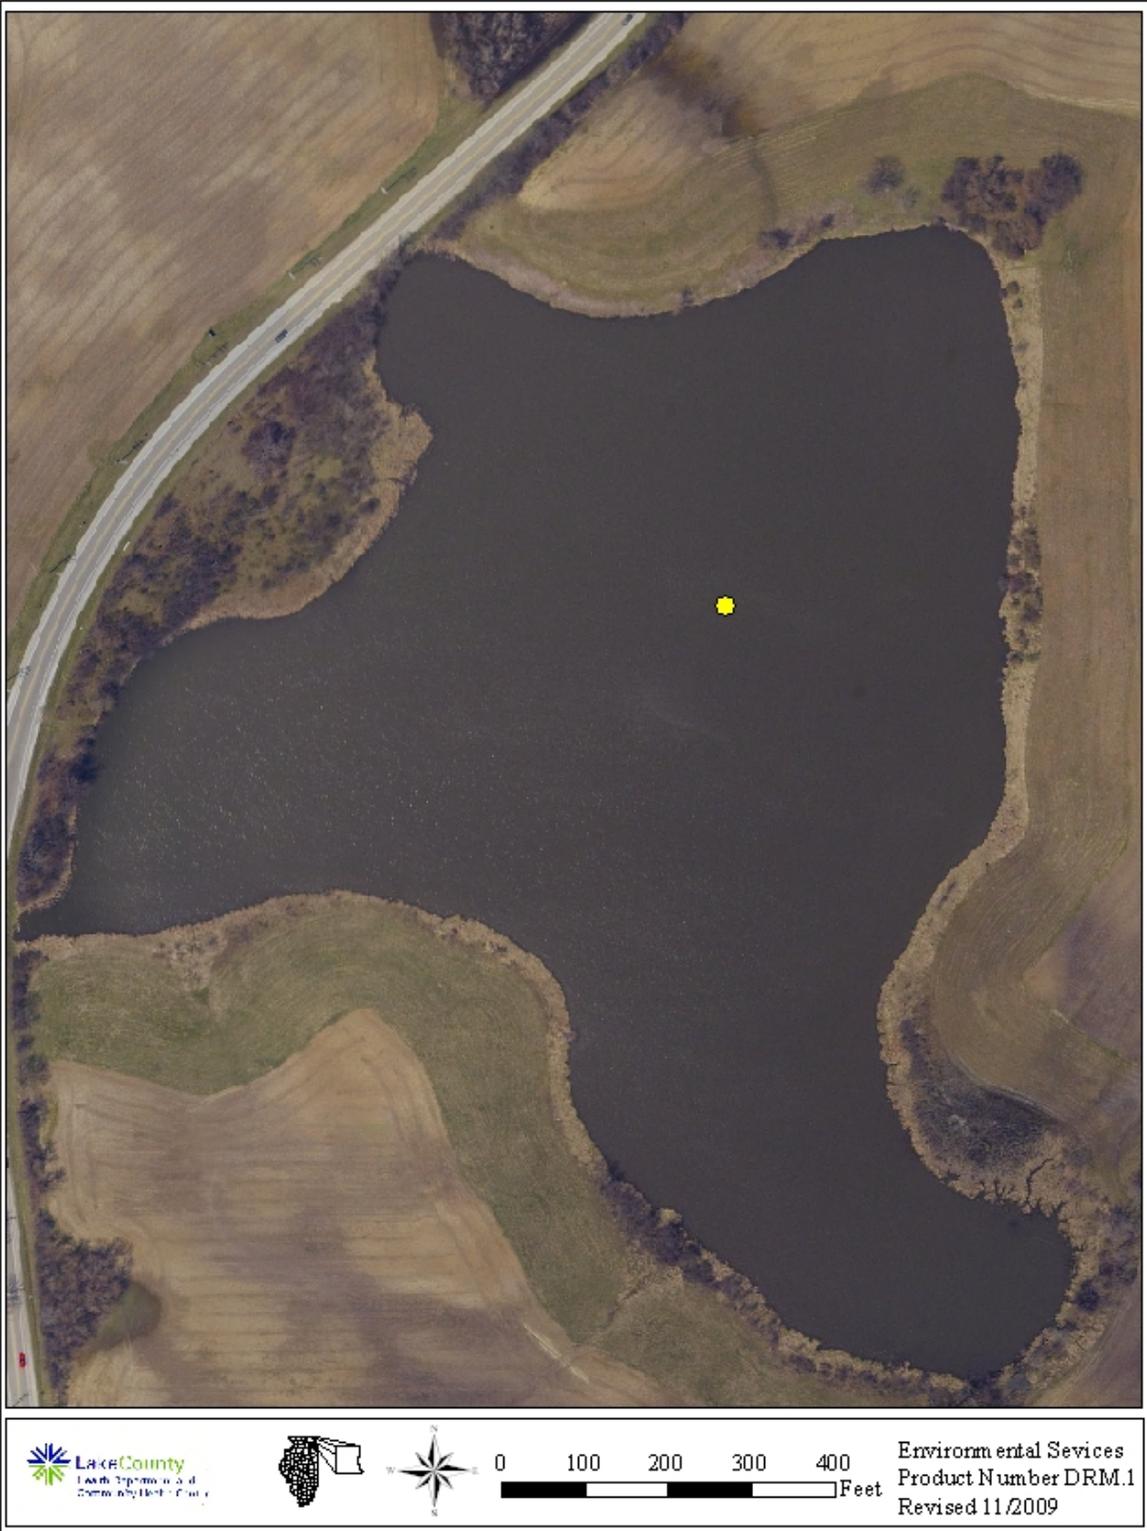
Figure 1. Water quality sampling site on Ozaukee Lake, 2009.

Water samples were collected monthly from May through September at the deepest point located on the west side of the lake (Figure 1, Appendix A). Samples were collected at the surface and analyzed for various water quality parameters (Appendix C). The Lakes Management Unit (LMU) also sampled Ozaukee Lake in 2002. Ozaukee Lake is located in the Mutton Creek watershed and is completely owned and managed by the Lake County Forest Preserve District (LCFPD). The LMU sampled one other lake within the Mutton Creek watershed in 2009, Lake Napa Suwe. Ozaukee Lake drains west under Fairfield Road into Lake Napa Suwe that is connected to a tributary to Mutton Creek and eventually flows into the Fox River. Other lakes in the Mutton Creek watershed include Lake Fairfield and Island Lake.

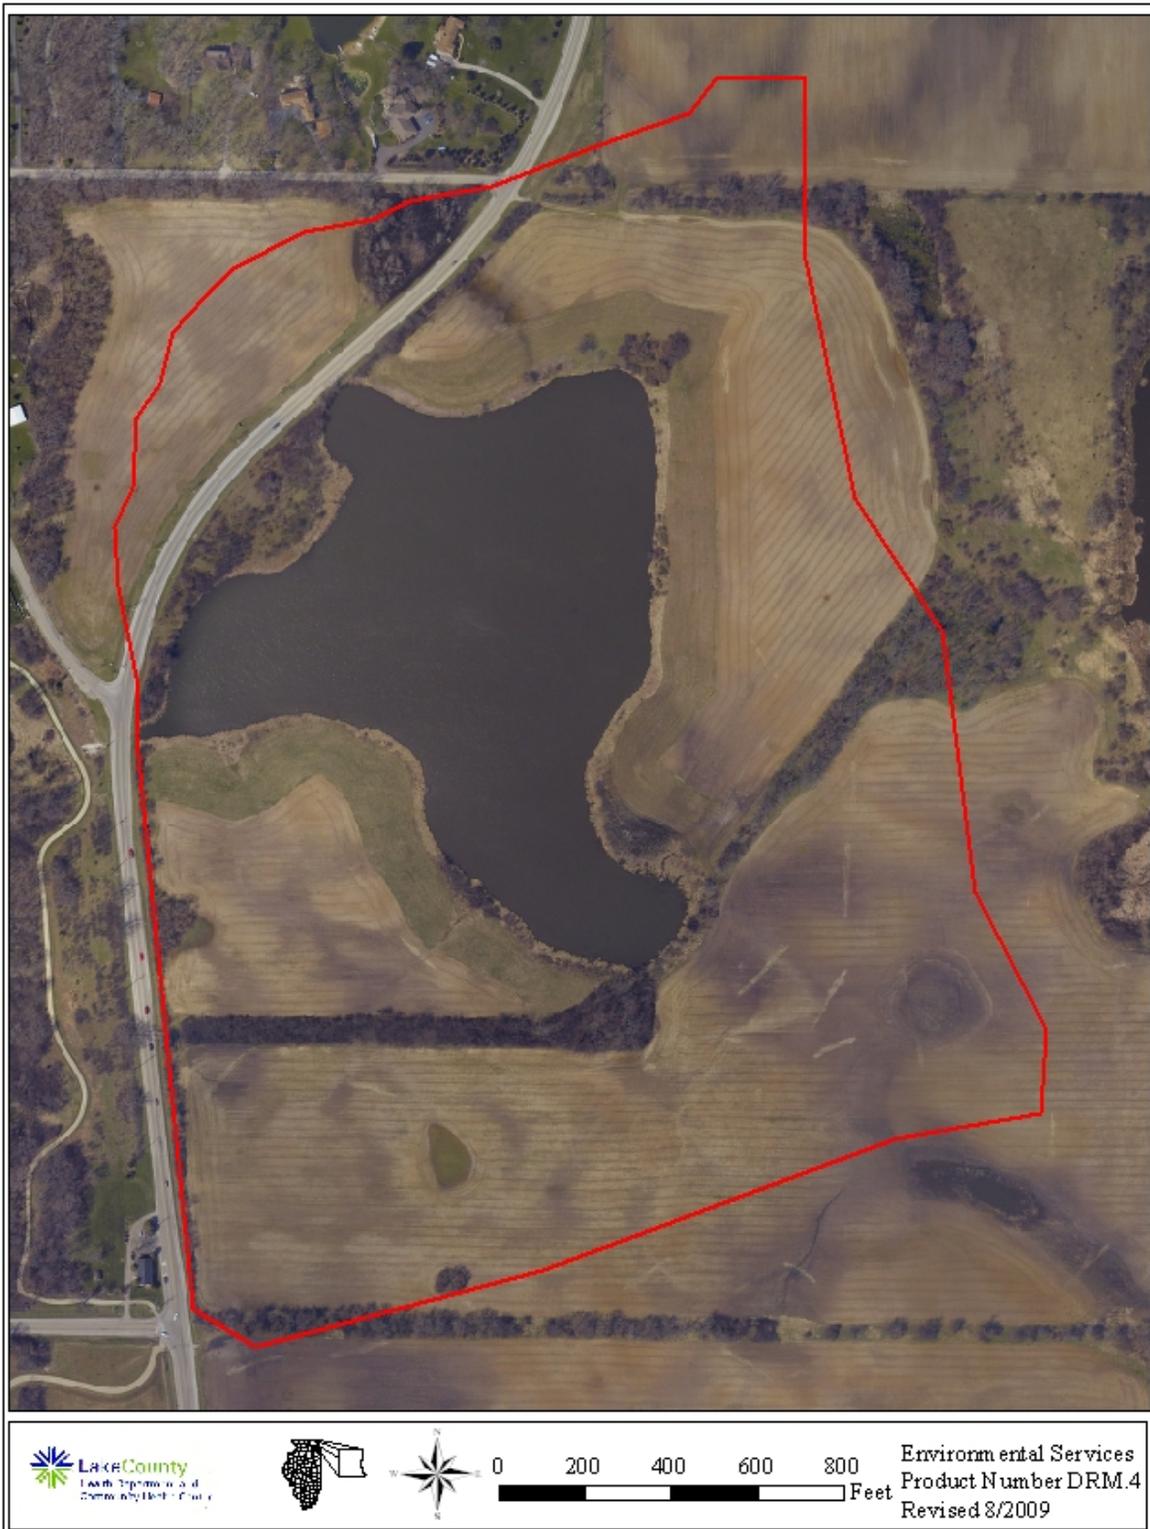
Figure 4. Approximate watershed delineation for Ozaukee Lake, 2009.

Ozaukee Lake receives water from its 101.83 acre watershed and drains west under Fairfield Road into Lake Napa Suwe that is connected to a tributary to Mutton Creek and eventually flows into the Fox River. The primary land use within the Ozaukee Lake watershed was public and private open space (92%); which is a unique and valuable characteristic as Lake County only has 13% of land preserved as public and private open space.

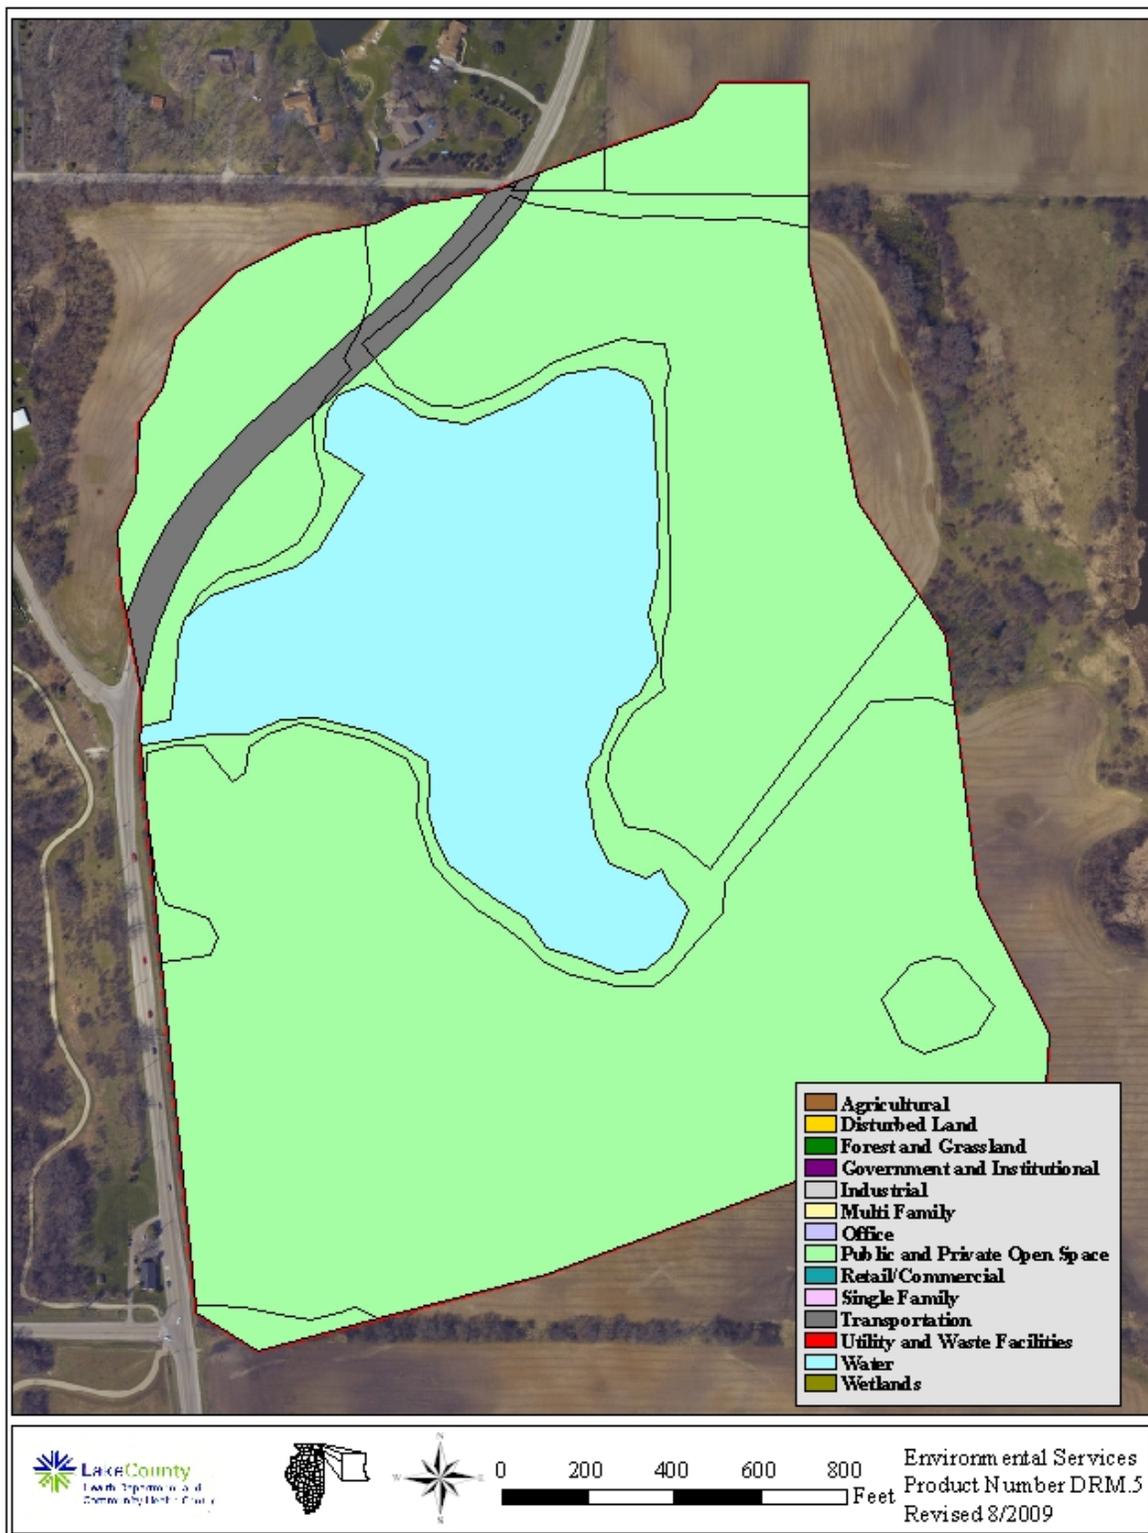
Figure 5. Approximate land use within the Ozaukee Lake watershed, 2009.

transportation (2%) and water (6%) were the only land uses within the watershed (Figure 5). The public and private space land use was a unique and valuable characteristic within a watershed as Lake County only has 13% of land preserved as open space. Based on the amount of impervious surfaces each land use contributes varied amounts of runoff. The two sources of runoff for Ozaukee Lake were public and private open space (88%) and transportation (12%, Table 4). Watershed characteristics are important lake management tools when considering options to reduce nutrient loads. The retention time (the amount of time it takes for water entering a lake to flow out of it again) was calculated to be approximately 85 days. A watershed is an area of land that drains into a body of water and the land management directly affects the water quality. Historically Ozaukee Lake's main external source of TP was from agricultural runoff entering the lake and farming within the current lake boundary. Currently the Lake County Forest Preserve is restoring the public and private open space into a savannah oak prairie and the external nutrient runoff should be minimal. This may indicate that a majority of Ozaukee Lake's TP was from internal sources. The Lake County Forest Preserve active management in 2009 included: winter cutting of exotic terrestrial plants and shrubs including Buckthorn and Honeysuckle and early summer herbicide treatments for those species and native prairie seed planting in the historical agricultural fields. Future restoration efforts will include planting a large quantity of oak trees within the prairie and wetland plant species around Ozaukee Lake.

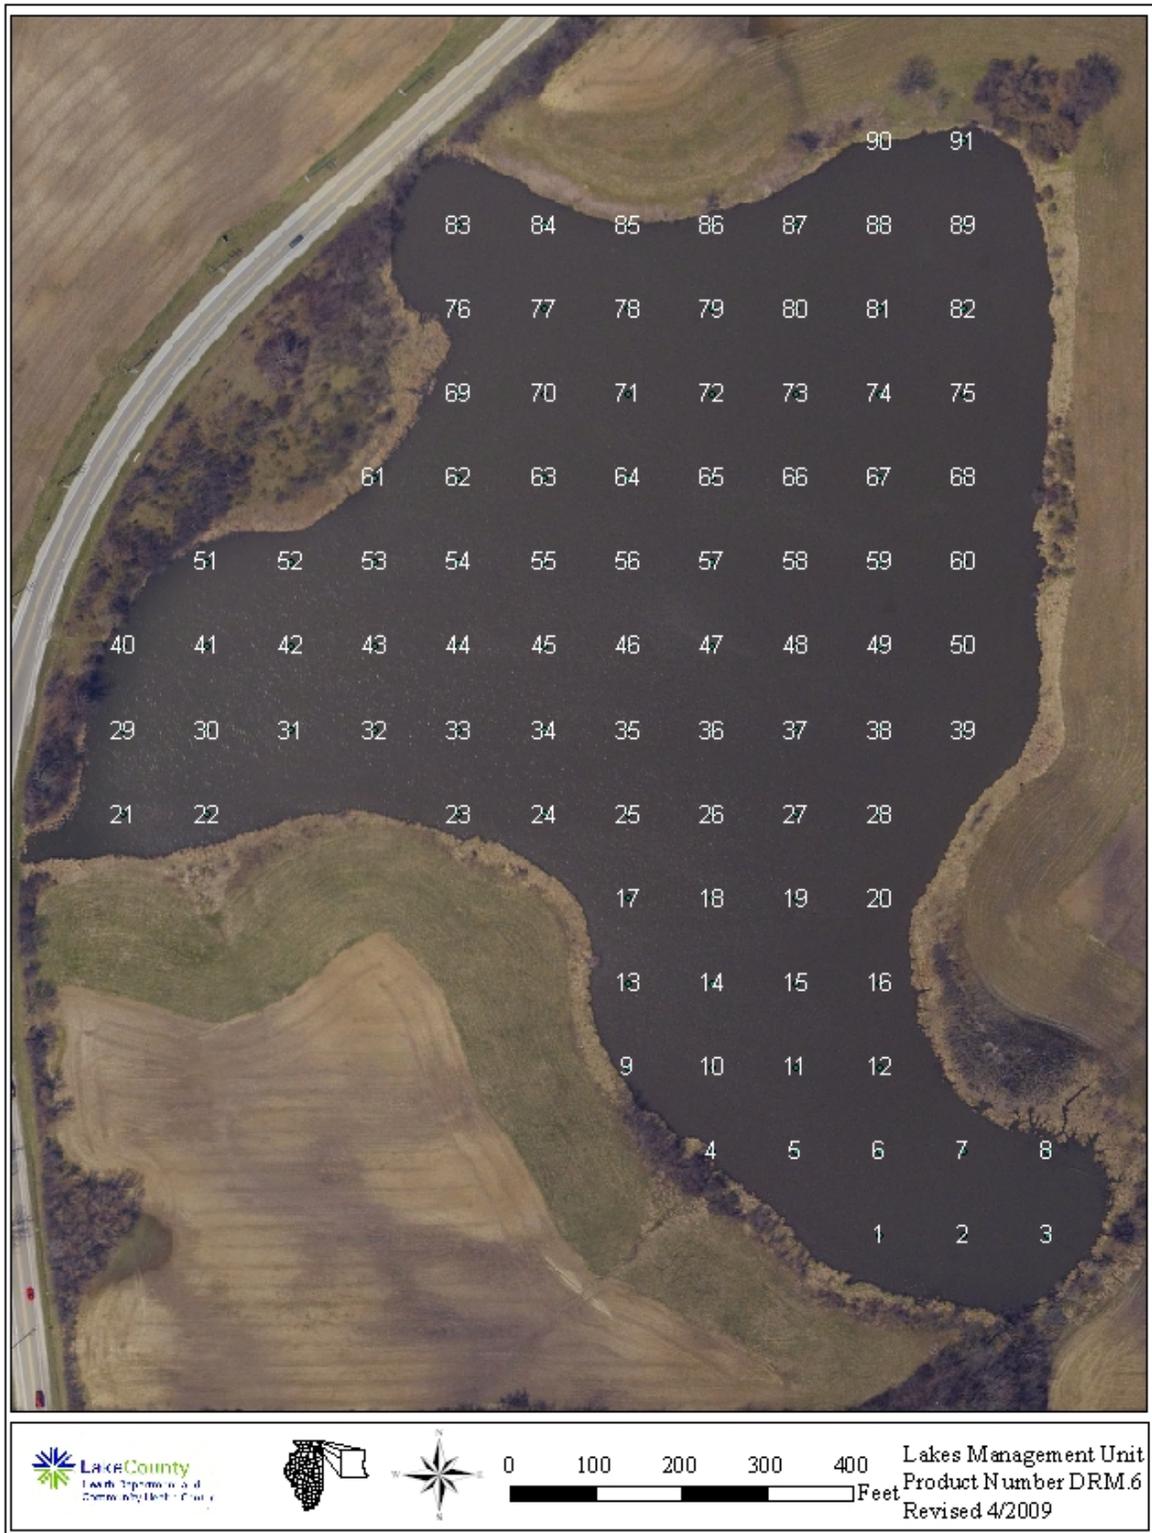
Figure 6. Aquatic plant sampling grid on Ozaukee Lake, July 2009.

Plant sampling was conducted on Ozaukee Lake in July. There were 91 points sampled based on a computer generated grid system with points 30 meters apart (Figure 6). Aquatic plants were only found at four of the sites (Figure 7). In an effort to eliminate sampling bias and to document any existing aquatic plant populations a perimeter assessment and meandering survey within the entire lake was also conducted. The meander method was random and covered areas that could have small amounts of vegetation while the perimeter survey consisted of the areas near the shorelines. During these combined sampling procedures no additional aquatic plants were found. In 2002 Ozaukee Lake had approximately 10% aquatic plant surface coverage in 2009 that percentage was nearly halved at 5.5% (Table 5b). The diversity and health of aquatic plant populations can be influenced by a variety of factors. Water clarity and depth are the major limiting factors in determining the maximum depth at which aquatic plants will grow. When the light level in the water column falls below 1% of the surface light level, plants can no longer photosynthesize. The 1% light level in Ozaukee Lake reached the 3 foot depth (bottom) for the entire sampling season. Plants were only found at a maximum depth of 0.5 feet. The morphology of Ozaukee Lake is particularly shallow with the average depth being 1.64 feet. The shallow nature, availability of light and high nutrients makes Ozaukee Lake likely to experience 100% aquatic plant cover. A healthy lake has an aquatic plant community that covers 30-40% of the lake; however only 5.5% of Ozaukee Lake experienced aquatic plants and the species documented were mostly considered nuisance species indicating poor water quality. There were two exotic species present in the lake, Curlyleaf Pondweed and Eurasian Watermilfoil. While the aquatic plant community was sparse the two species found at 3% of the sites were Coontail and Eurasian Watermilfoil (Table 5a). Curlyleaf Pondweed was only found at 2 sites. This exotic plant has a tolerance for low light and low water temperatures that allow it to get a head start and out-compete native plants in the spring. Curlyleaf Pondweed in Lake County is known for forming dense mats that interfere with boating and other recreational uses. An example of this was Summerhill Lake sampled in 2009 by the LMU. However due to the degraded water quality of Ozaukee Lake even an exotic with advantages that other native plants do not have could not establish a population in the lake due to the exceptionally high TSS levels. Duckweed was only found at one site in Ozaukee Lake. Duckweed is an aquatic floating plant that is not limited by light availability or substrate, this species typically appears in highly nutrient enriched lakes and reproduces at an alarming rate. However this situation did not occur on Ozaukee Lake as the Duckweed population has not increased as the 2002 inventory also documented a 1% occurrence. Blue-green algae dominated the surface of Ozaukee Lake during the entire sampling season. Blue green algae are often described as “nuisance” or “noxious” because some can grow to enormous populations that discolor lakes and form floating scums. This was the situation on

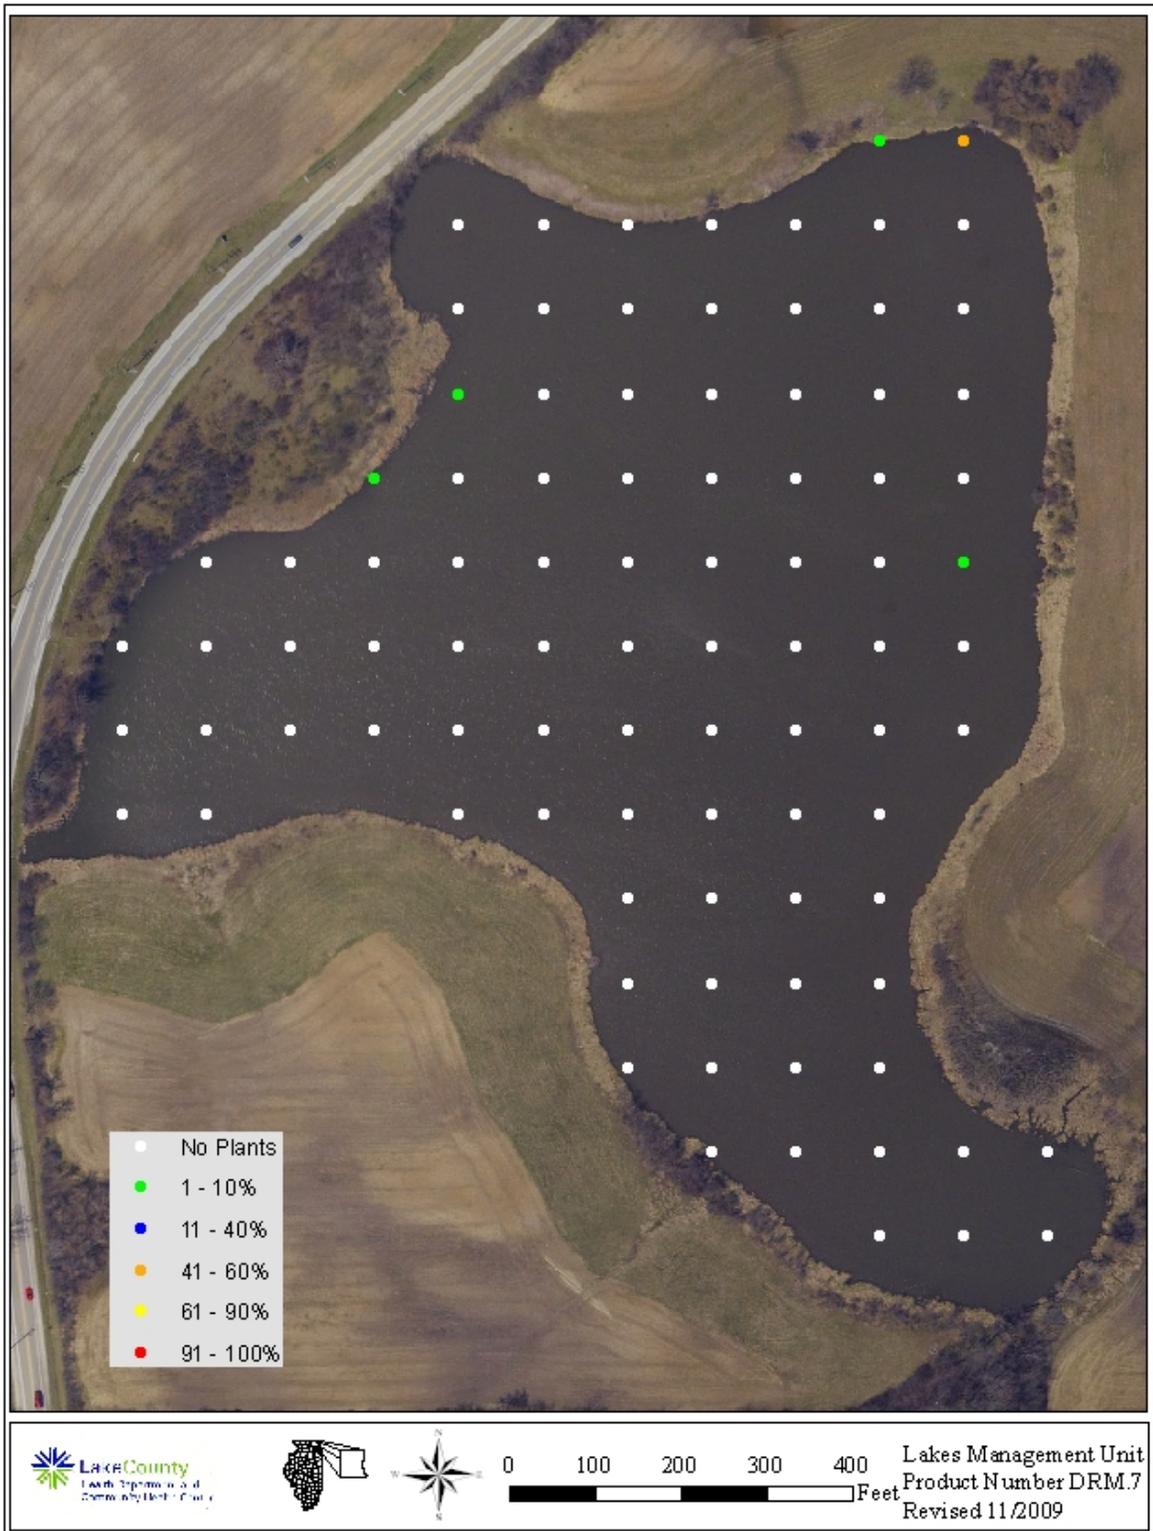
Figure 7. Aquatic plant sampling grid that illustrates plant density on Ozaukee Lake, July 2009.

Presence of aquatic plants in Ozaukee Lake was sparse; only 5.5% of the lake surface area exhibited aquatic plants and the species documented were mostly considered nuisance species indicating poor water quality. There were two exotic species present in the lake, Curlyleaf Pondweed and Eurasian Watermilfoil. Although these exotic species possess many advantages over native aquatic plants Ozaukee Lake could not support an increase in aquatic plant populations due to the low light availability and the competition from blue-green algae. Blue-green algae are a concern due to the threat they pose through the potential release of cyanotoxins that may harm invertebrates, fish, and mammals.

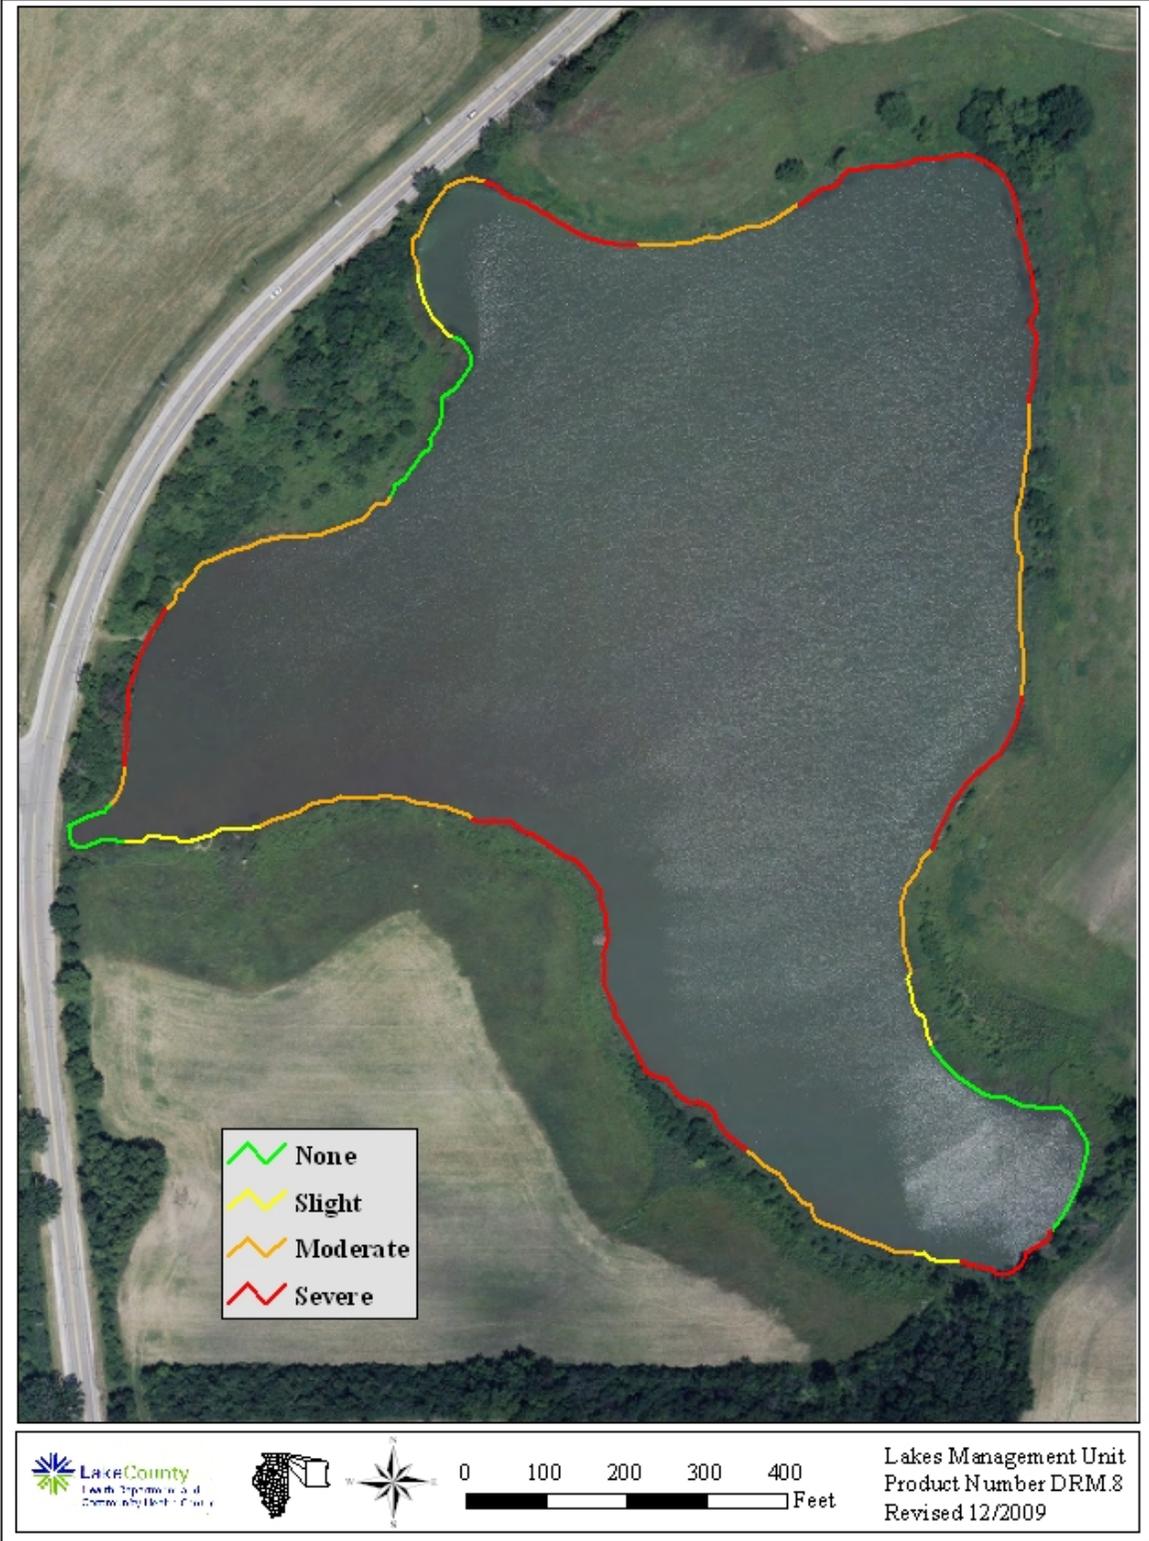
Figure 8. Shoreline erosion on Ozaukee Lake, 2009.

The shoreline was reassessed in 2009 for significant changes in erosion since 2002. Based on the 2009 assessment, there was an increase in shoreline erosion with 85% of the shoreline having some degree of erosion (Figure 8). This was higher than the 2002 assessment of 77% and the most notable change was the 40% increase in severe erosion. Overall, 9% of the shoreline had slight erosion, 36% had moderate erosion, and 40% had severe erosion. The severe and moderately eroded areas should be remediated immediately to prevent additional loss of shoreline and prevent continued degradation of the water quality through sediment inputs. It is much easier and less costly to mitigate slightly eroding shorelines than those with more severe erosion. The most affected shoreline type was buffer; these areas that have experienced erosion were found to be moderately to steeply sloped. Additionally, these buffer areas, which normally have less erosion, were found to be overrun with the invasive species that have poor (shallow) root systems and offer little stabilization benefit.

Based on the 2009 assessment, there was an increase in shoreline erosion with 85% of the shoreline having some degree of erosion. This was higher than the 2002 assessment of 77% and the most notable change was the 40% increase in severe erosion. The erosion should be addressed soon. All of the eroded areas should be remediated to prevent additional loss of shoreline and prevent continued degradation of the water quality through sediment inputs. Buffered areas around the lake also exhibited erosion especially areas with steep slopes remediation of shoreline slopes may be necessary to implement successful shoreline restoration (Appendix D2).
