LAKE COUNTY, ILLINOIS

# 2010 WHITE LAKE SUMMARY REPORT

PREPARED BY THE LAKE COUNTY HEALTH DEPARTMENT

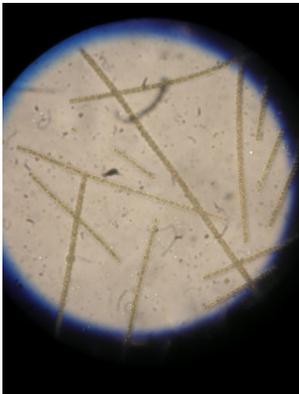
Figure 5. Planktothrix, a filamentous cyanobacteria collected in September, 2010.

In September during a site visit, a grab sample collected near the outlet of White Lake of filamentous algae, turned

out to be *Planktothrix* (Figure 5), a cyanobacteria. It is unclear if this particular species found in White Lake carries toxic compounds.
