LAKE COUNTY, ILLINOIS

2011 GAGES LAKE SUMMARY REPORT

PREPARED BY THE
LAKE COUNTY HEALTH DEPARTMENT
Population Health Environmental Services

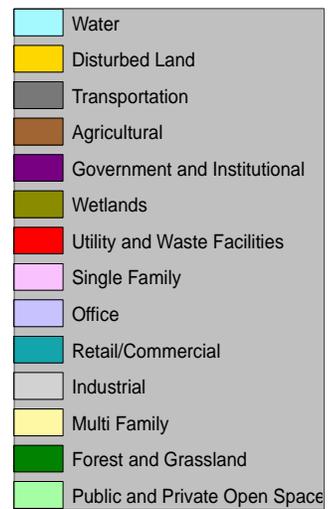
2011 LAND USE IN THE GAGES LAKE WATERSHED

Land Use	Acreage	Runoff Coeff.	Estimated Runoff, acft.	% Total of Estimated Runoff
Agricultural	0.12	0.05	0.0	0.0%
Forest and Grassland	11.70	0.05	1.6	0.4%
Government and Institutional	7.69	0.50	10.6	2.6%
Multi Family	30.15	0.30	24.9	6.2%
Public and Private Open Space	32.28	0.15	13.3	3.3%
Retail/Commercial	8.11	0.85	18.9	4.7%
Single Family	221.48	0.30	182.7	45.4%
Transportation	64.04	0.85	149.7	37.2%
Utility and Waste Facilities	0.52	0.30	0.4	0.1%
Water	144.75	0.00	0.0	0.0%
Wetlands	0.90	0.05	0.1	0.0%
TOTAL	521.74		402.3	100.0%

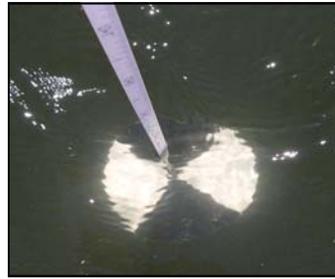
A Secchi disk is an eight-inch diameter weighted metal plate painted black and white in alternating quadrants. A calibrated rope is used to lower the disc into the water and measure the depth to which it is visible.

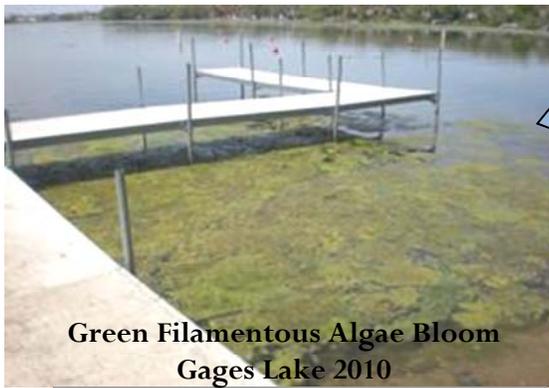
Monthly Total Suspended Solid Concentrations and Secchi Depth in Gages Lake,

Calculated nonvolatile suspended solids (NVSS) was 2.4 mg/L. This means that 50% of the TSS concentration in 2011 can be attributed to organic particles, such as algae and 50% can be attributed to non-organic particles such as sediment. Turbidity caused by algae and

***2011 Lake County median TSS = 8.6 mg/L**

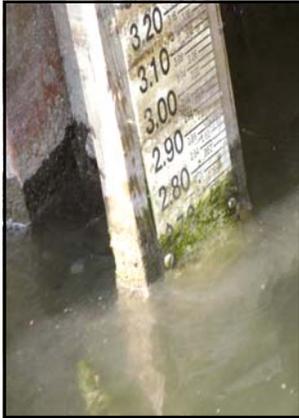
EXAMPLE OF A PERMANENT STAFF GAGE

watershed and large lake size helps reduce fluctuations in lake level. In order to accurately monitor water levels it is recommended that a staff gauge be installed and levels measured and recorded frequently (daily or weekly).

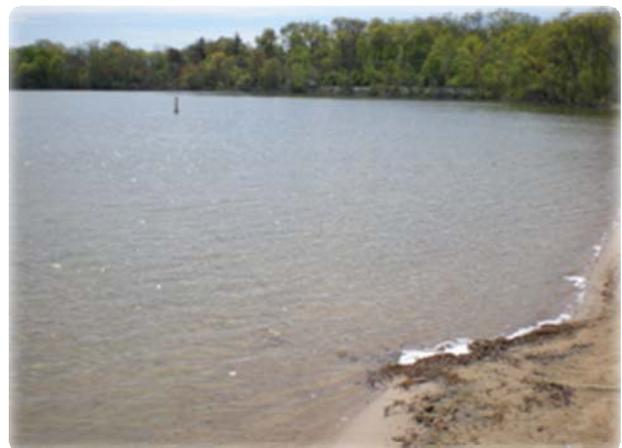
Water quality data for Gages Lake 1999, 2003, and 2011.

2011		Epilimnion														
DATE	DEPTH	ALK	TKN	NH3-N	NO3-N	TP	SRP	TDS	Cl-	TSS	TS	TVS	SECCHI	COND	pH	DO
11-May	3	137	0.62	<0.1	0.3	0.013	<0.005	NA	249	2.0	646	113	8.3	1.1670	8.26	10.03
22-Jun	3	105	0.51	<0.1	<0.05	0.024	<0.005	NA	241	3.2	578	93	7.12	0.8893	8.74	8.71
22-Jul	3	117	0.65	<0.1	<0.05	0.020	<0.005	NA	256	4.4	640	106	5.18	1.0730	8.43	7.94
17-Aug	3	113	2.34	<0.1	<0.05	0.026	<0.005	NA	239	9.4	600	99	3	0.9822	8.7	8.99
21-Sep	3	113	0.73	<0.1	<0.05	0.016	<0.005	NA	244	4.8	603	106	3.63	0.9999	8.46	8.87

- **Decrease Curlyleaf Pondweed populations**
- **Decrease Eurasian Watermilfoil population**
- **Continue Participation in Volunteer Lake Monitoring Program**
- **Participate in the Clean Waters Clean Boats Program**
- **Mitigate shoreline exhibiting erosion**
- **Encourage homeowners to incorporate native plants in their landscaping through rain gardens or shoreline filter strips**
- **Continue fish work with Illinois Division of Natural Resources**
- **Use salt alternatives and proper application**
