# Lake Michigan Watershed Ravine Inventory, Lake and Cook Counties, Illinois

## Summary Report

March 2019

Thirty-three ravines in Lake County and seven ravines in Cook County were assessed in the late fall of 2018 and the early winter of 2019 by Lake County Stormwater Management Commission (SMC). An additional thirteen ravines in Lake County were assessed by the City of Lake Forest in the summer of 2017. Appendix A contains an index map of all the ravines inventoried. It is accompanied by a set of maps with one map for each individual ravine inventoried. This report updates previous summaries produced in 2009 (“Stresses and Opportunities in Illinois Lake Michigan Watersheds: Strategic Sub-Watershed Identification Process Report (SSIP) for the Lake Michigan Watershed Ecosystem Partnership”) and in 2013 (Addendum #1).

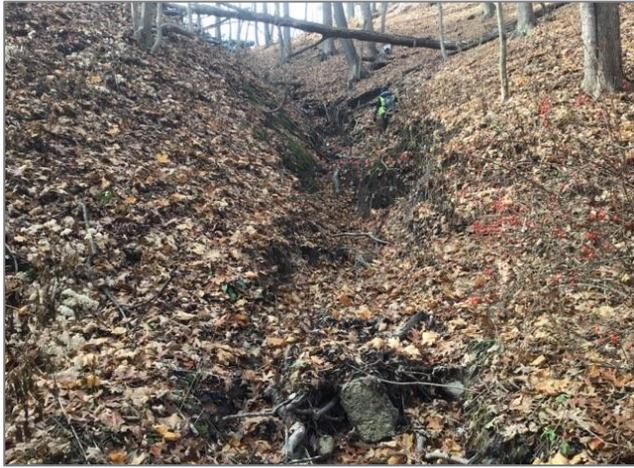
**Figure 1.** Gully rated 'most unstable' in Ravine 7L.

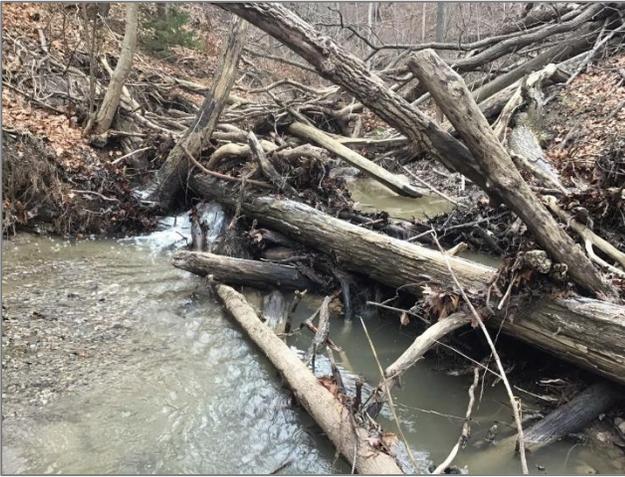
Figure 7. Log jam in South Ravine.

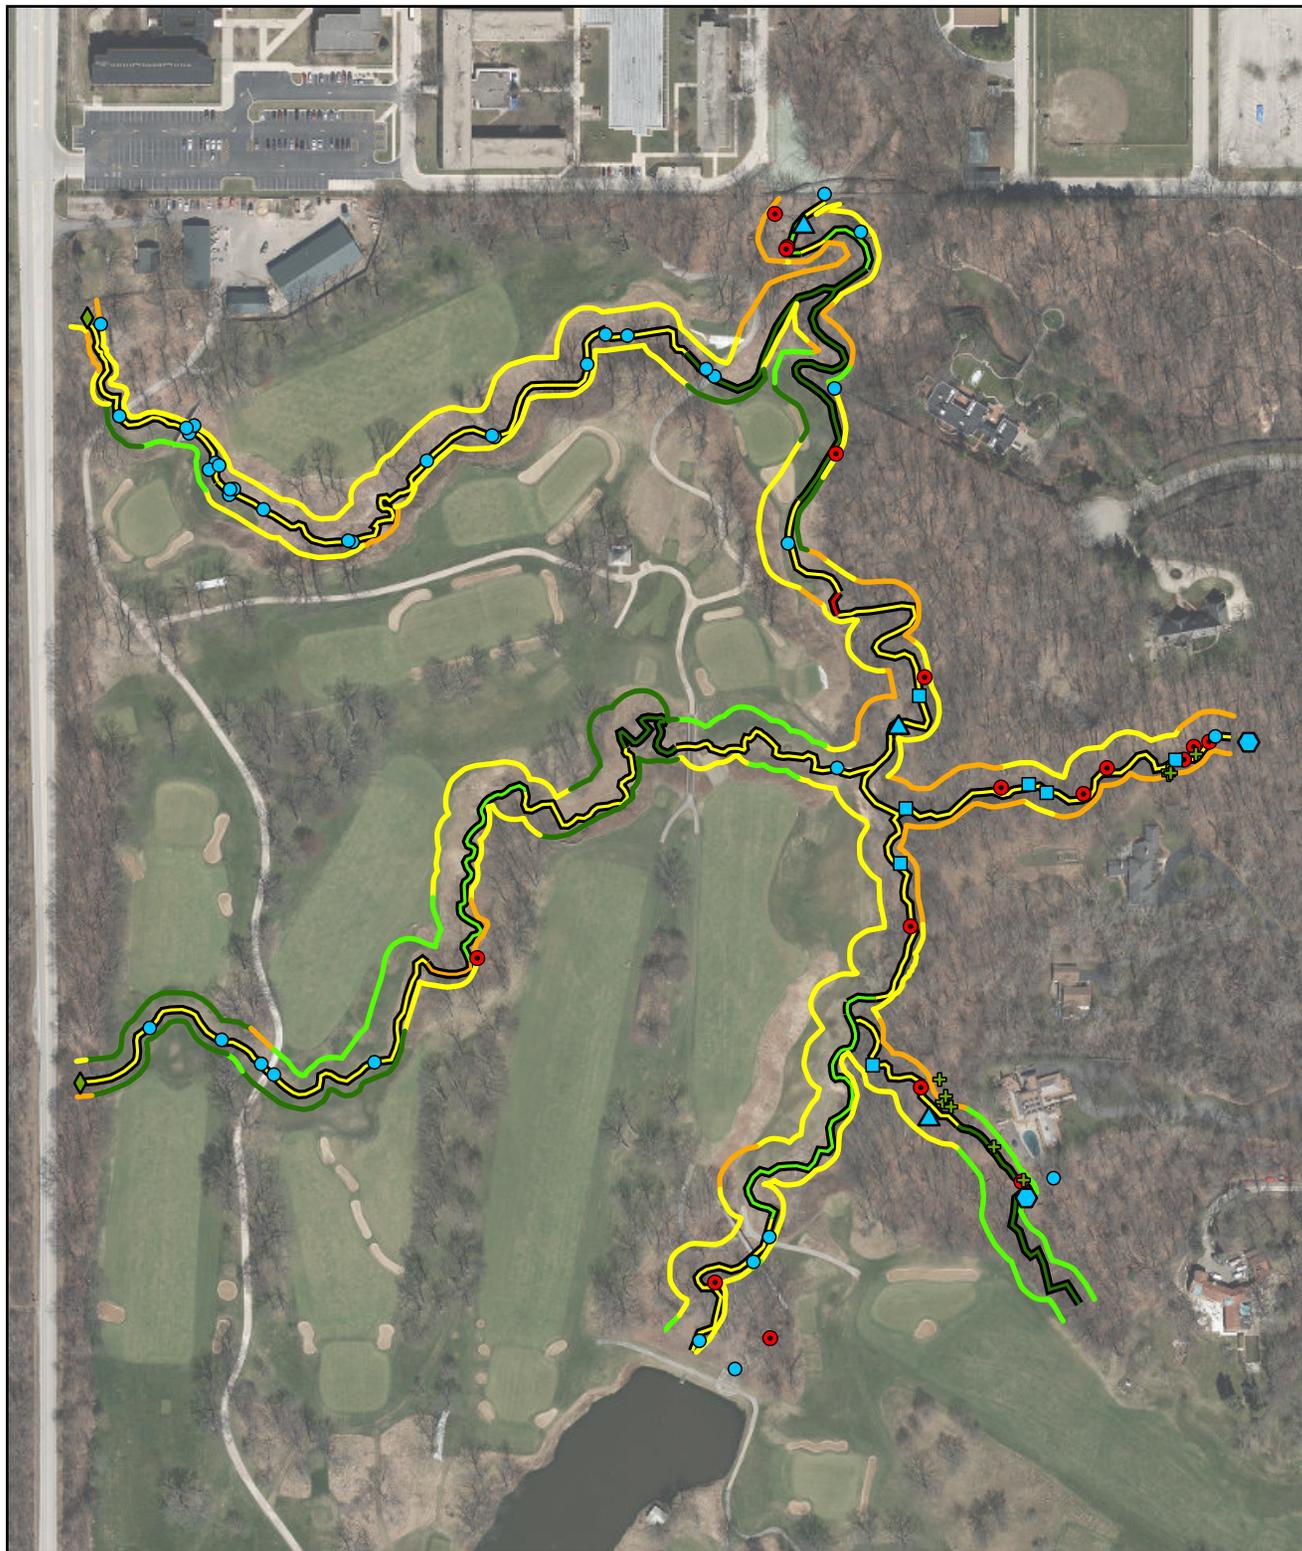
**McCormick/Janes  
Ravine**

**Ranked 13 out of 53  
for Erosion Potential**

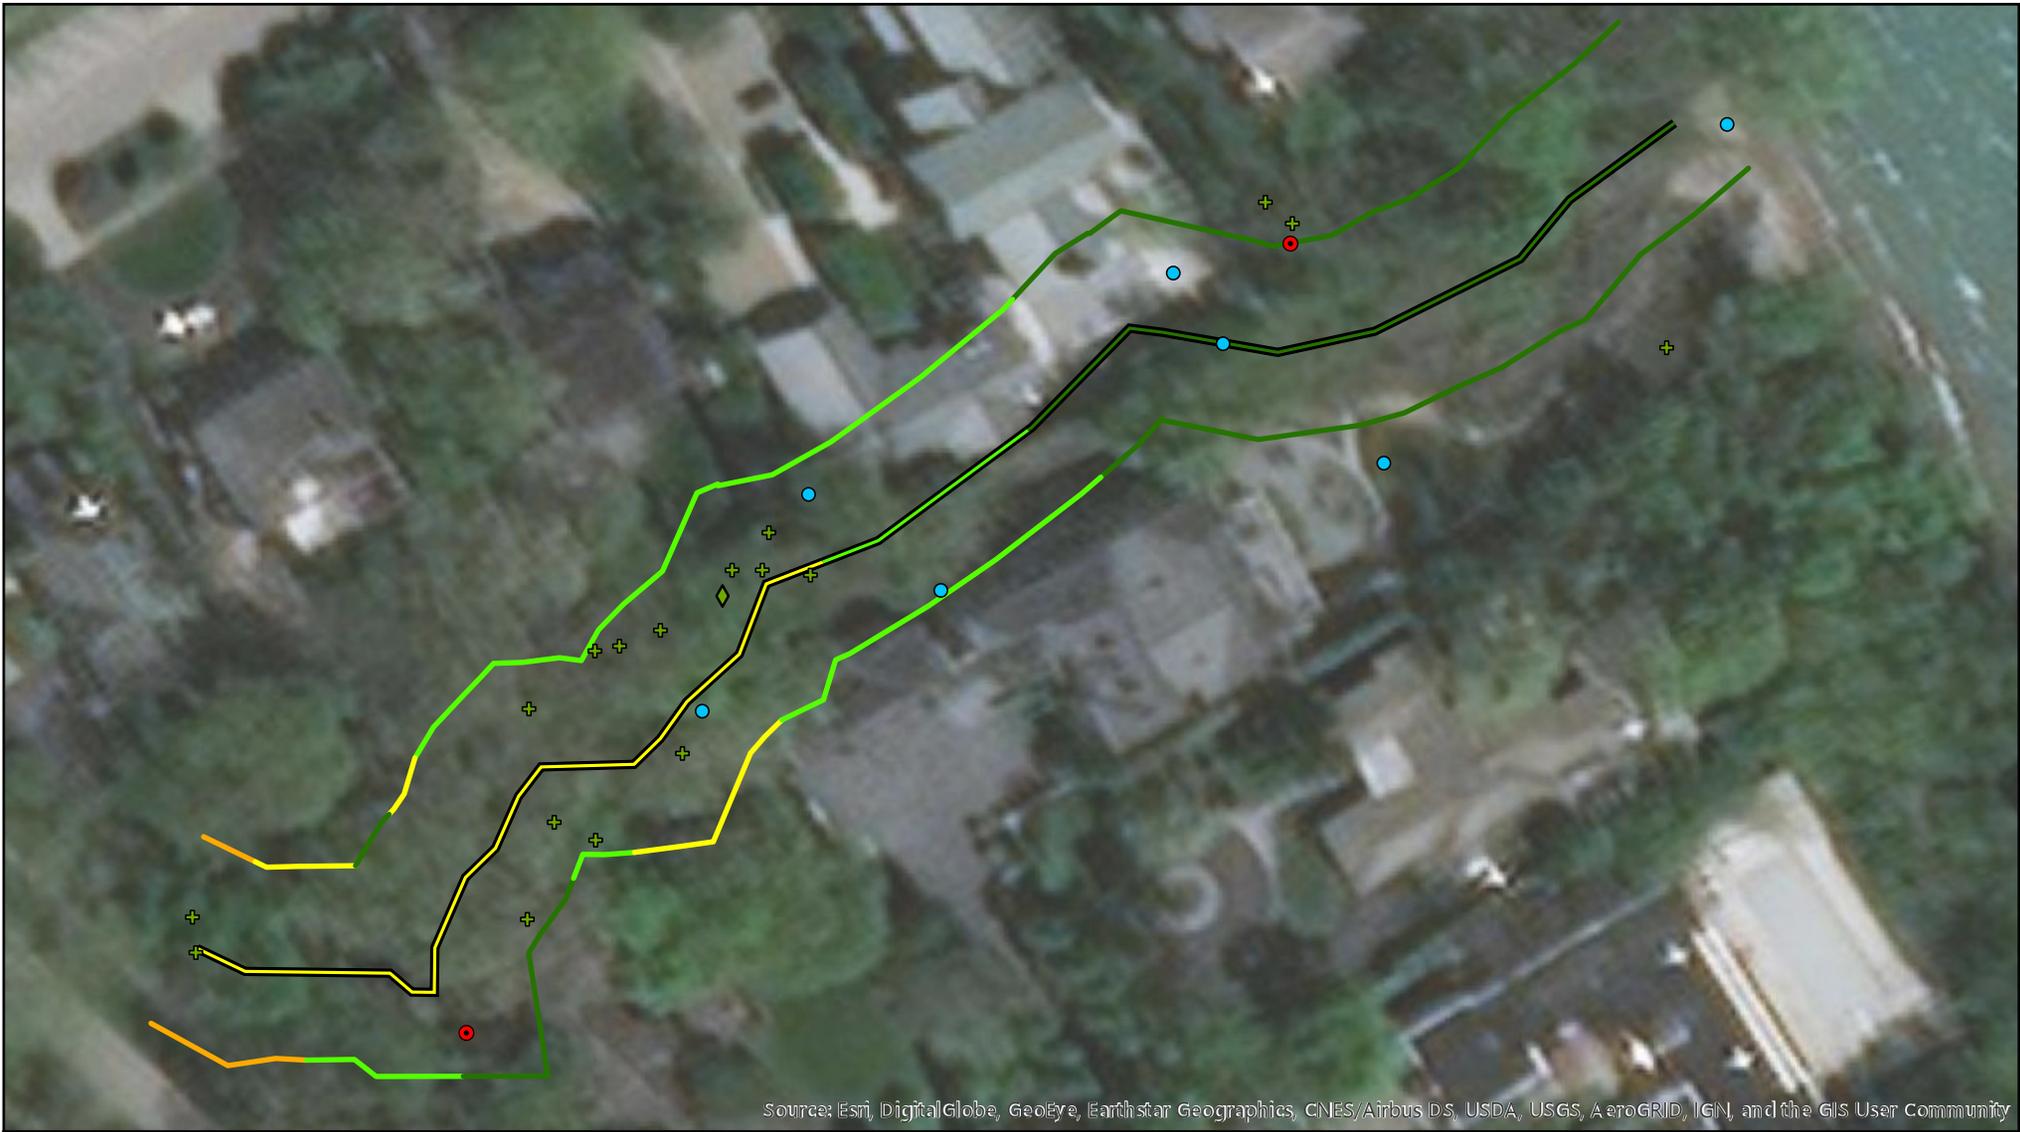
**Ravine 2L**

**Ranked 22 out of 53  
for Erosion Potential**

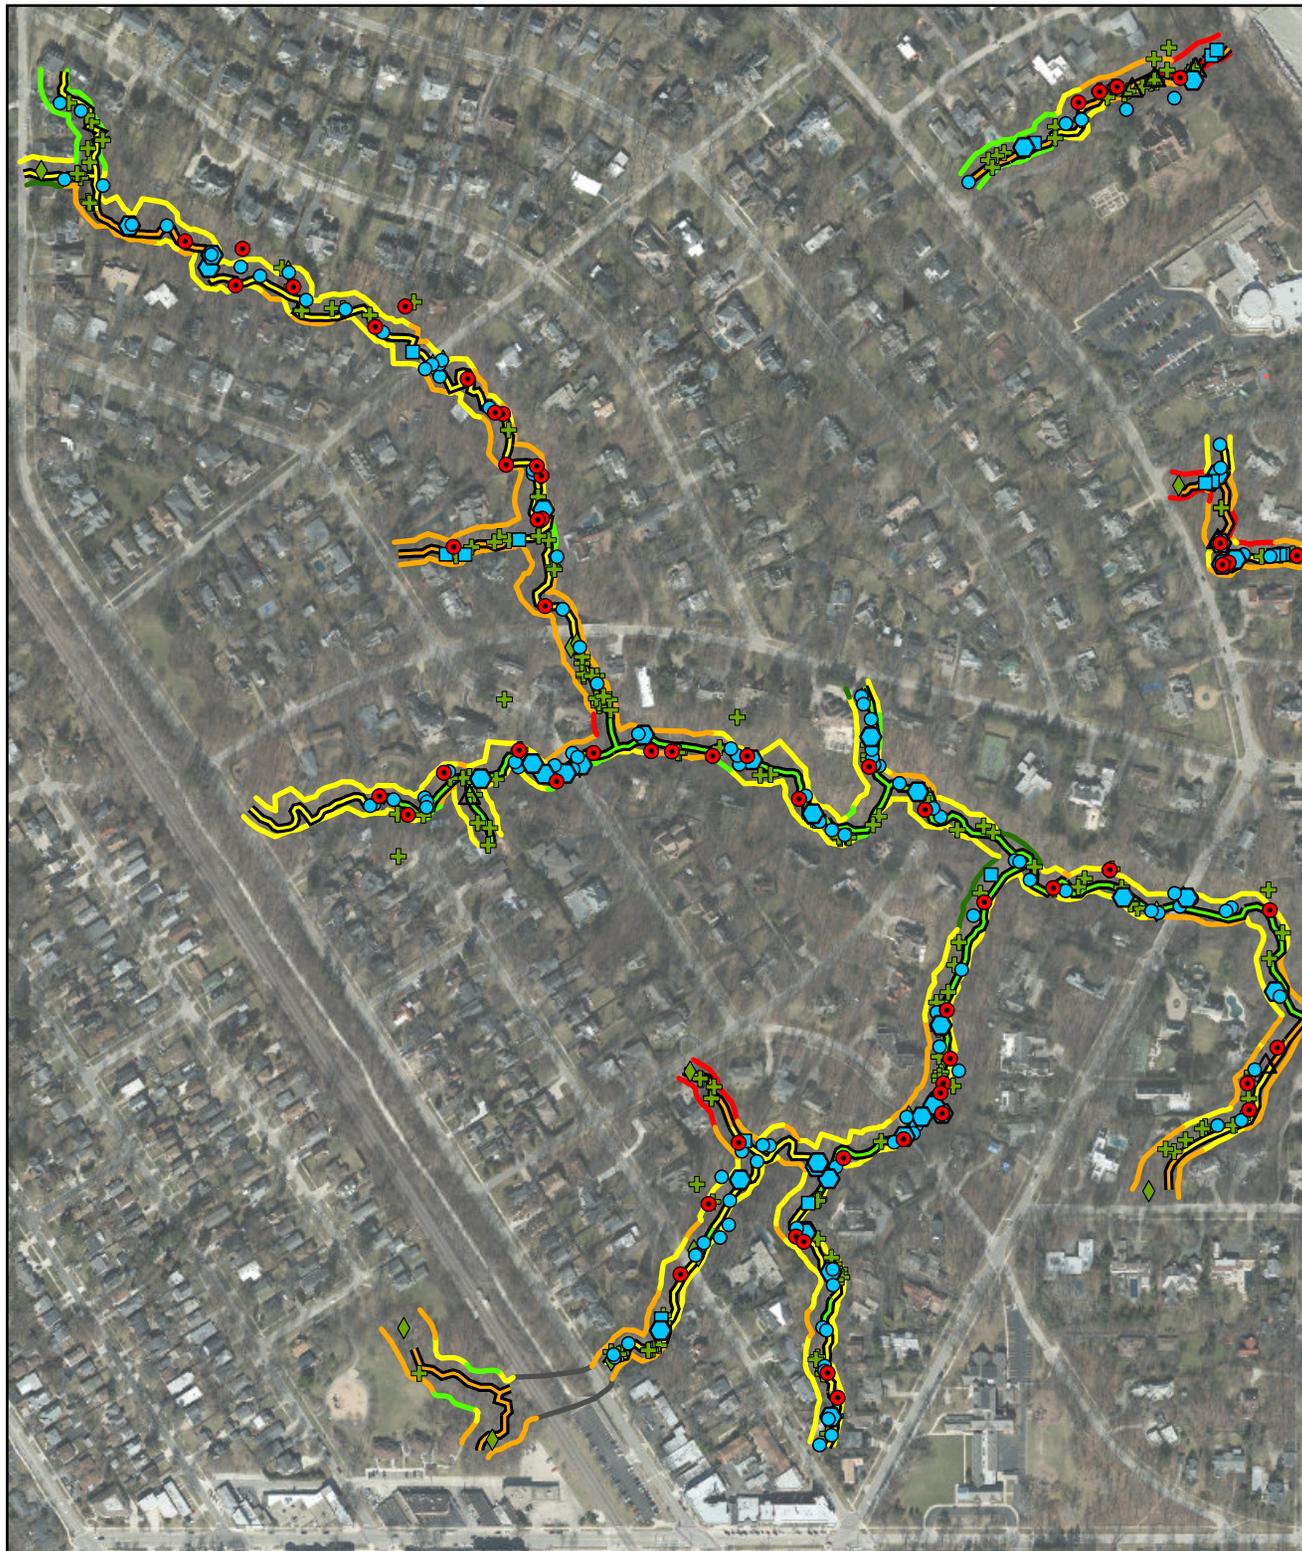
**Ravine 3C**

**Ranked 26 out of 53  
for Erosion Potential**

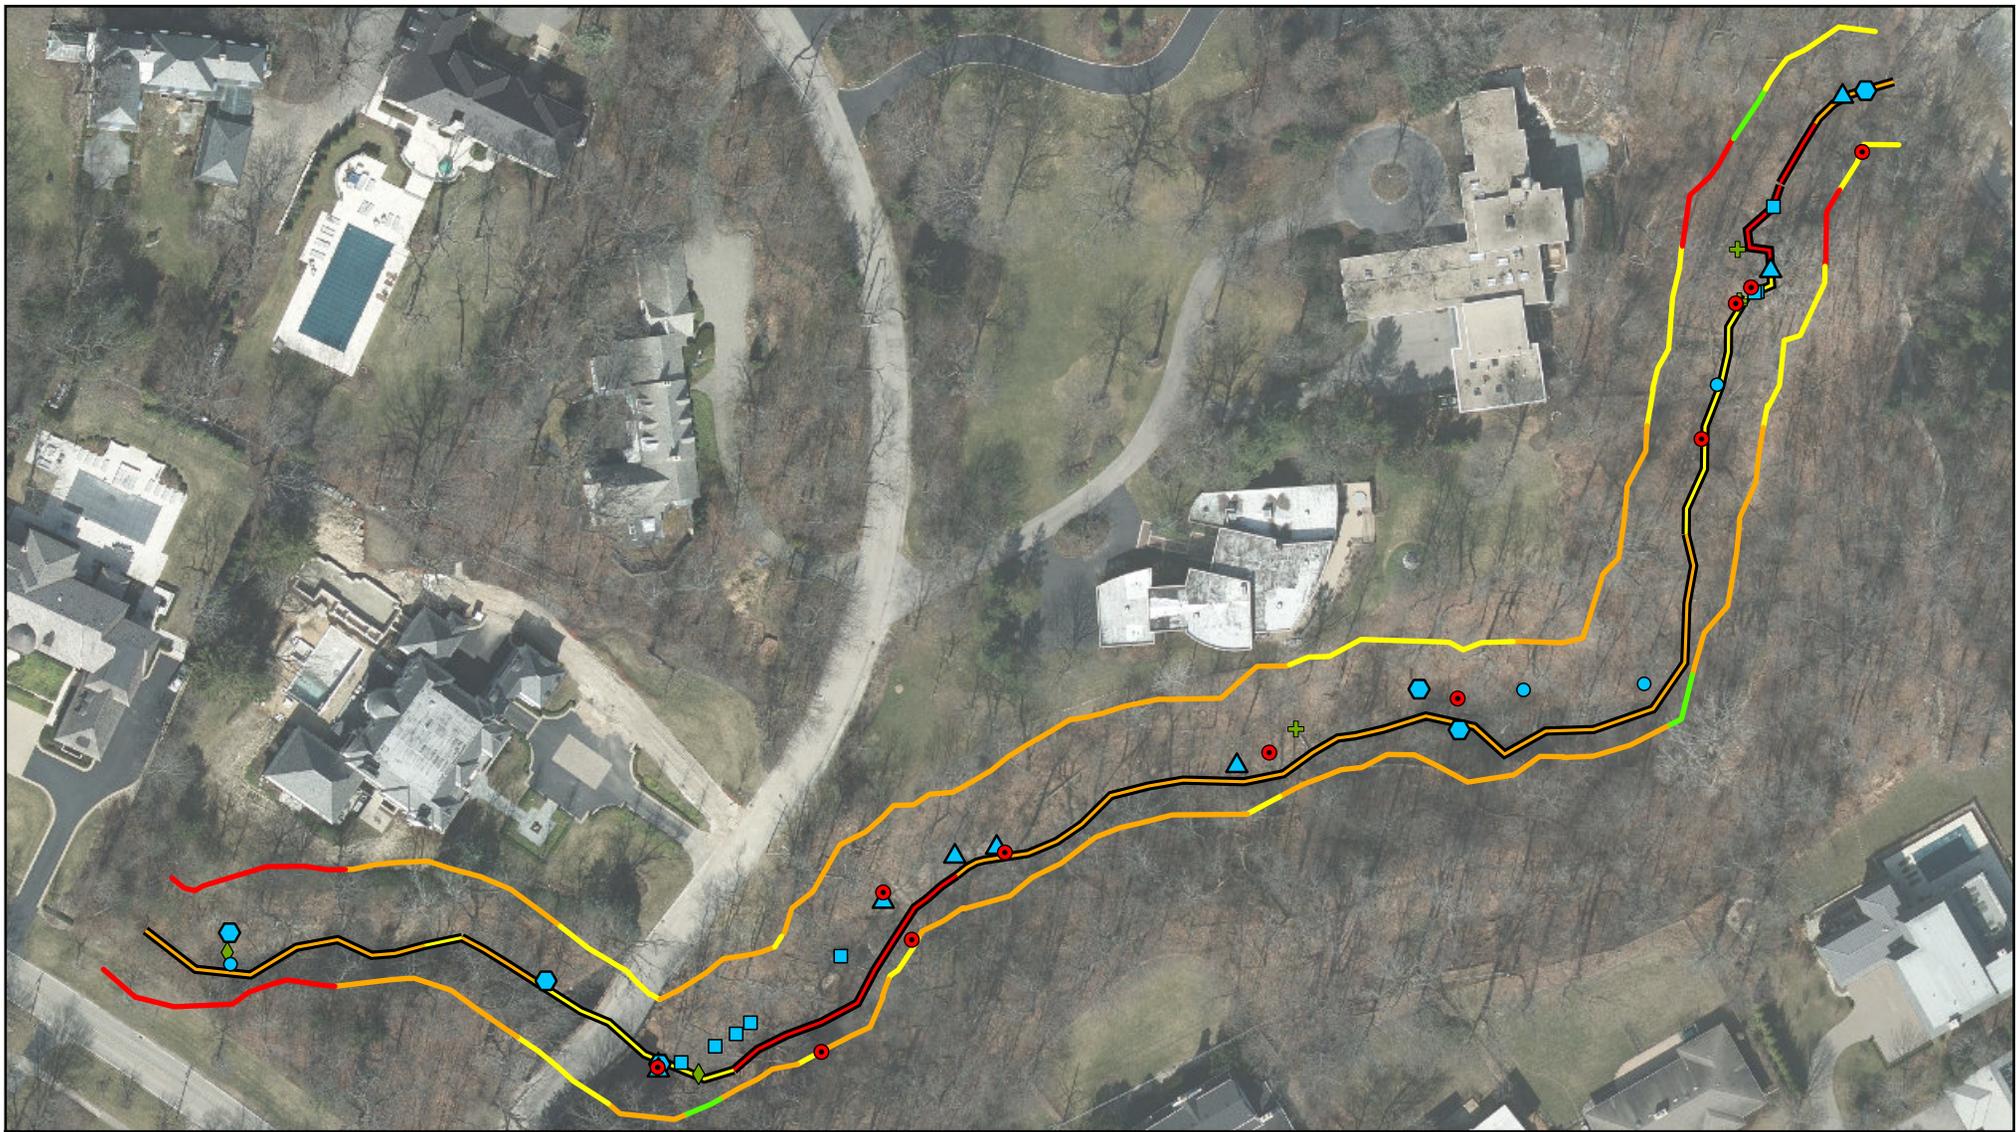
**Ravine 6C**

**Ranked 25 out of 53  
for Erosion Potential**

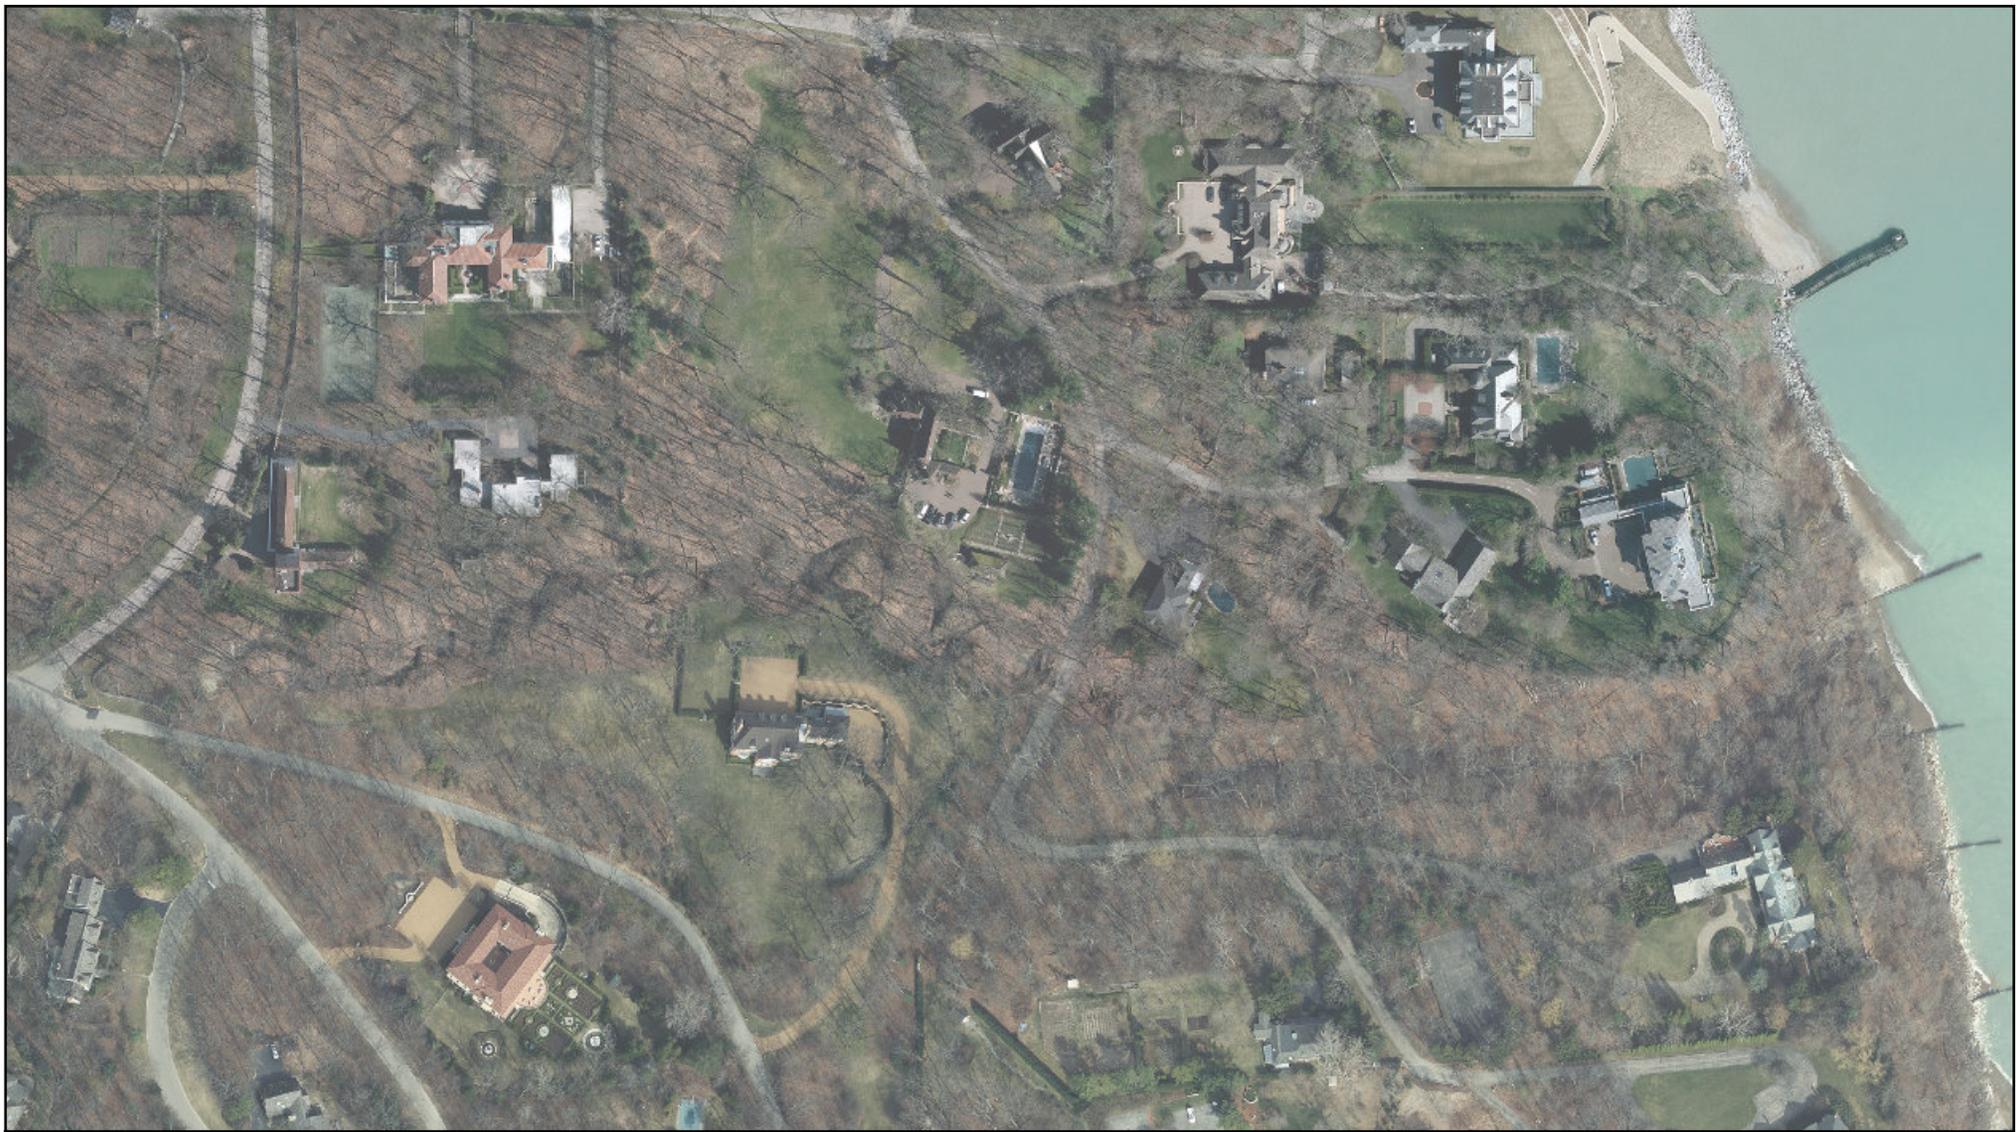
**Stanley Ravine**

**Ranked 33 out of 53  
for Erosion Potential**
